**CONSTRUCTION NOTICE**

**ASHTABULA EAST SUBSTATION 138 KV  
TRANSMISSION LINE CONNECTION  
RECONFIGURATION PROJECT  
OPSB CASE NO.: 26-0010-EL-BNR**

**February 2, 2026**

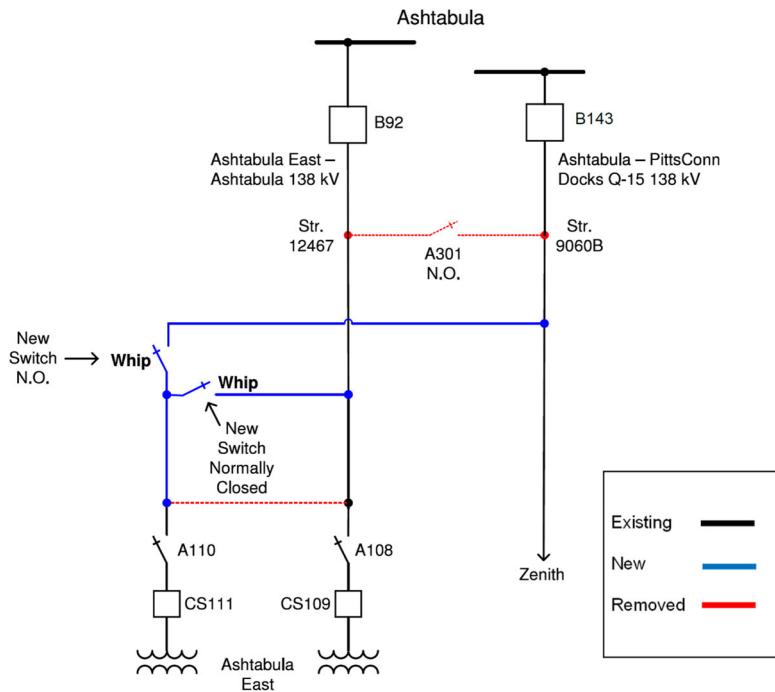
**FIGURE 1**

The proposed Project is intended to improve reliability and operational flexibility for customers served in the Ashtabula County area, as well as surrounding areas. The Ashtabula East Substation, which serves approximately 16 MVA of load, is currently fed from the Ashtabula Substation via the Ashtabula-Ashtabula East 138 kV Transmission Line, with a tap and normally open switch (A301 on Structure #12467, which is currently inoperable) from this line to the Ashtabula-Pitts Conn Dock Q-15 138 kV Transmission Line. The location of this tap and switch results in nine spans of conductor and eight wood poles that cannot be maintained without a complete outage of the Ashtabula East Substation and its customer load. This Project will provide a second dedicated feed to Ashtabula East from the Ashtabula-PittsConn Docks Q-15 138 kV Transmission Line. The existing tap from Ashtabula Substation to Ashtabula East Substation will be removed and replaced with a new tap that includes a new switch that will be normally closed (Structure #3). The new second dedicated feed from the Ashtabula-PittsConn Dock Q-15 138 kV Transmission Line will be installed and includes a new switch that will be normally open (Structure #2). This will allow for switching between the two sources during maintenance or outage events, which is not possible today. This will allow for work to be performed on the switch, spans, and poles that could not be serviced without an outage of the entire Ashtabula East Substation. See **Figure 1** for details.

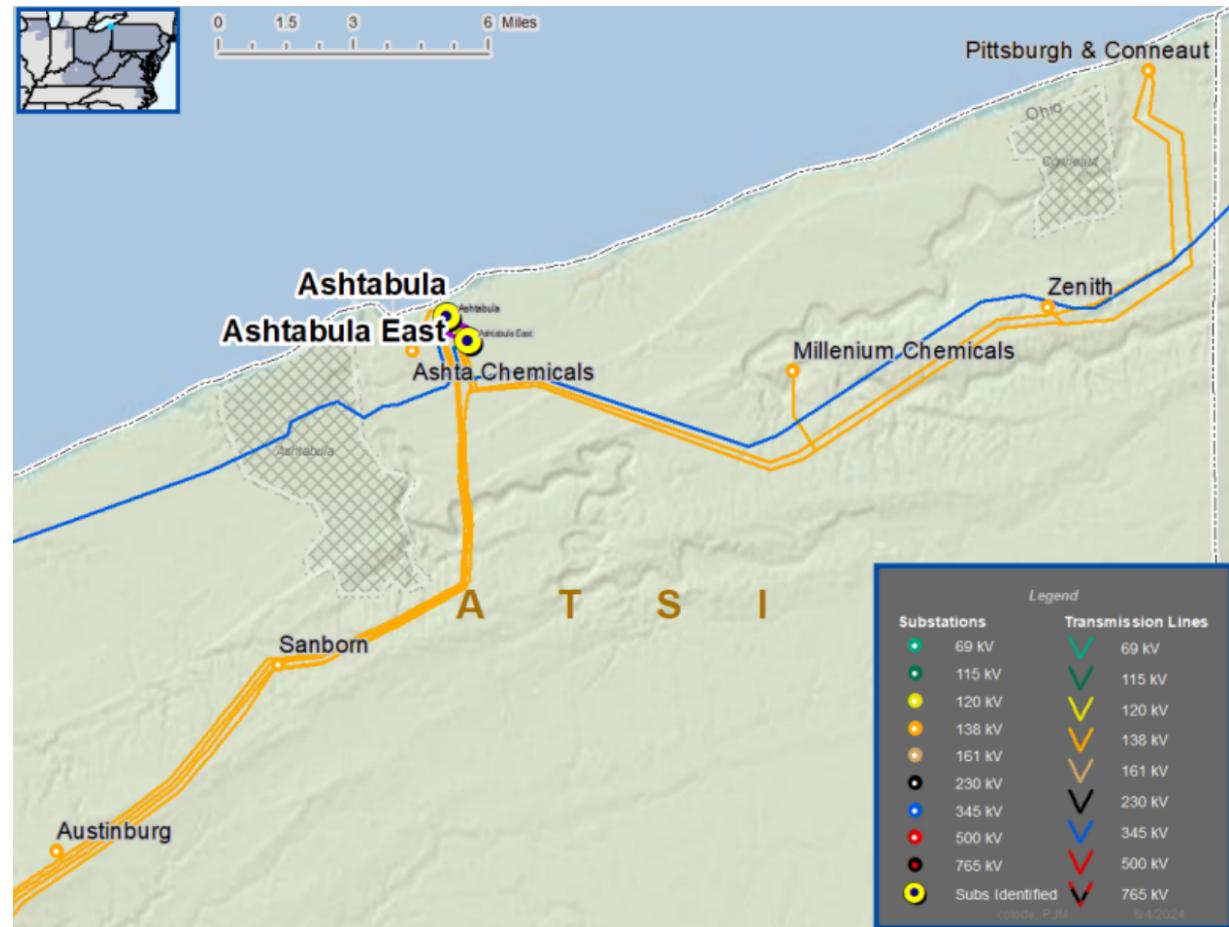
The Ashtabula – Ashtabula East 138 kV Line is 0.30 miles long and serves one distribution substation. - Maintenance work cannot be performed on certain sections of the Ashtabula – Ashtabula East 138 kV Line without an outage to the Ashtabula East Substation. - Ashtabula East Substation serves approximately 16 MW of load and 36,000 customers. - Since 2015, the Ashtabula – Ashtabula East 138 kV Line has experienced two unscheduled sustained outages.

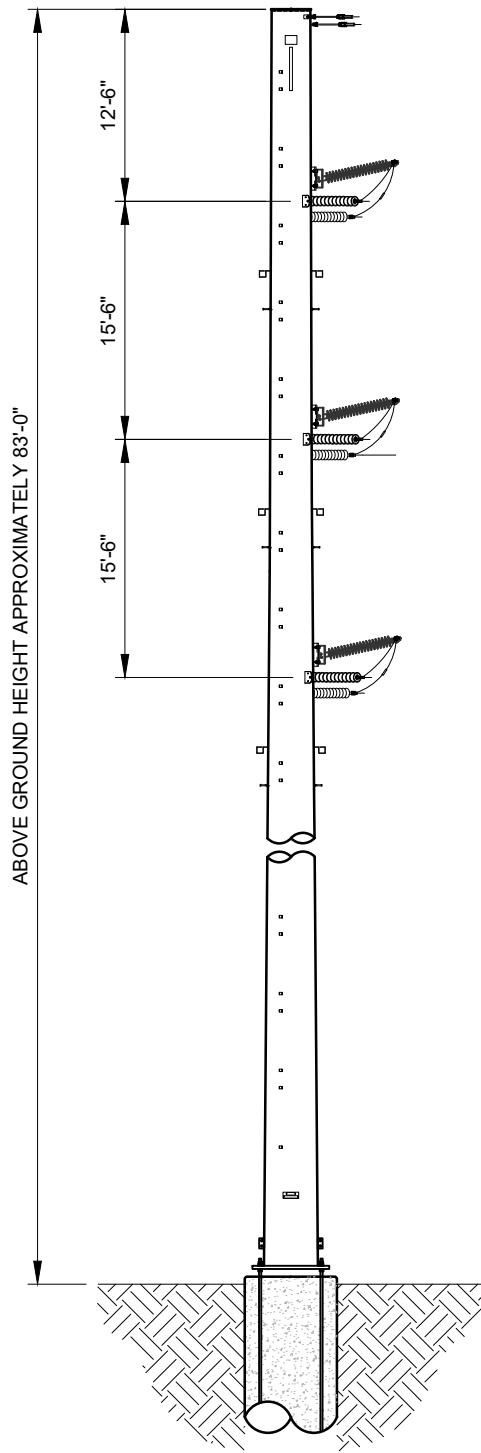
**EXHIBIT 5**

138KV SINGLE CIRCUIT TUBULAR STEEL STRUCTURE  
DEADEND SINGLE POLE ANGLES 0° TO 60°

Insulators: Porcelain  
ROW Width: 100'  
Structure Types: Exhibit 5: 138 kV Steel Monopole DE Structure on Concrete Foundation (Qty. 1)  
Exhibit 6: 138 kV Steel Monopole Switch Structure on Concrete Foundation (Qty. 1)  
Exhibit 7: 138 kV 3-Pole Steel Tap Structure on Concrete Foundation (Qty. 1)  
Exhibit 8: 138 kV 2-Pole Steel Switch Structure on Concrete Foundation (Qty. 1)  
Exhibit 9: 138 kV 2-Pole Steel DE Structure on Concrete Foundation (Qty. 1)

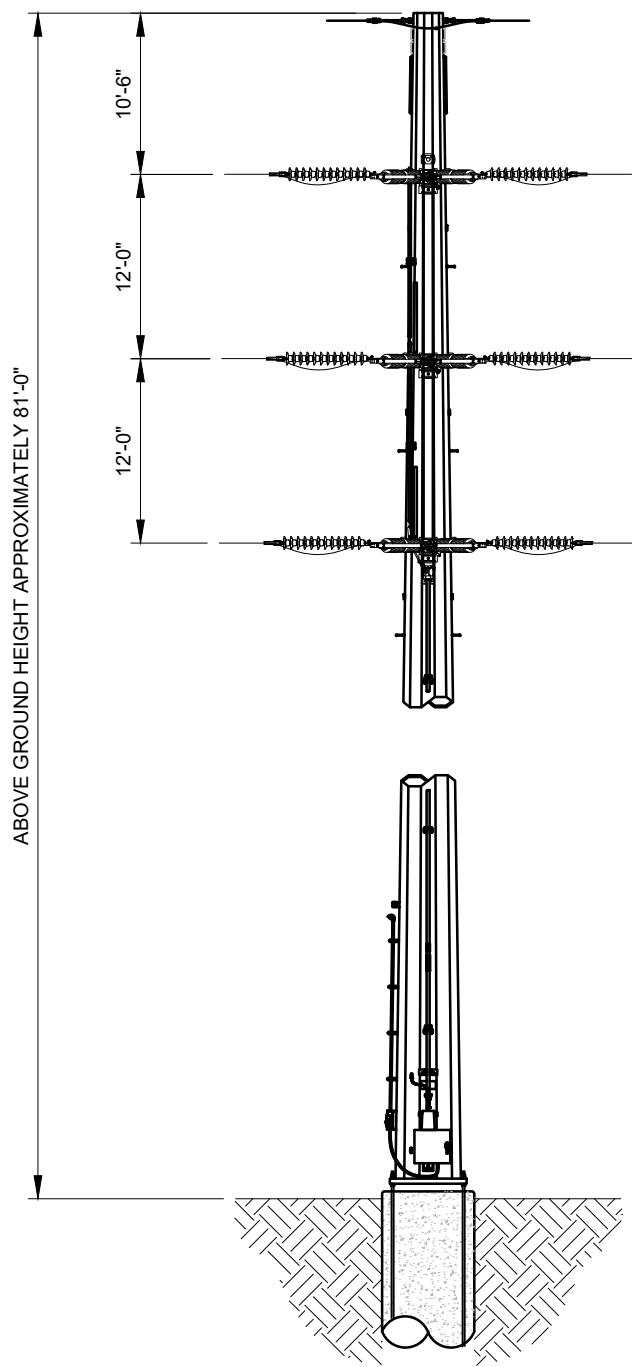
**EXHIBIT 6**

138KV SINGLE CIRCUIT TUBULAR STEEL UNITIZED 2000A  
SWITCH STRUCTURE WITH WHIP OR SINGLE BOTTLE  
INTERRUPTER VERTICAL SINGLE POLE WITH SHIELD WIRE

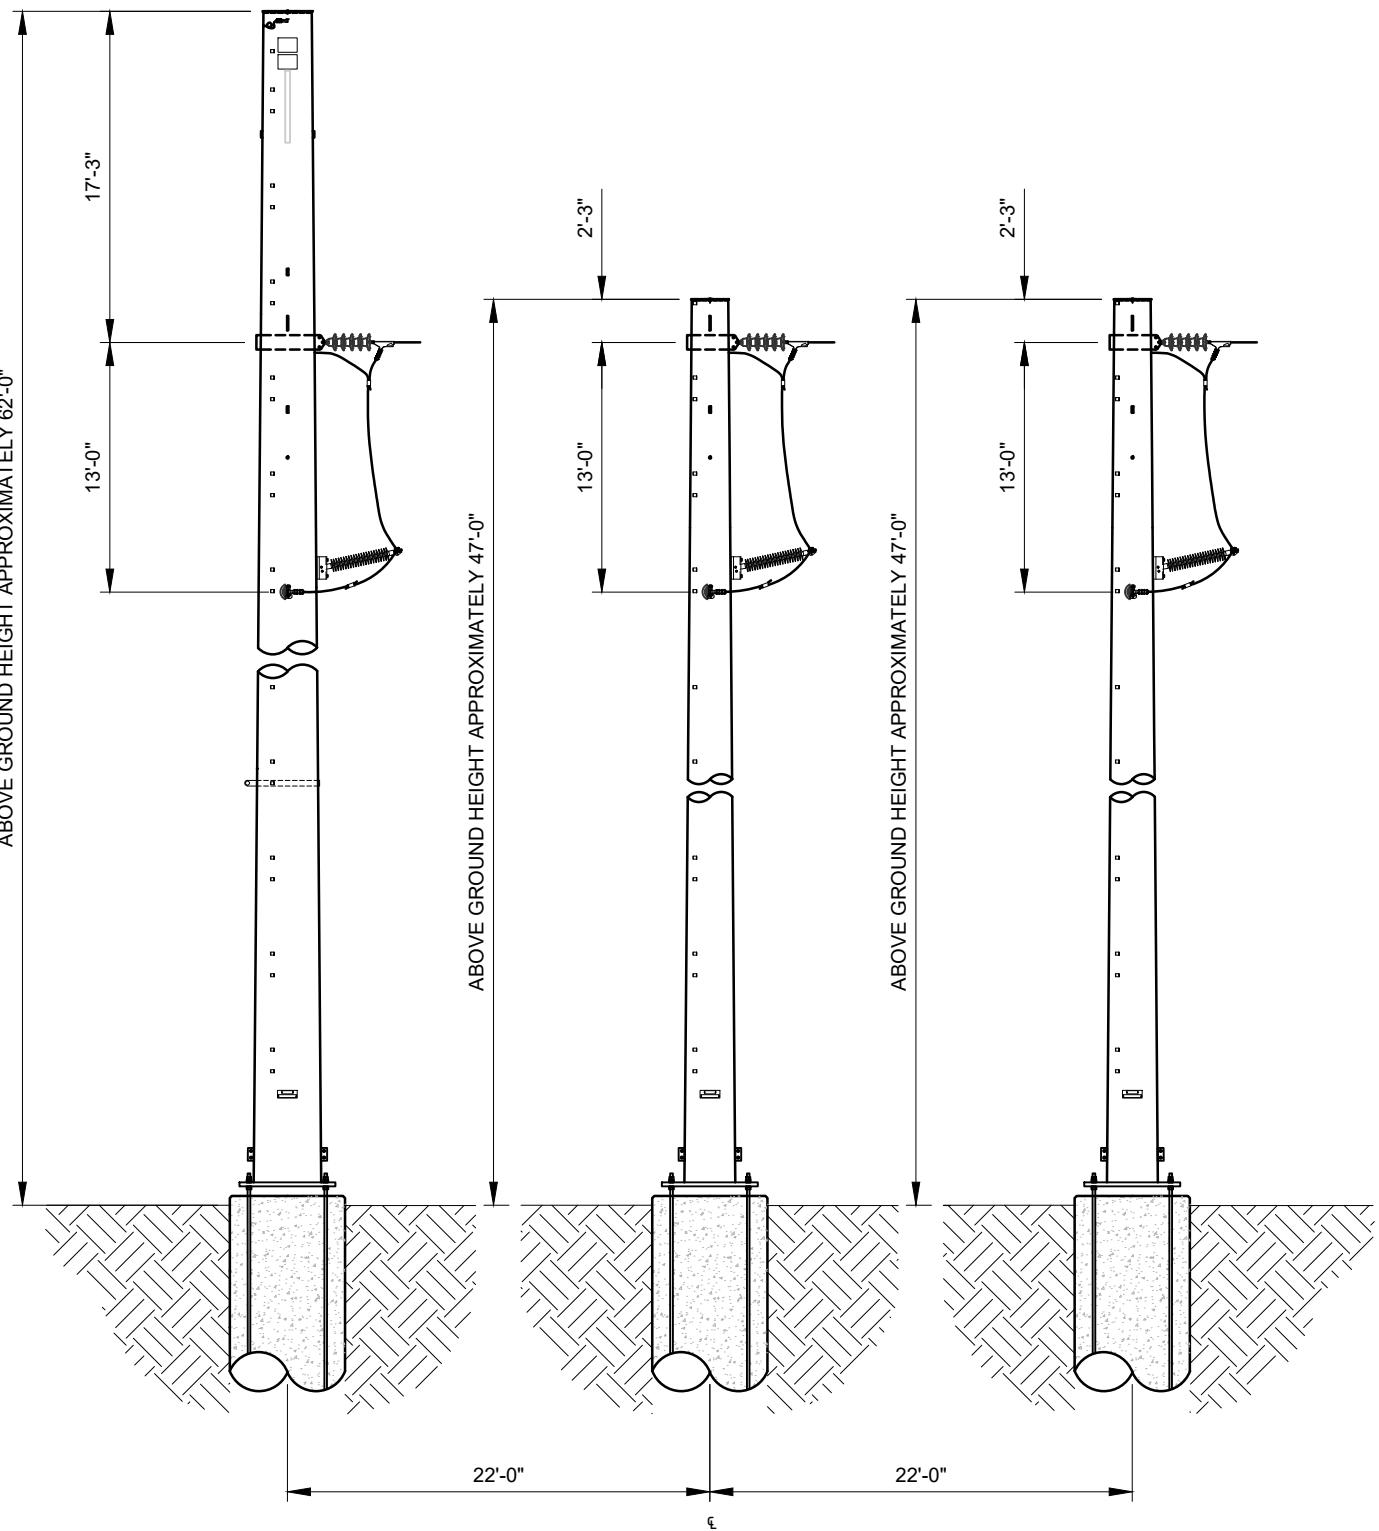
**EXHIBIT 7**

138KV SINGLE CIRCUIT TUBULAR STEEL TAP STRUCTURE  
HORIZONTAL THREE POLE

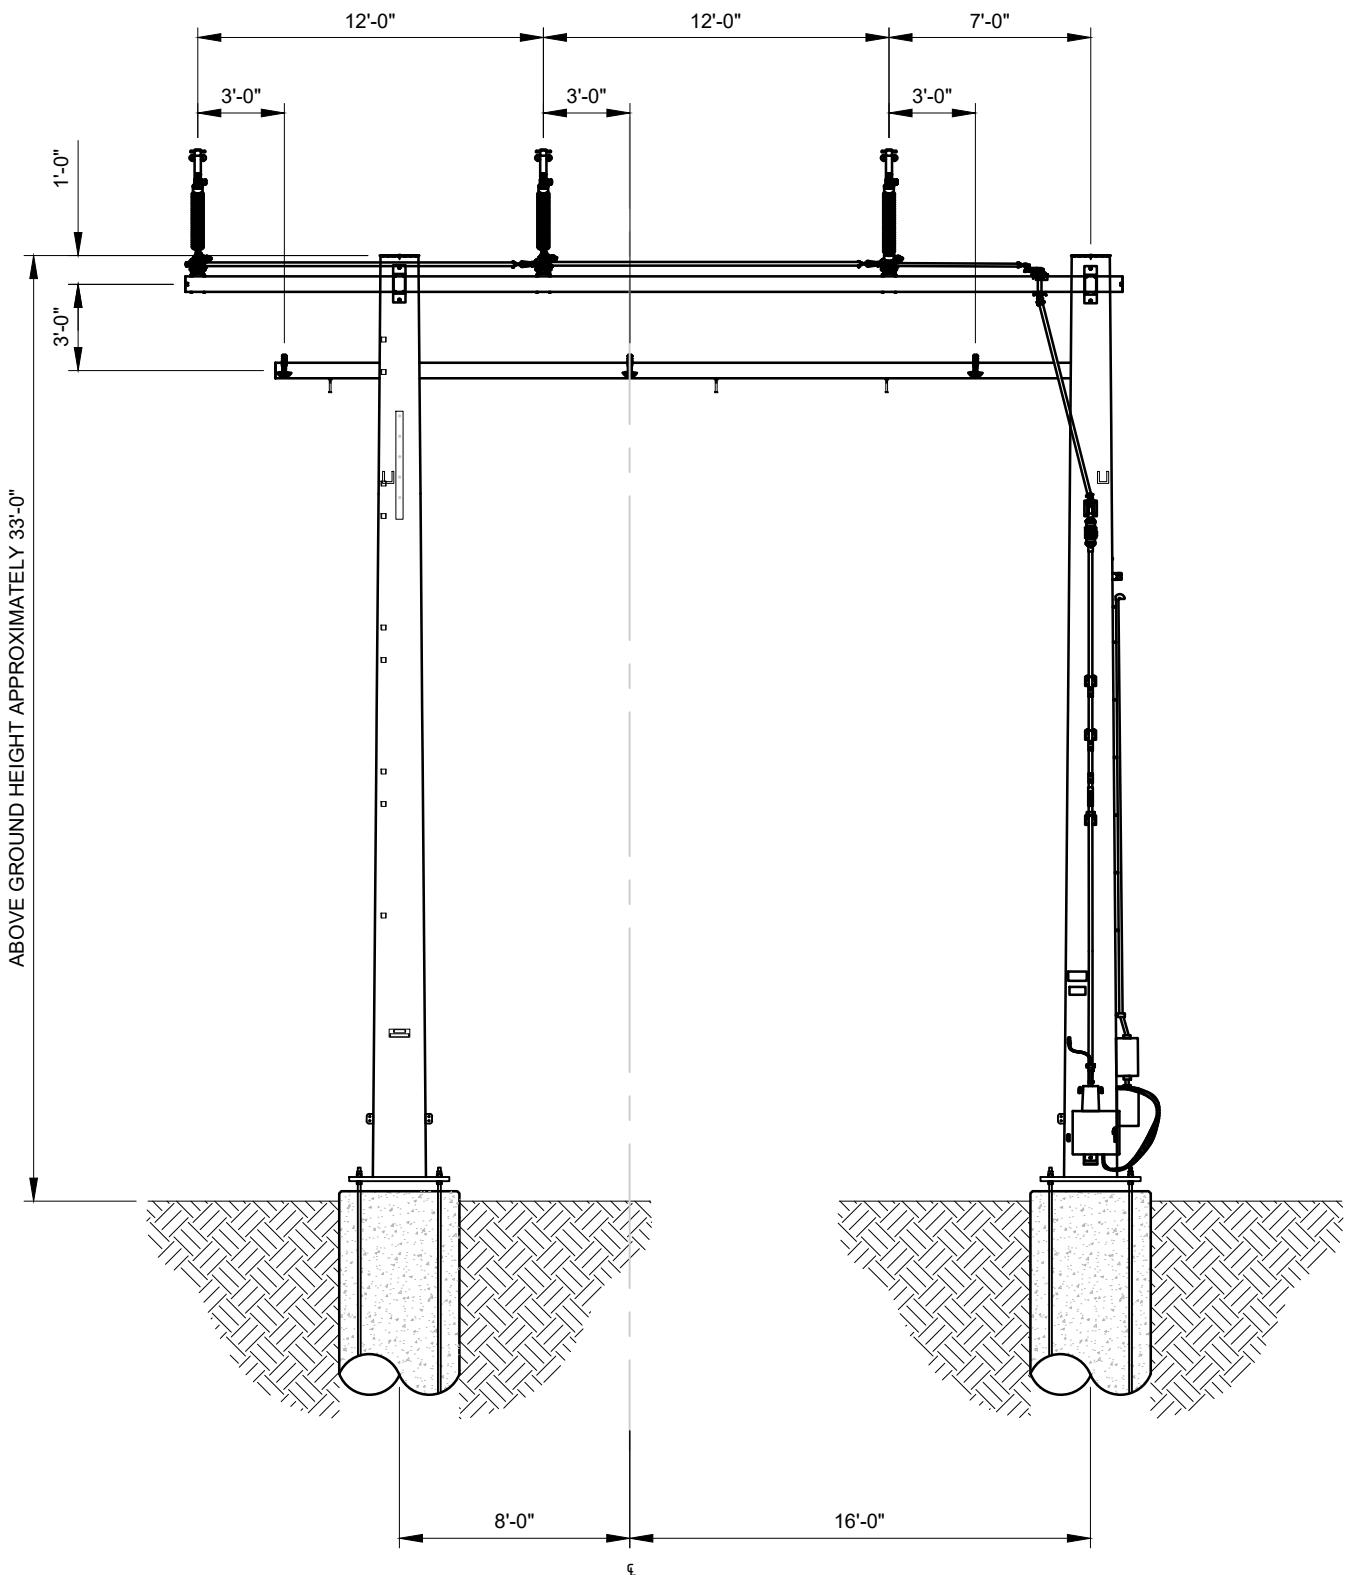
EXHIBIT 8

138KV SINGLE CIRCUIT TUBULAR STEEL UNITIZED 2000A SWITCH  
STRUCTURE WITH WHIP OR SINGLE BOTTLE INTERRUPTER  
HORIZONTAL TWO POLE WITHOUT SHIELD WIRE

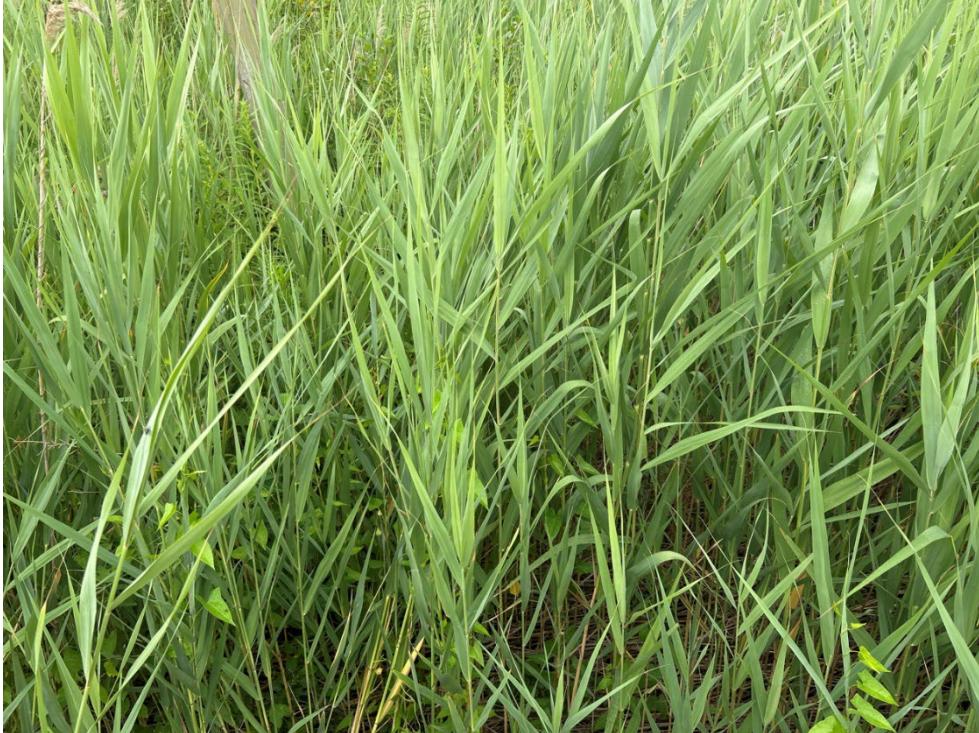
<b>Photo No. 5.</b>

<b>Photo Date:</b> 7/16/2025	
<b>Description:</b>  Photo of PEM Wetland W-EVN-2, facing north.

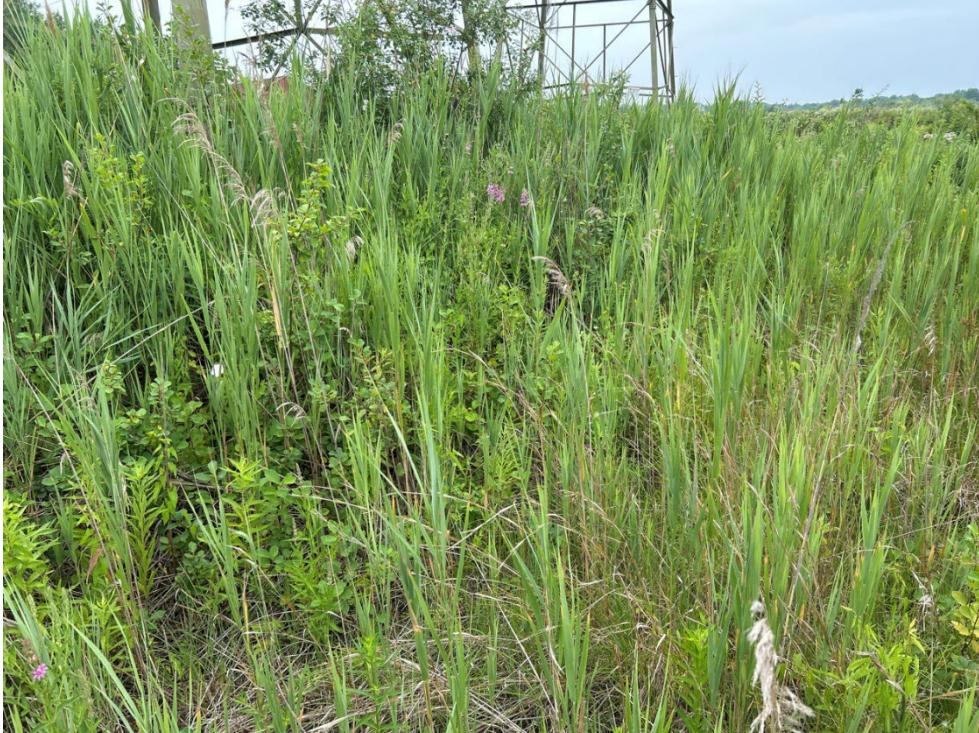
<b>Photo No. 6.</b>

<b>Photo Date:</b> 7/16/2025	
<b>Description:</b>  Photo of PEM Wetland W-EVN-2, facing west.

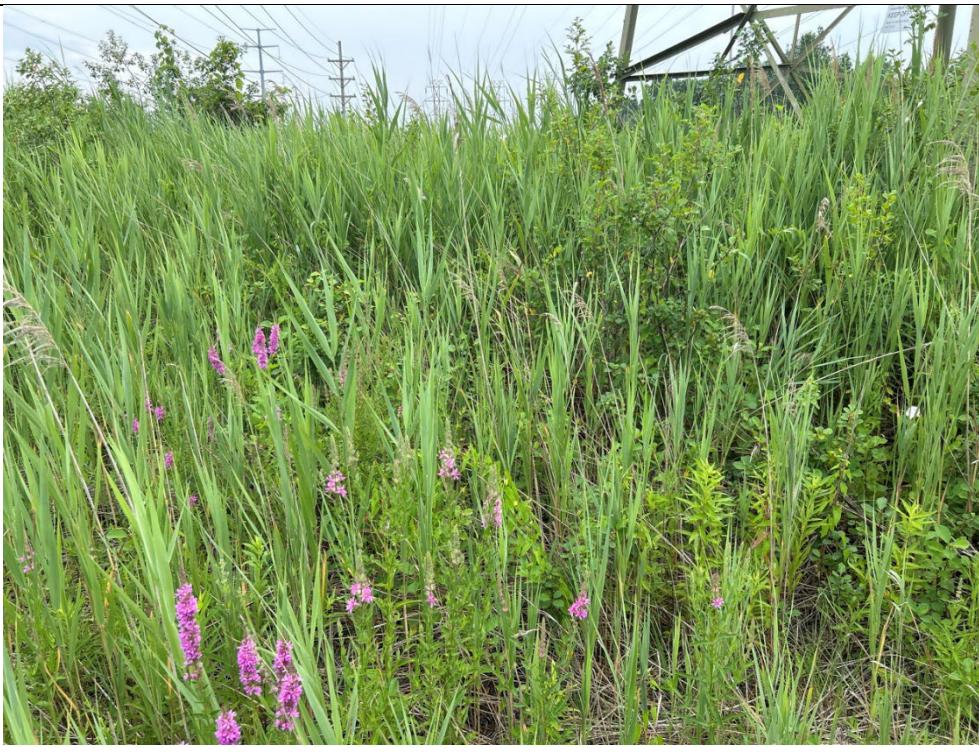
<b>Photo No. 7.</b>

<b>Photo Date:</b> 7/16/2025	
<b>Description:</b>  Photo of PEM Wetland W-EVN-2, facing south.

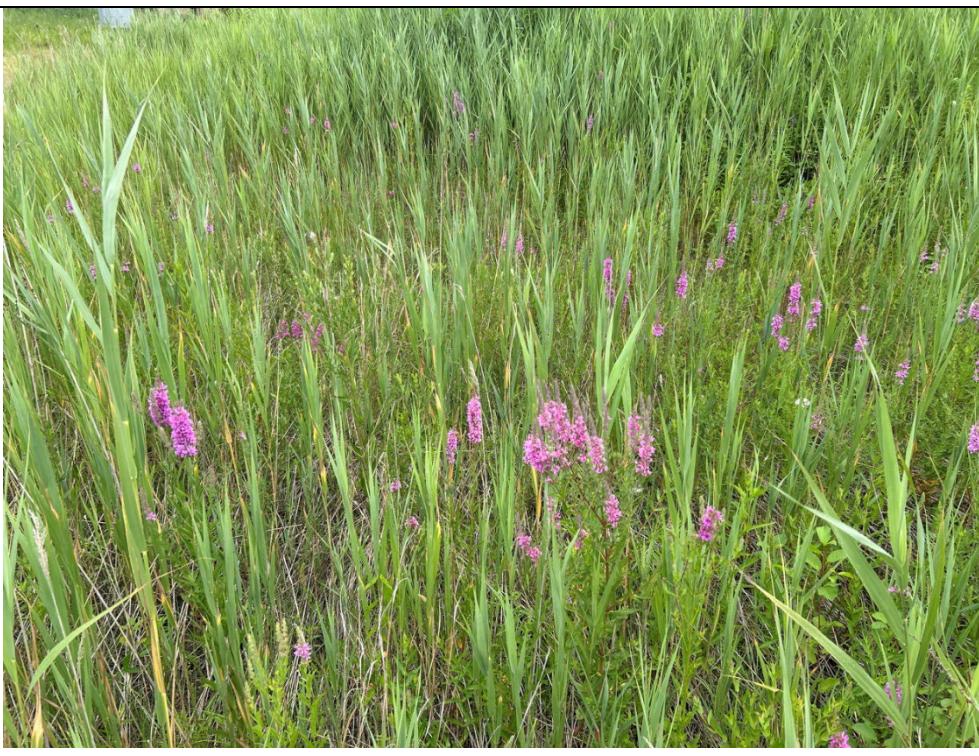
<b>Photo No. 8.</b>

<b>Photo Date:</b> 7/16/2025	
<b>Description:</b>  Photo of PEM Wetland W-EVN-2, facing east.

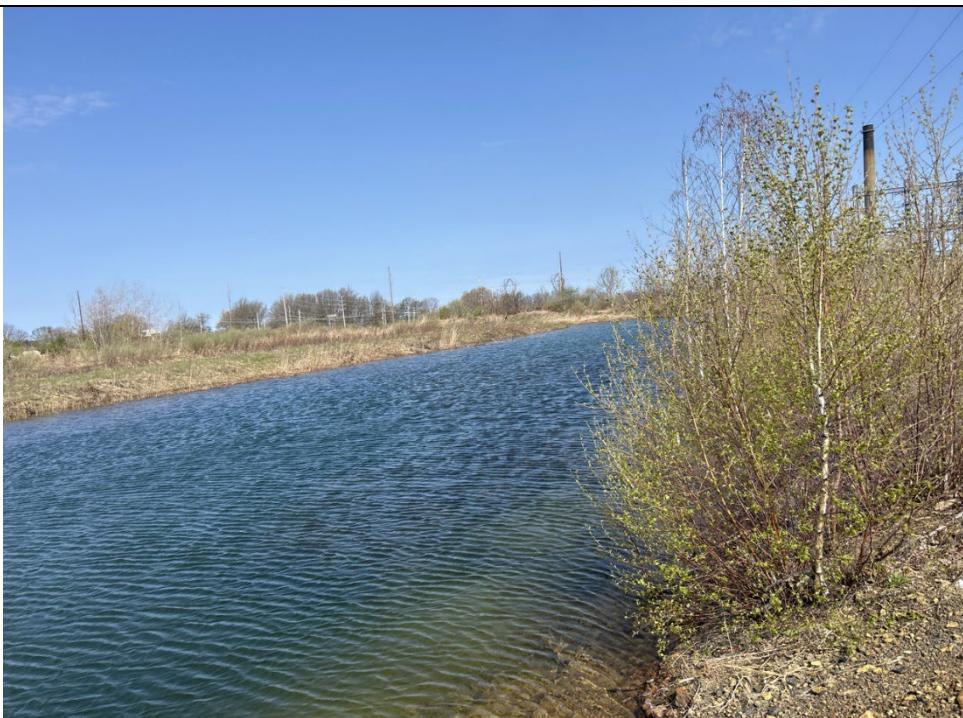
<b>Photo No. 9.</b>

<b>Photo Date:</b> 4/23/2025	
<b>Description:</b>  Photo of the stormwater pond WB-EVN-1, facing northwest.

During the field investigations, one (1) waterbody (WB-EVN-1), a stormwater pond, was delineated within the Project Study Area. A detailed summary of the waterbody resource identified is provided in **Table 3** and **Appendix A, Figure 5**. Data points were recorded to provide a characterization of the delineated waterbody resource located within the Project Study Area. Representative photographs of the described waterbody identified within the Project Study Area can be found in **Appendix B**.

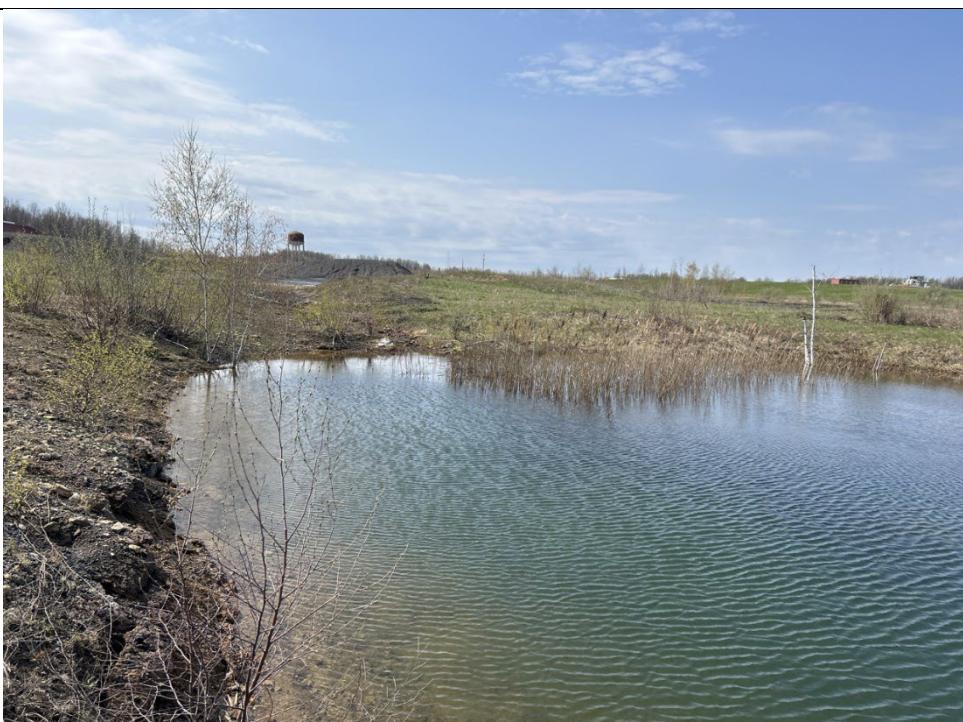
<b>Photo No. 10.</b>

<b>Photo Date:</b> 4/23/2025	
<b>Description:</b>  Photo of the stormwater pond WB-EVN-1, facing southeast.
