**LETTER OF NOTIFICATION**

**EAST SPRINGFIELD-LONDON #2 138 kV TRANSMISSION  
LINE EXTENSIONS TO NORTH TITUS SUBSTATION  
PROJECT**

**OPSB CASE NO.: 18-0086-EL-BLN**

**February 1, 2018**

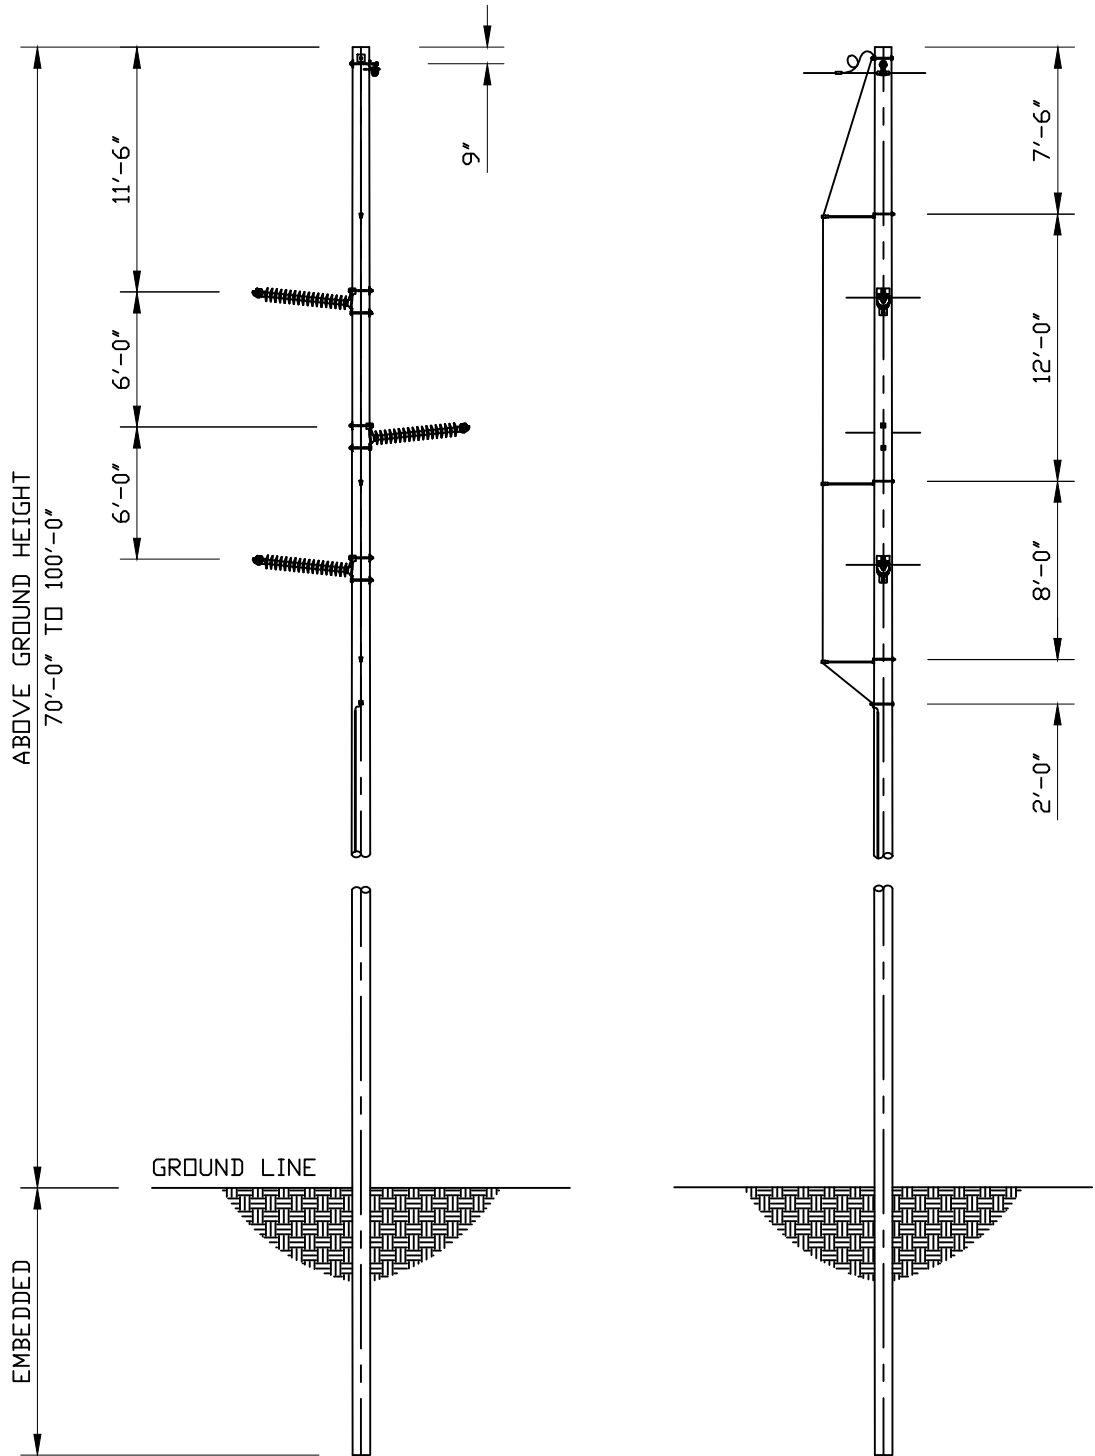
EXHIBIT 4

miles). This route requires fifteen (15) new structures of which twelve (12) are shown in Exhibit 4, two (2) are shown in Exhibit 6, and one (1) is shown in Exhibit 9.

SINGLE CIRCUIT, WOOD POLE  
HORIZONTAL POST, TANGENT STRUCTURE

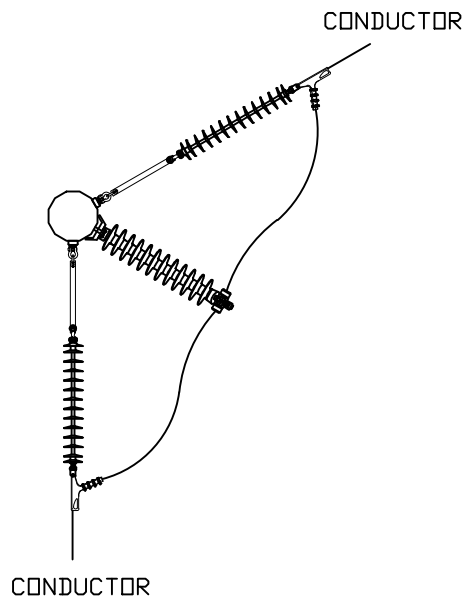
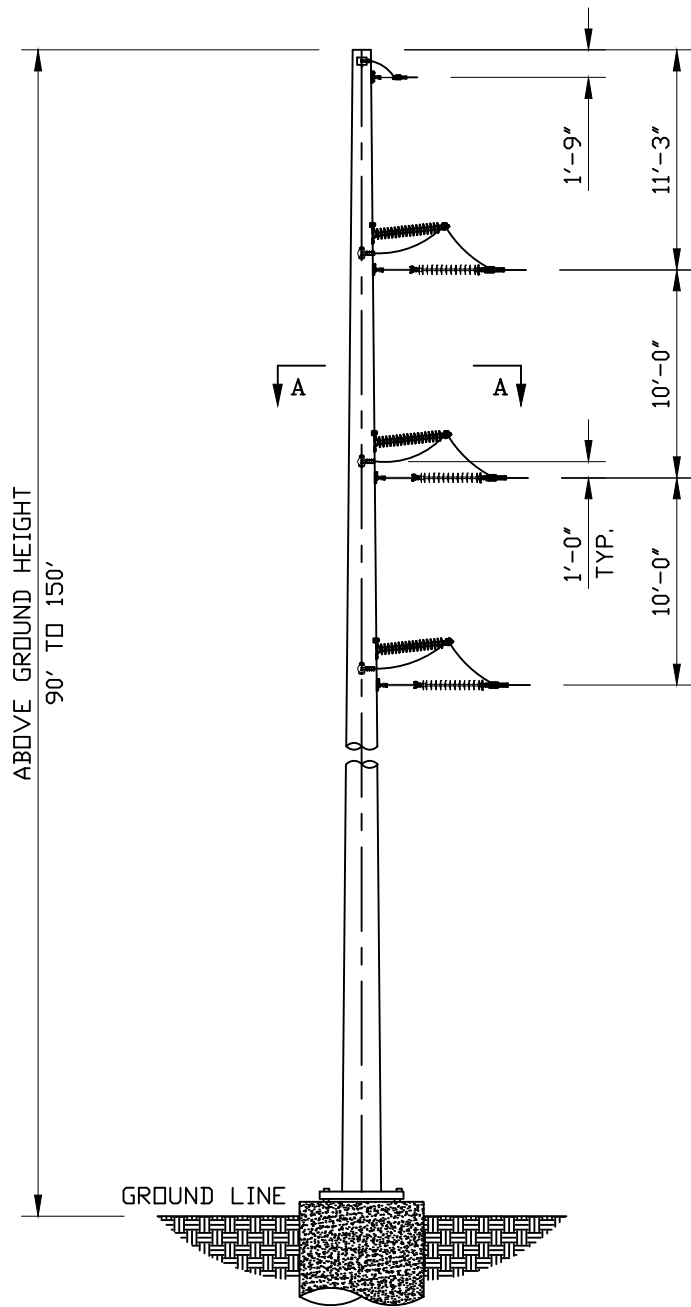
EXHIBIT 5

The proposed London-North Titus 138 kV Transmission Line Extension begins approximately 35 feet (0.01 miles) west of Titus Road and approximately 60 feet (0.01 miles) east of existing Structure #5728. The route of this extension trends to the north approximately 1,060 feet (0.20 miles) before turning to the northeast for approximately 390 feet (0.07 miles). The route then heads north for approximately 1,330 (0.25 miles) feet before turning to the east for approximately 125 feet (0.02 miles) and into the proposed location of North Titus Substation. The total length of this route will be approximately 2,905 feet (0.55 miles). This route will install eight (8) new structures of which three (3) are shown in Exhibit 4, three (3) are shown in Exhibit 5, one (1) is shown in Exhibit 7, and one (1) is shown in Exhibit 8.

SINGLE CIRCUIT, STEEL POLE  
 DEADEND ANGLES 0-60 DEGREES

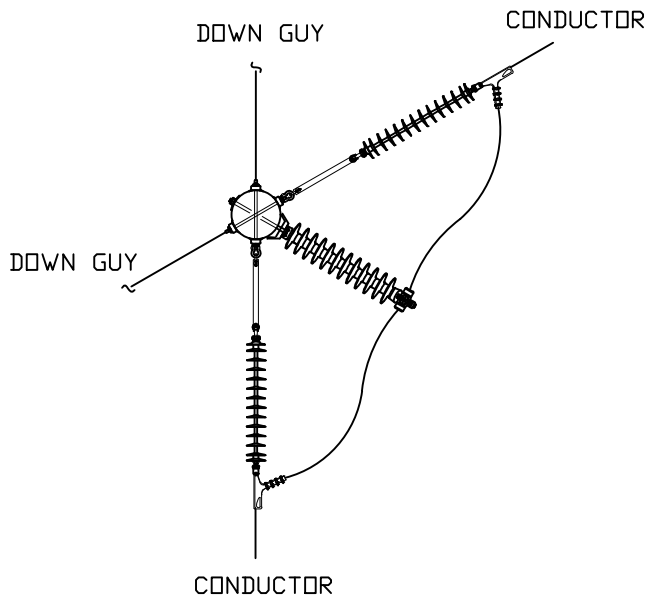
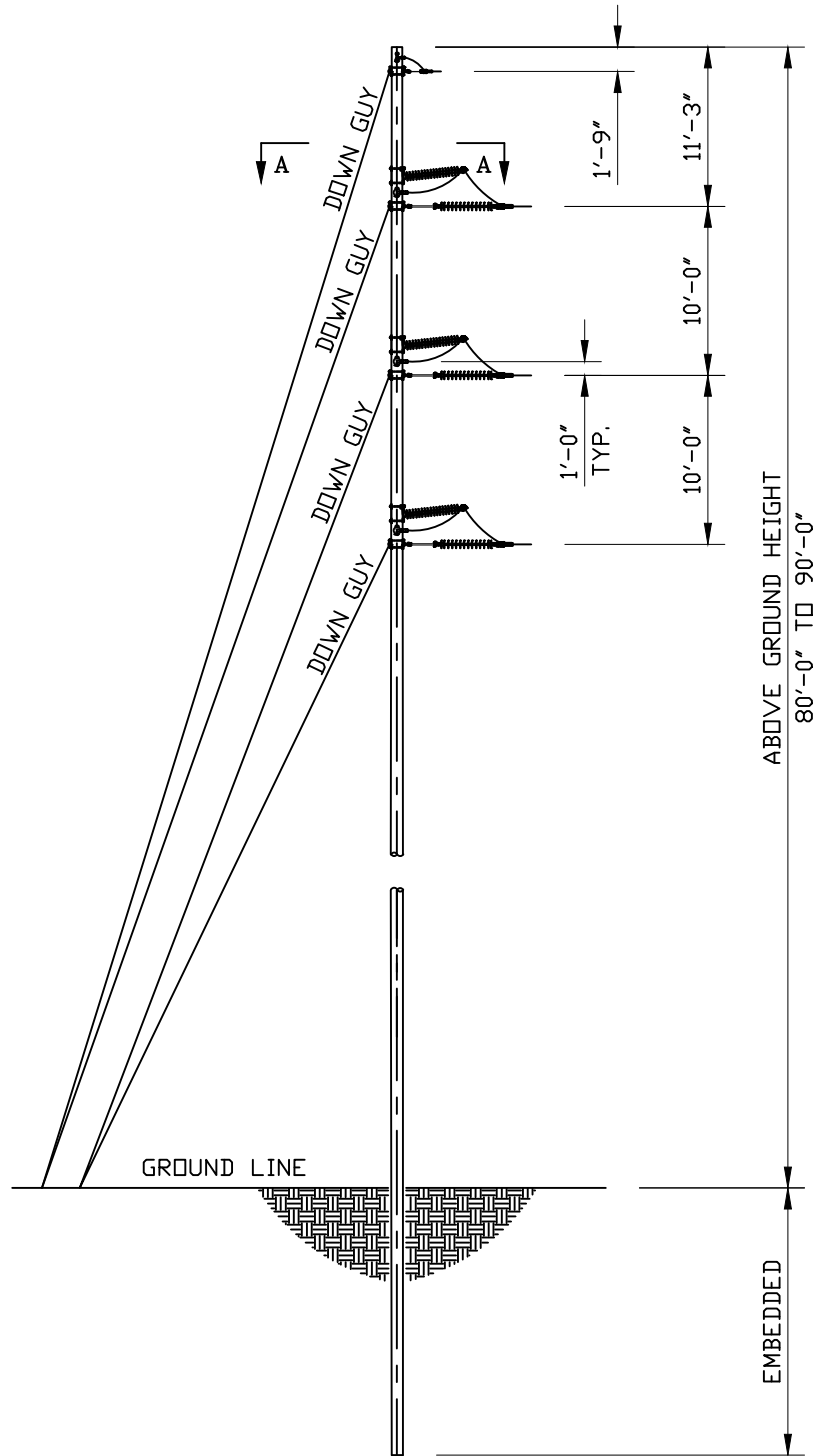
EXHIBIT 6

SINGLE CIRCUIT, WOOD POLE  
 DEADEND ANGLES 20-60 DEGREES

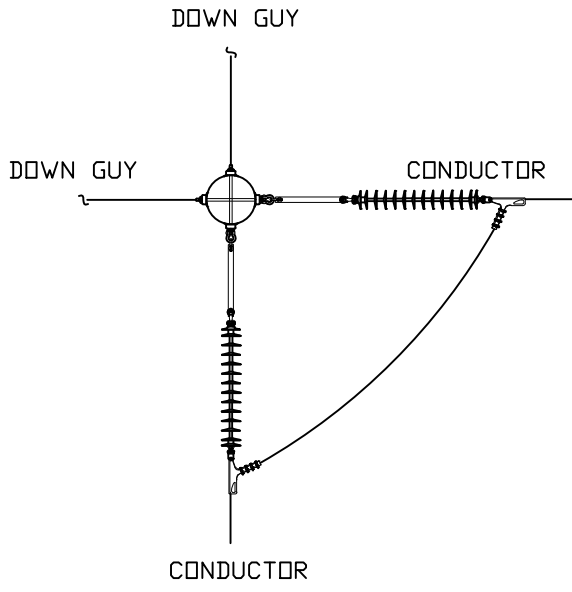
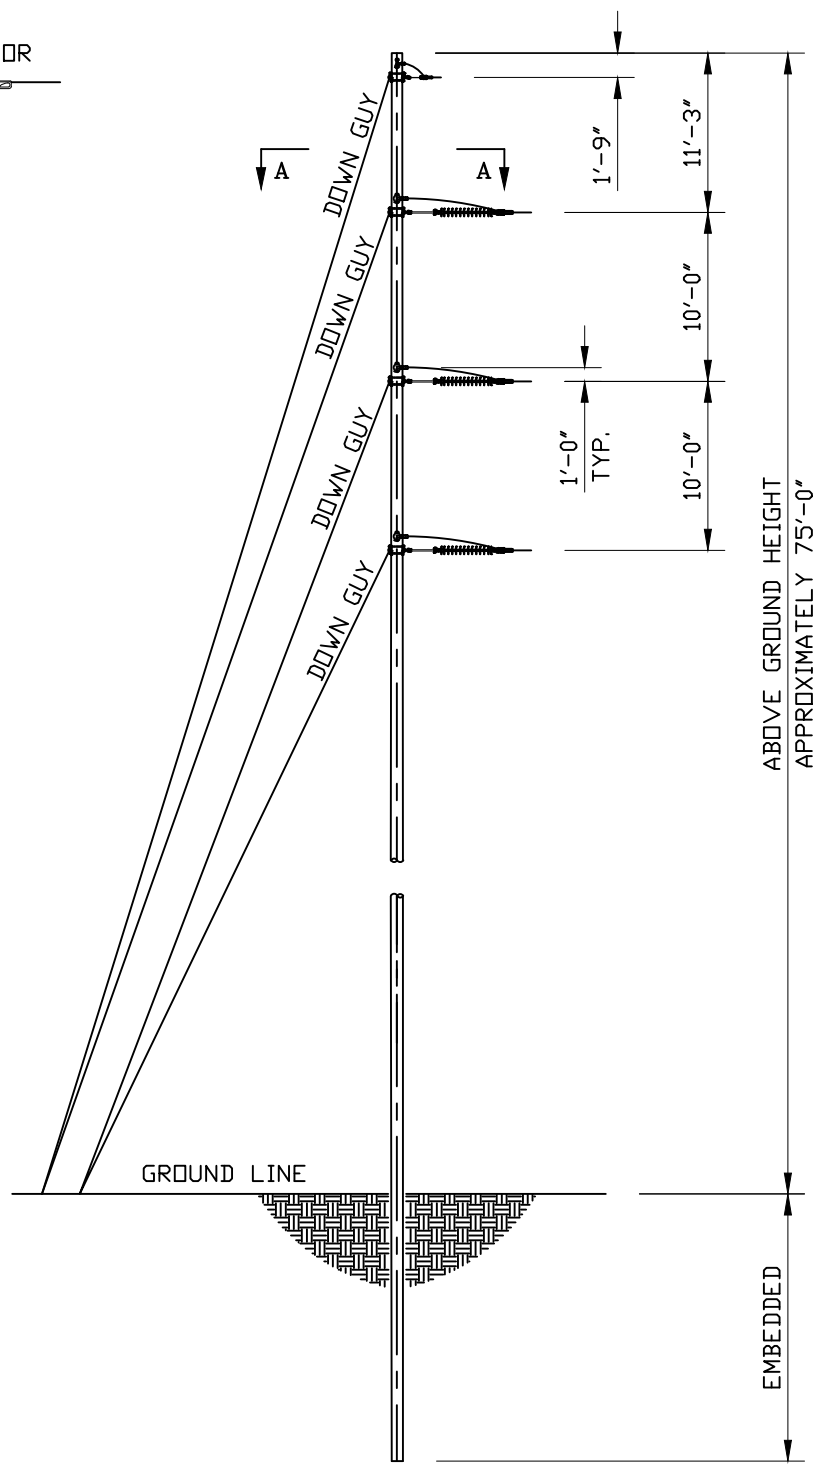
<p><b>ATSI</b><sup>®</sup> American Transmission Systems, Inc. <small>a subsidiary of FirstEnergy Corp.</small></p>	<p>EAST SPRINGFIELD-LONDON #2 138kV TRANSMISSION LINE EXTENSIONS TO NORTH TITUS SUBSTATION PROJECT</p>
<p>SINGLE CIRCUIT, WOOD POLE DEADEND ANGLES 60-120 DEGREES</p>	
<p>EXHIBIT 7</p>

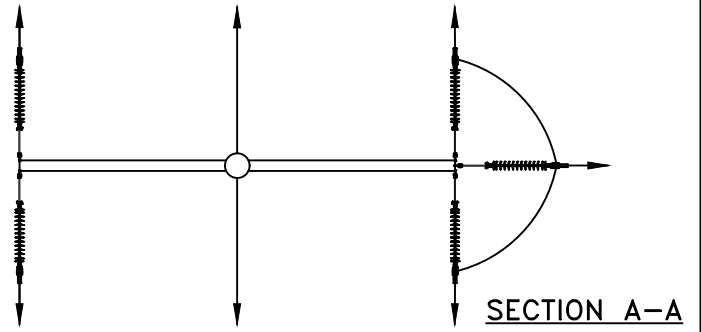
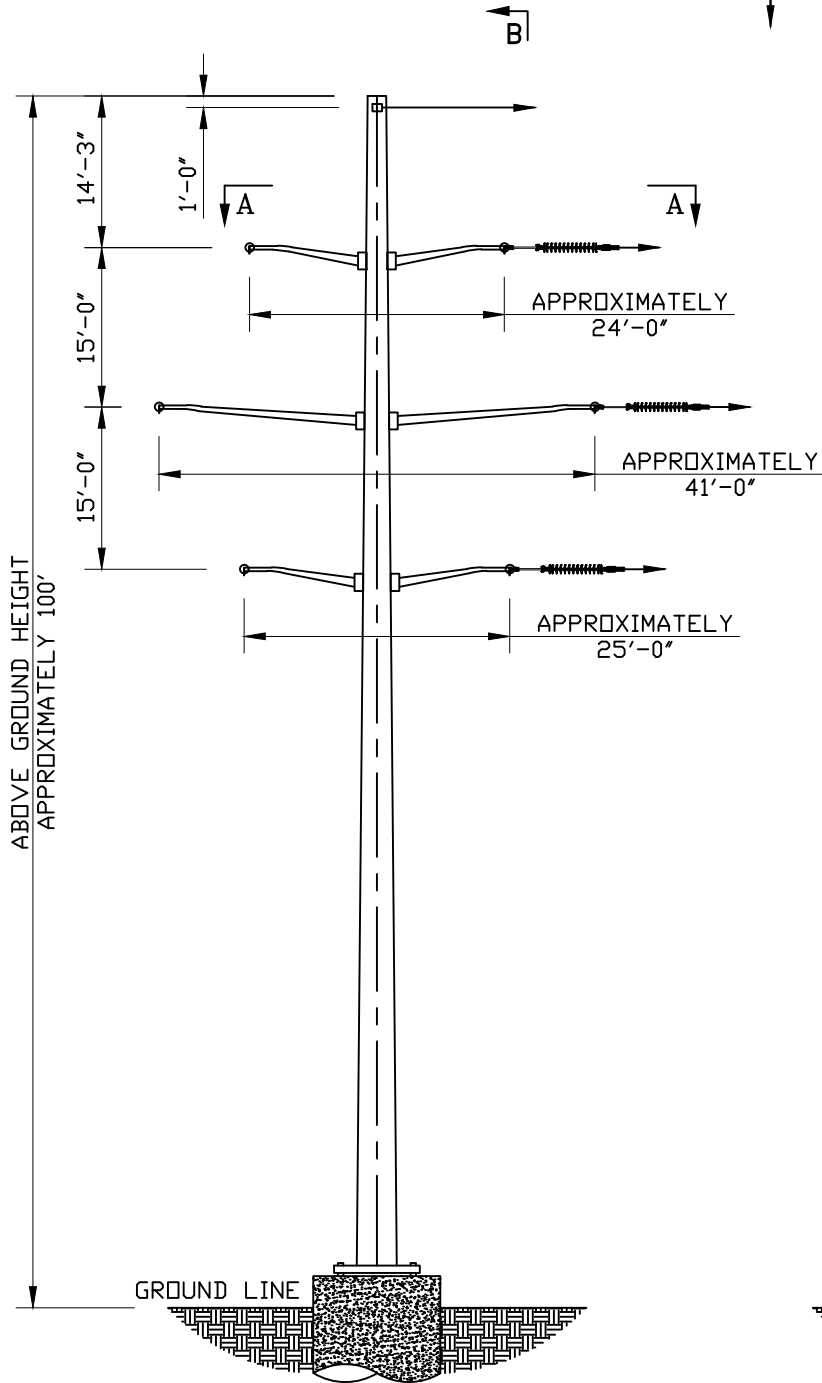
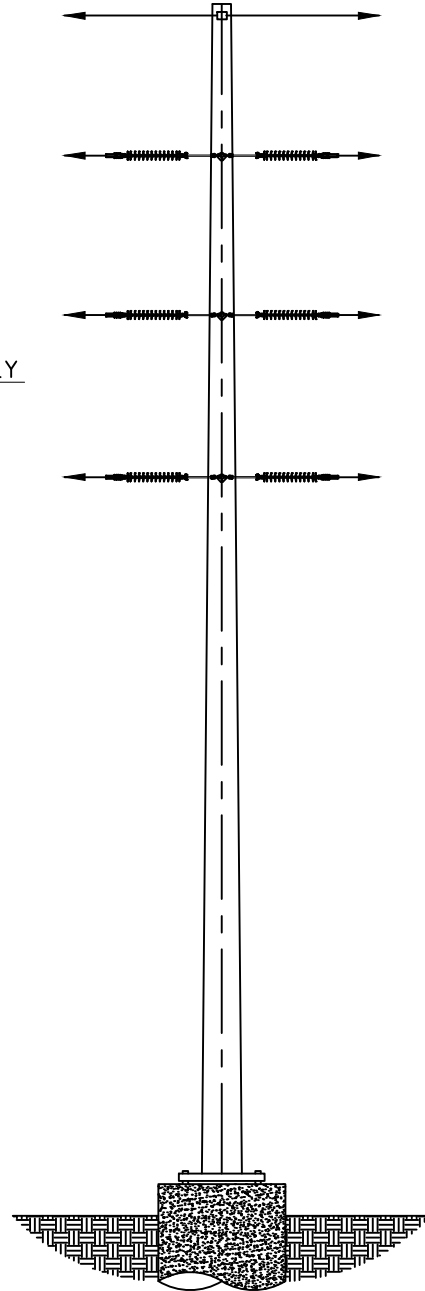
EXHIBIT 8

DOUBLE CIRCUIT, STEEL POLE  
3-WAY DEADEND TAP STRUCTURE

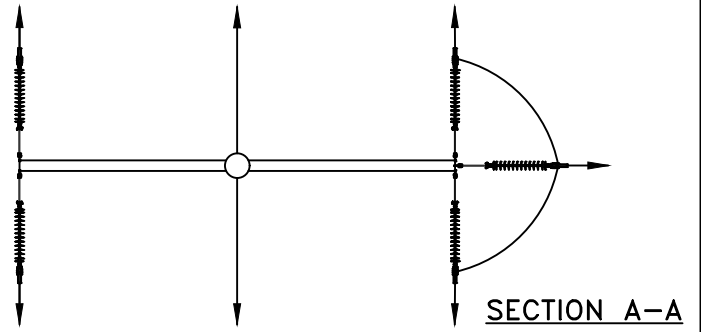
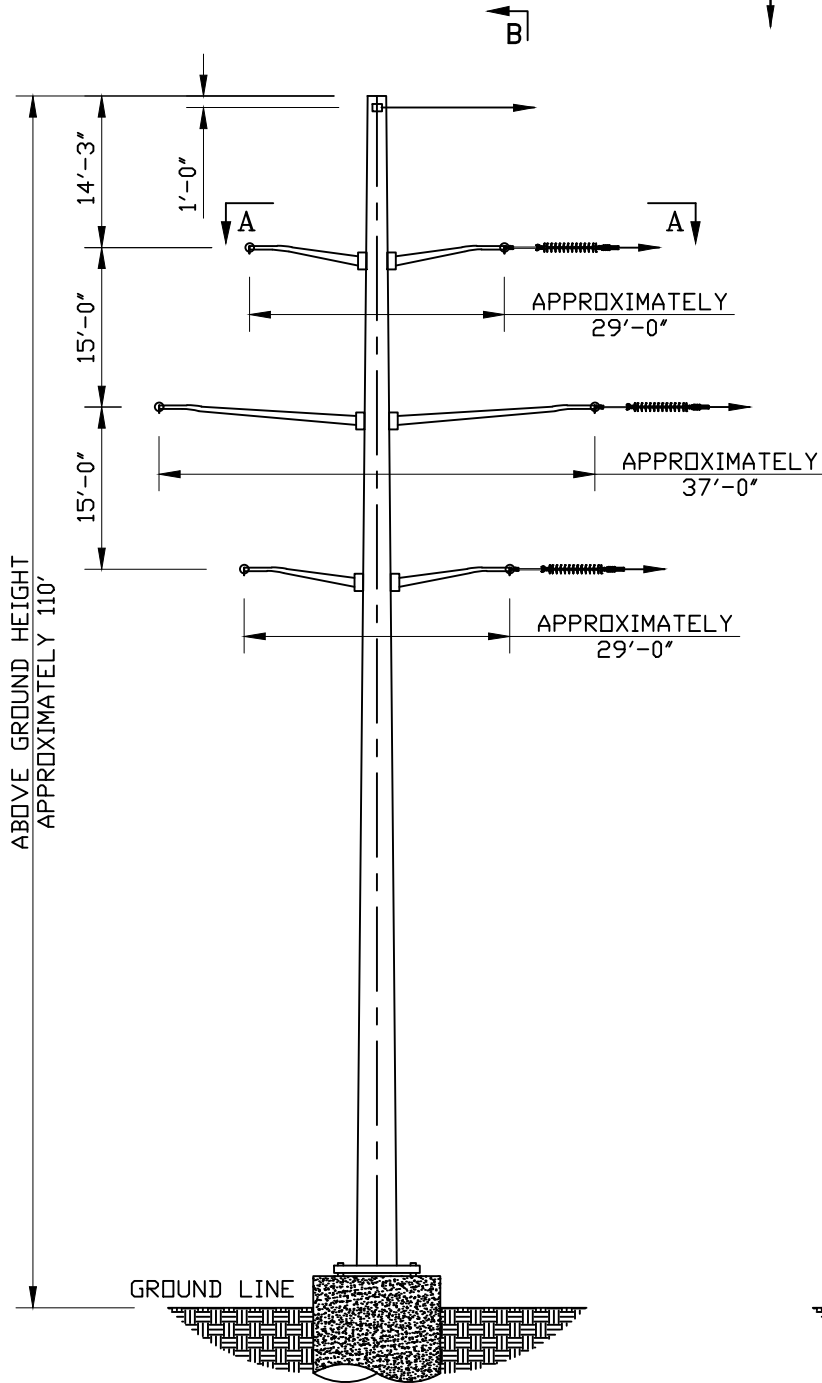
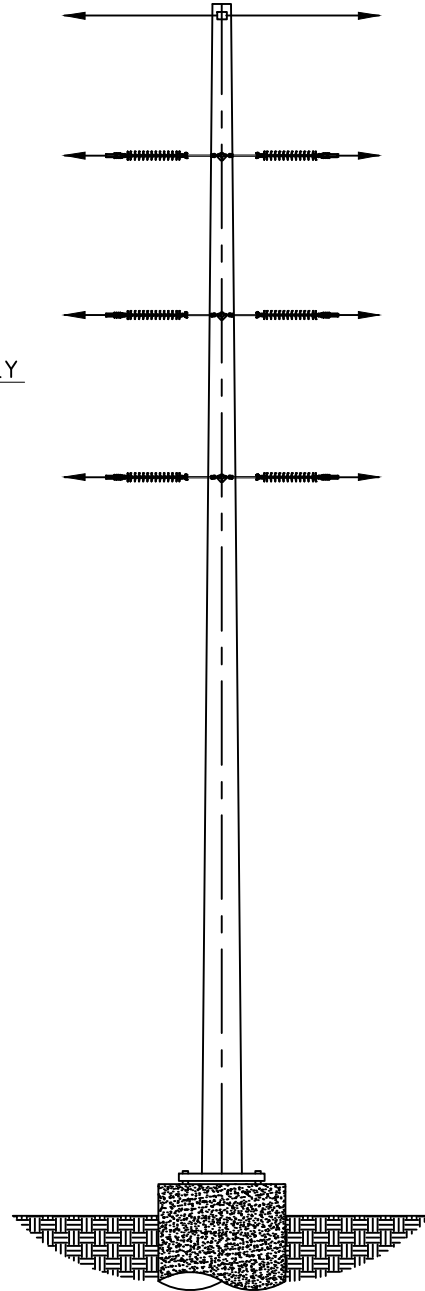
<p><b>ATSI</b><sup>®</sup> American Transmission Systems, Inc. <small>a subsidiary of FirstEnergy Corp.</small></p>	<p>EAST SPRINGFIELD-LONDON #2 138kV TRANSMISSION LINE EXTENSIONS TO NORTH TITUS SUBSTATION PROJECT</p>
<p>DOUBLE CIRCUIT, STEEL POLE 3-WAY DEADEND TAP STRUCTURE</p>	
<p>EXHIBIT 9</p>

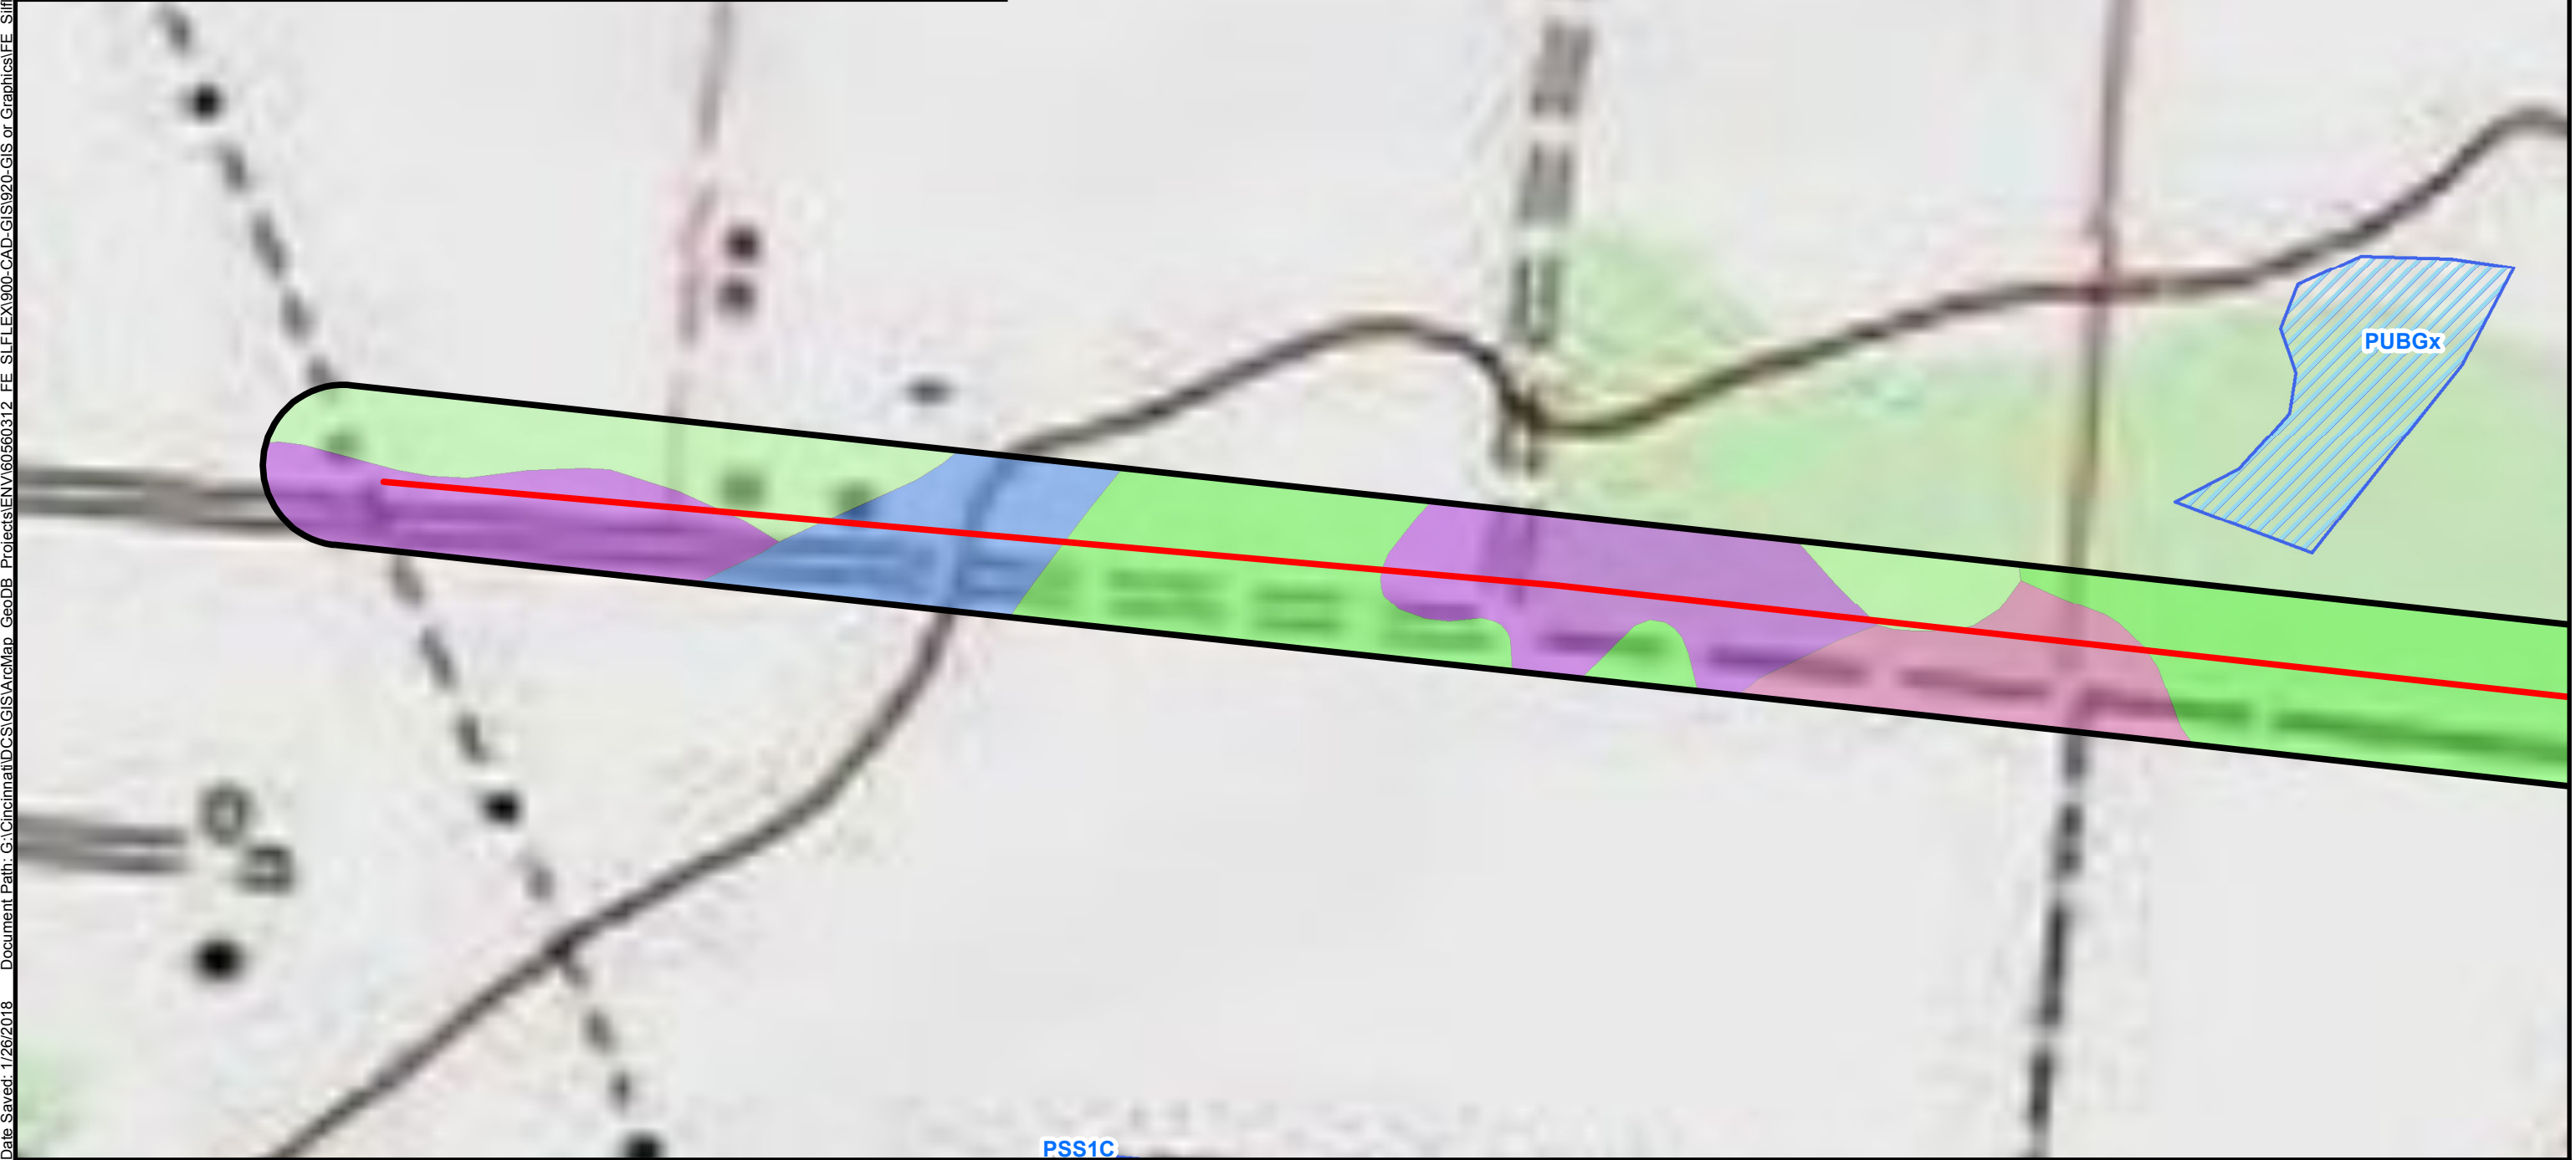
**FIGURE 2A**  
SOIL MAP UNIT AND NATIONAL  
WETLAND INVENTORY MAP

Soil Unit	Soil Unit Description	Hydric Soil	Drainage Class	Acreage within Survey Corridor
WrA	Waynetown silt loam, 0 to 2 percent slopes	No	Somewhat poorly drained	3.55
MmD3	Miamian clay loam, shallow to dense till substratum, 12 to 18 percent slopes, severely eroded	No	Well drained	1.52
MmC3	Miamian clay loam, shallow to dense till substratum, 6 to 12 percent slopes, severely eroded	No	Well drained	4.51
ThA	Thackery silt loam, 0 to 2 percent slopes	No	Moderately well drained	4.65
EmA	Eldean silt loam, 0 to 2 percent slopes	No	Well drained	1.36
Ko	Kokomo silty clay loam, 0 to 2 percent slopes	Yes	Very poorly drained	16.69
MhB	Miamian silt loam, 2 to 6 percent slopes	Yes	Well drained	4.57
MhB2	Miamian silt loam, 2 to 6 percent slopes, eroded	No	Well drained	5.29
MkD2	Miamian silty clay loam, 12 to 18 percent slopes, eroded	No	Well drained	1.11
OcA	Ockley silt loam, Southern Ohio Till Plain, 0 to 2 percent slopes	No	Well drained	2.11

Soils in each wetland were observed and documented as part of the delineation methodology. According to the USDA/NRCS Web Soil Surveys of Clark County, Ohio (NRCS 2017), and the NRCS Hydric Soils Lists of Ohio, 6 soil series are mapped within the Project survey corridor (NRCS 2017). Of those 6 soil series, 1 soil series contain soil map units that are listed with hydric components. Table 1 provides a detailed overview of all soil series and soil map units within the Project survey corridor. Soil map units located within the Project survey corridor are shown on Figures 2A-2D.

According to the NWI maps of the New Moorefield, Ohio quadrangle, the Project survey corridor contains two mapped NWI wetlands: one palustrine unconsolidated bottom, artificially flooded (PUBK), and one riverine, intermittent, stream bed, seasonally flooded (R4SBC) (USFWS, 2017). The two mapped wetlands were delineated in the field as Pond ESL-1 and Stream ESL-1. Locations of the NWI mapped wetlands are shown on Figure 2.

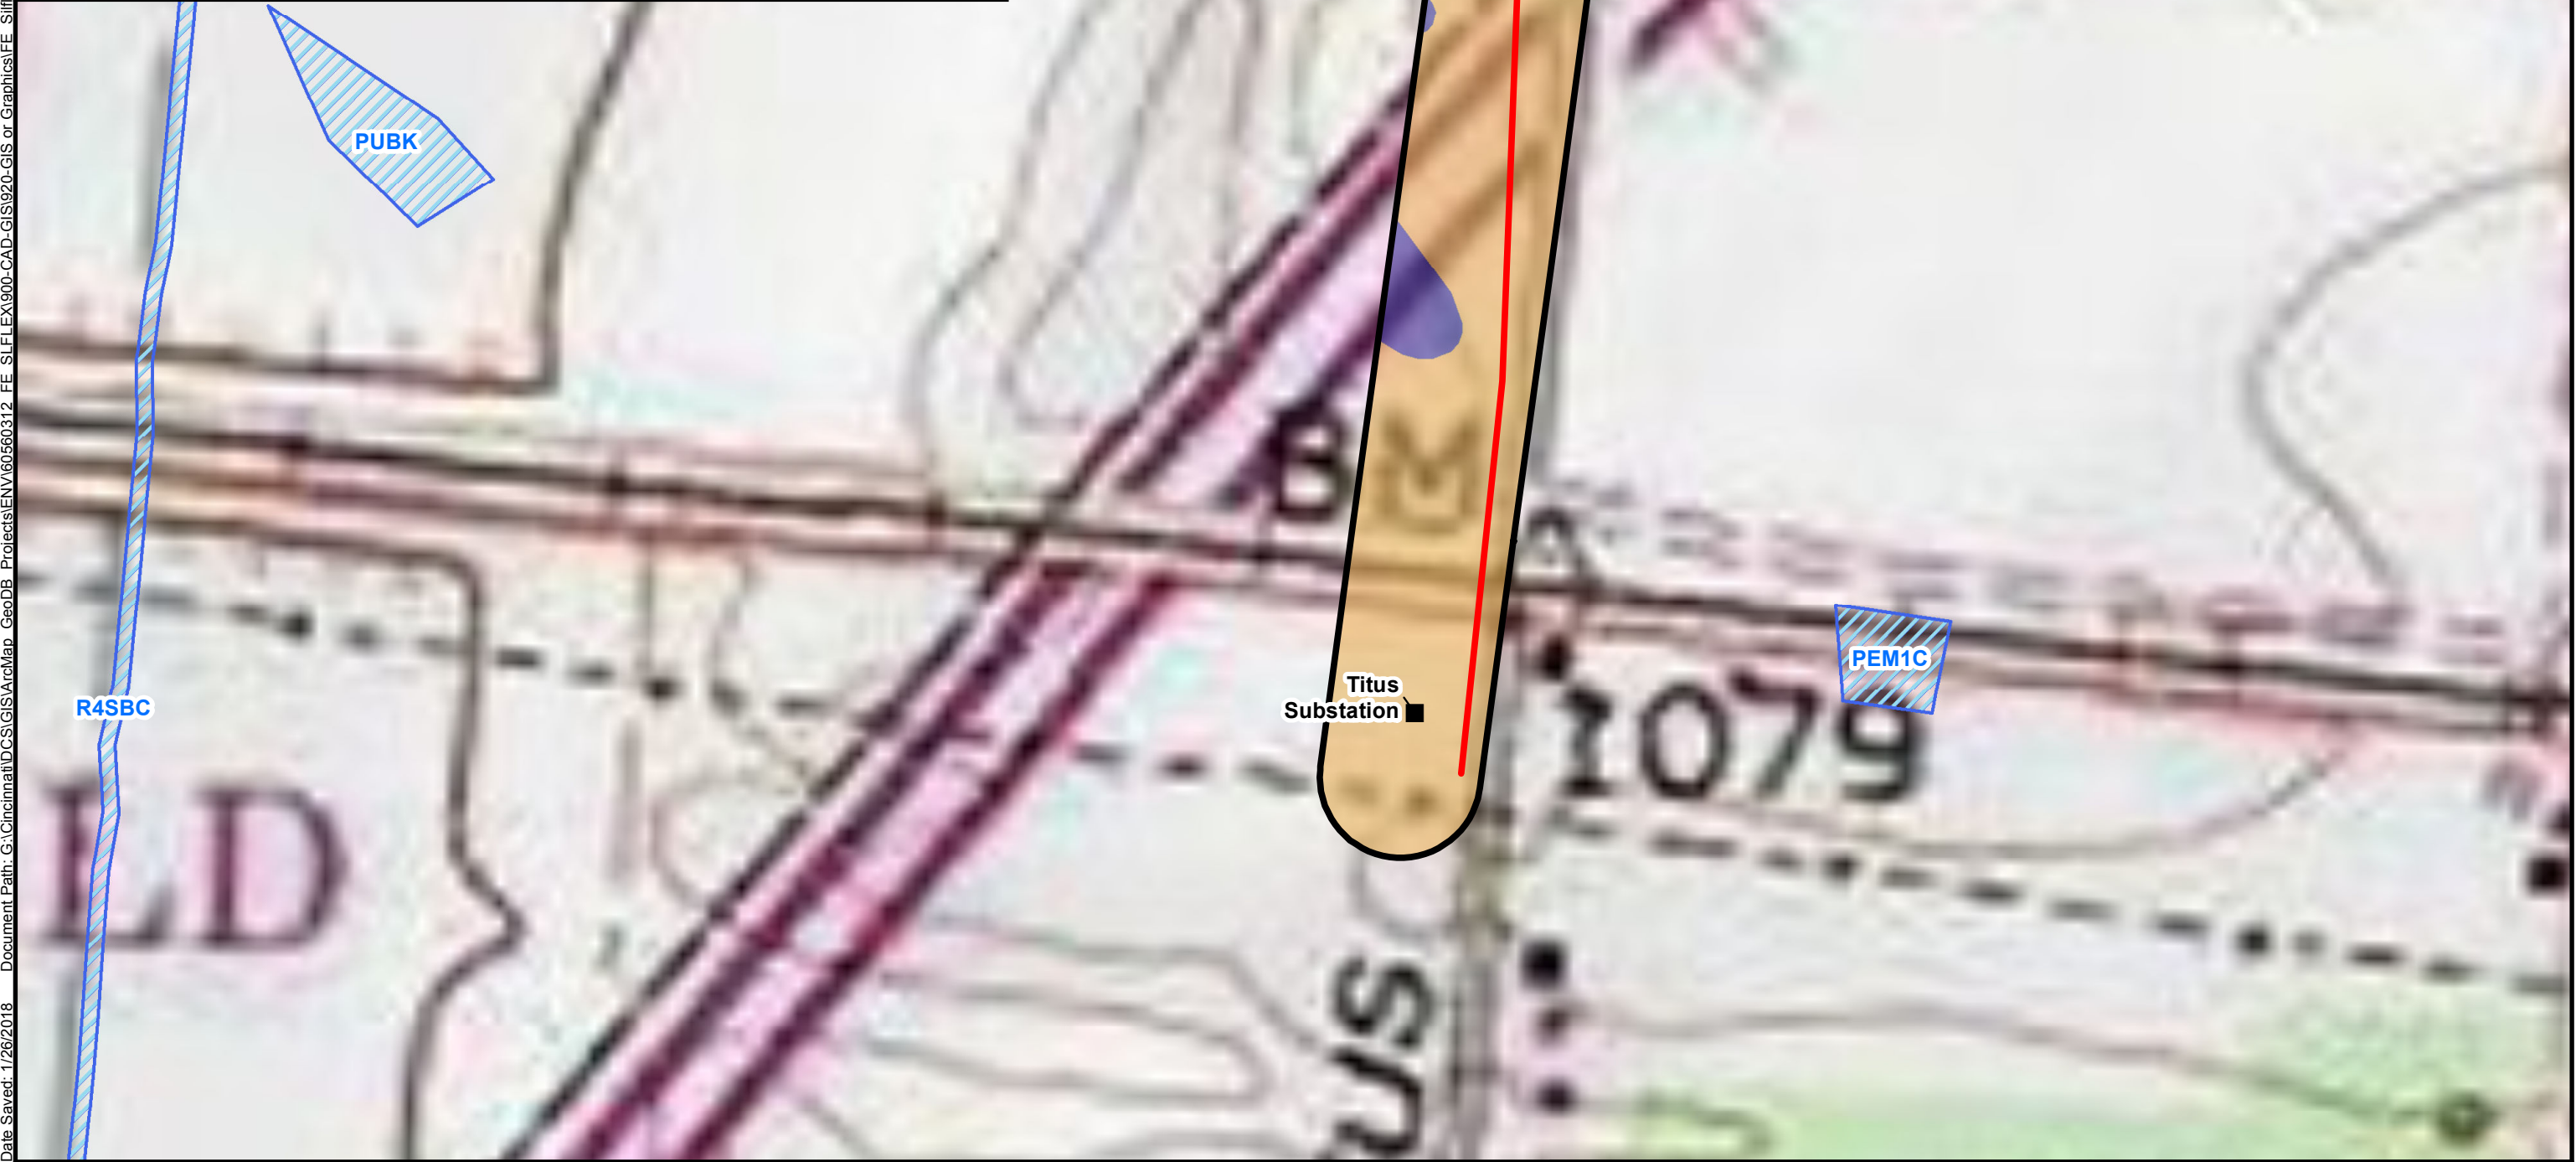
**FIGURE 2D**  
SOIL MAP UNIT AND NATIONAL WETLAND INVENTORY MAP

Soil Unit	Soil Unit Description	Hydric Soil	Drainage Class	Acreage within Survey Corridor
WrA	Waynetown silt loam, 0 to 2 percent slopes	No	Somewhat poorly drained	3.55
MmD3	Miamian clay loam, shallow to dense till substratum, 12 to 18 percent slopes, severely eroded	No	Well drained	1.52
MmC3	Miamian clay loam, shallow to dense till substratum, 6 to 12 percent slopes, severely eroded	No	Well drained	4.51
ThA	Thackery silt loam, 0 to 2 percent slopes	No	Moderately well drained	4.65
EmA	Eldean silt loam, 0 to 2 percent slopes	No	Well drained	1.36
Ko	Kokomo silty clay loam, 0 to 2 percent slopes	Yes	Very poorly drained	16.69
MhB	Miamian silt loam, 2 to 6 percent slopes	Yes	Well drained	4.57
MhB2	Miamian silt loam, 2 to 6 percent slopes, eroded	No	Well drained	5.29
MkD2	Miamian silty clay loam, 12 to 18 percent slopes, eroded	No	Well drained	1.11
OcA	Ockley silt loam, Southern Ohio Till Plain, 0 to 2 percent slopes	No	Well drained	2.11

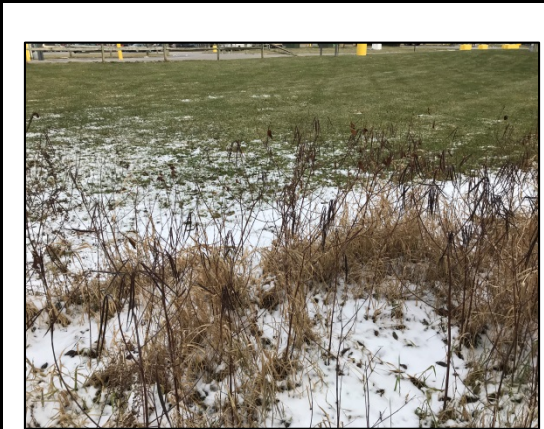
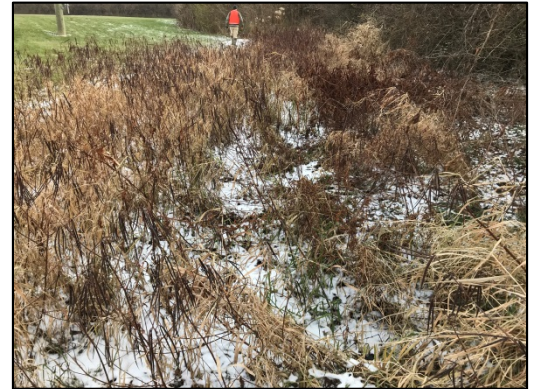
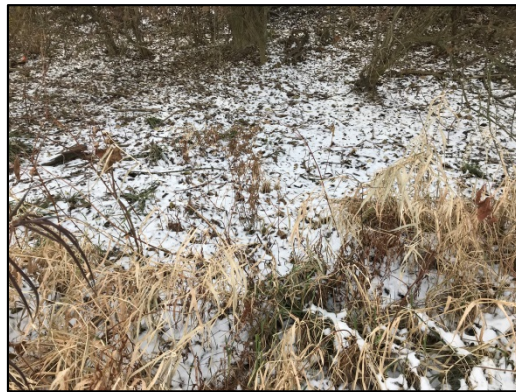
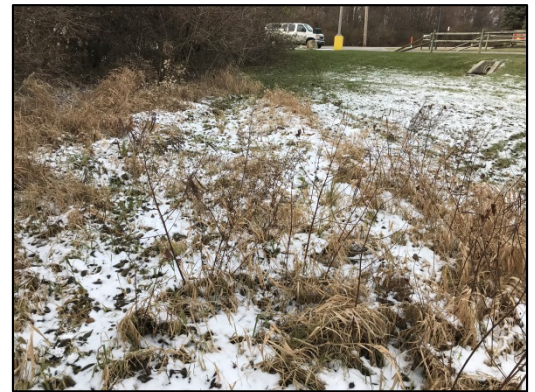
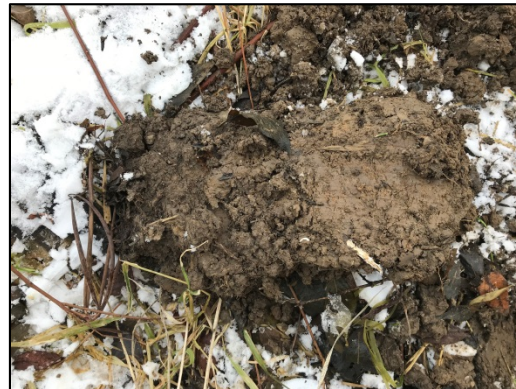
**Description:**  
Wetland ESL-1  
PEM Wetland  
Category 1

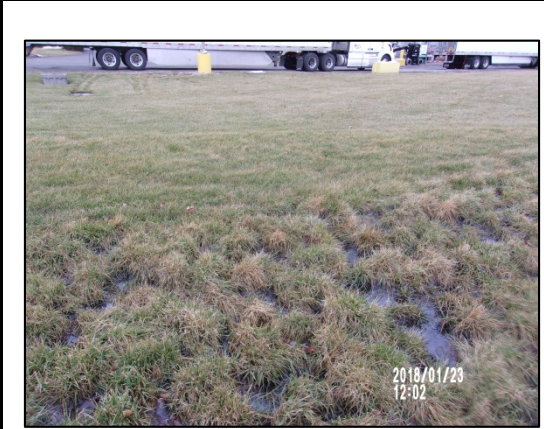
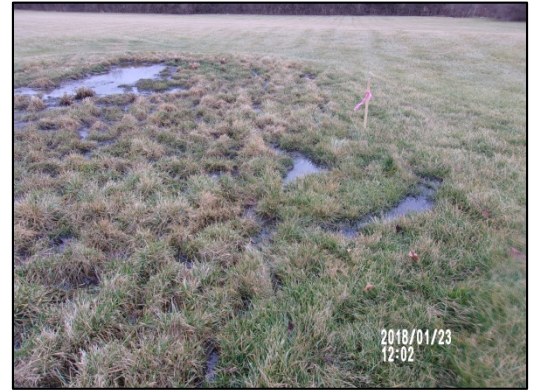
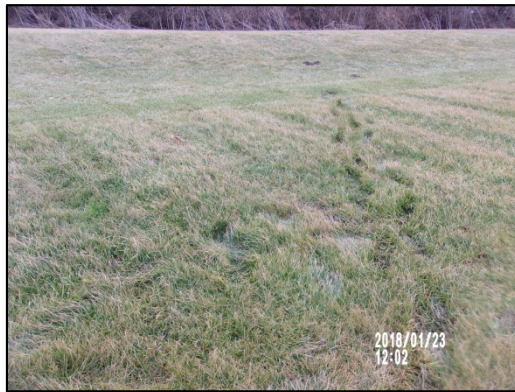
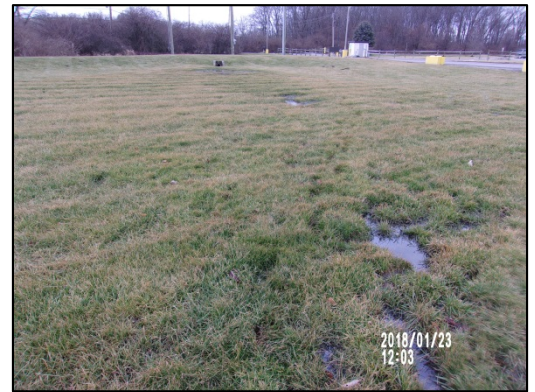
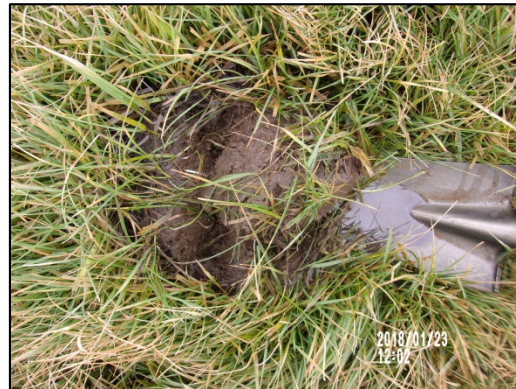
**Description:**  
Wetland ESL-3  
PEM Wetland  
Category 1

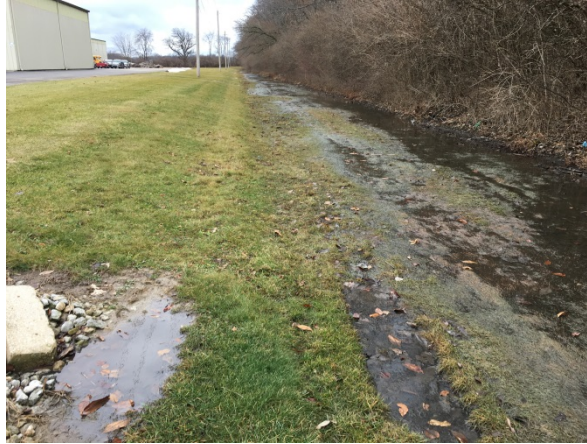
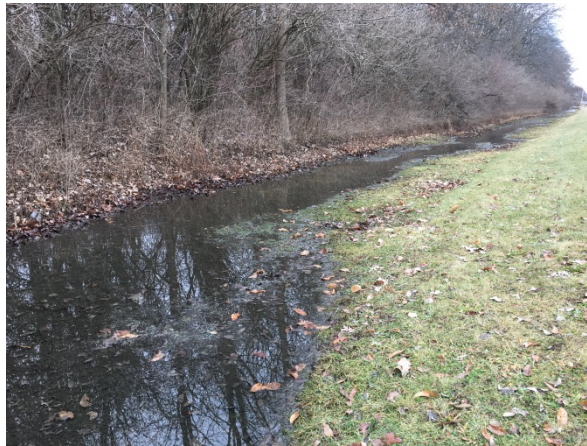
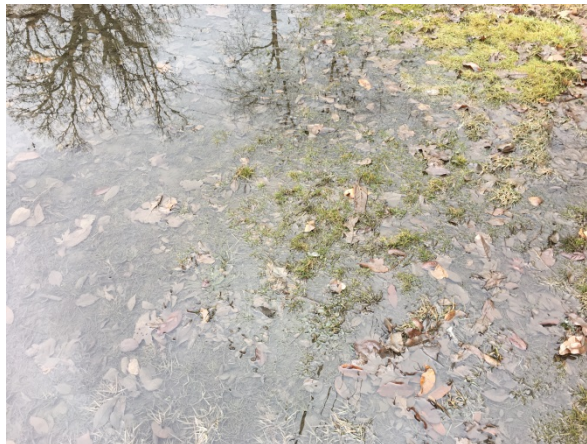
Non-jurisdictional  
Ditch

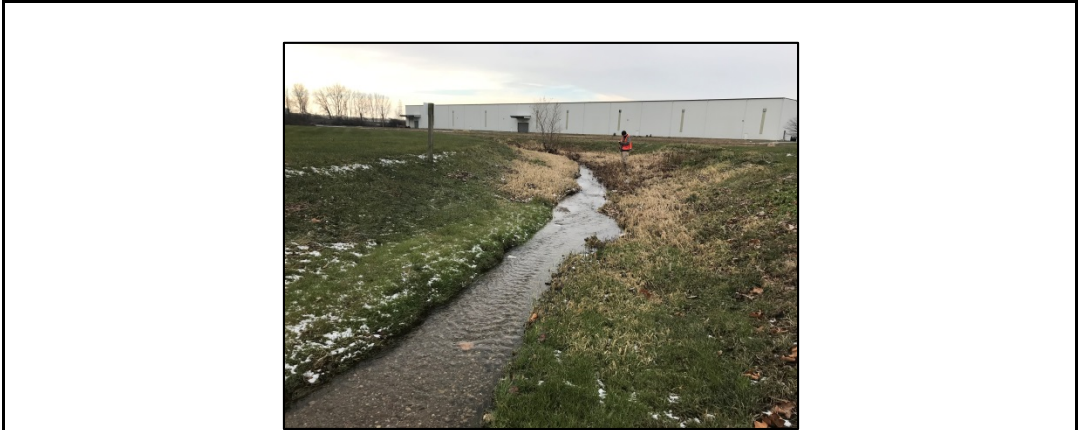
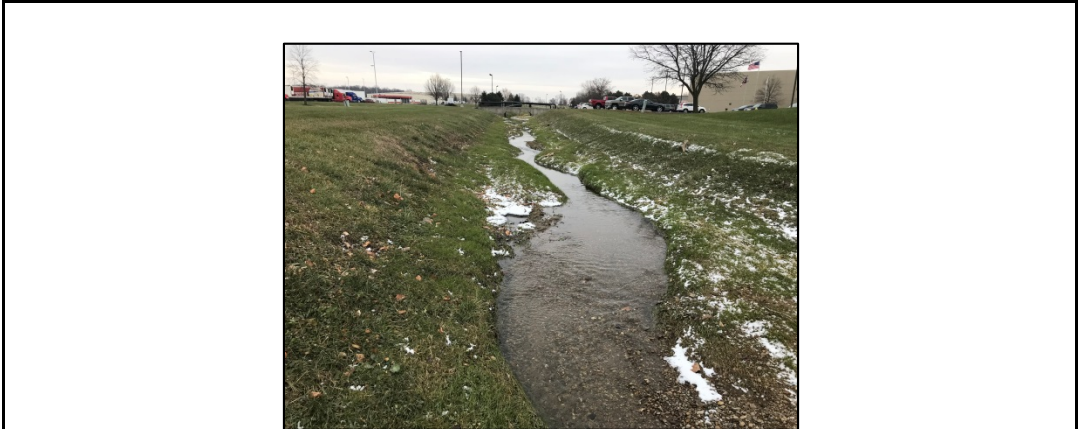
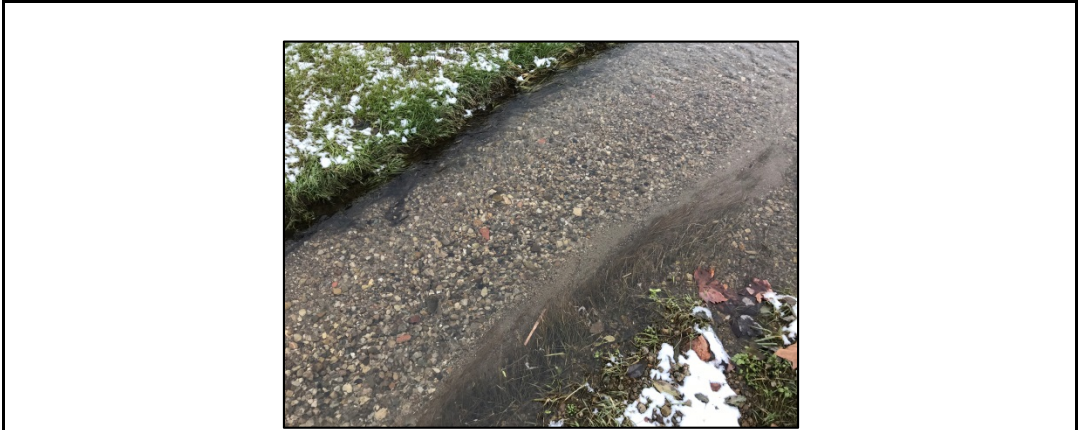
<b>Photo Location 1</b>
<b>Date/Location:</b> December 11, 2017
<b>Description:</b> Stream ESL-1 Intermittent Fair Warmwater QHEI stream
