**AMERICAN TRANSMISSION SYSTEMS, INCORPORATED
A FIRSTENERGY COMPANY**

LETTER OF NOTIFICATION

**HARDING-JUNIPER 345 kV & CHAMBERLIN-HARDING
345kV TRANSMISSION LINE RELOCATION PROJECT**

OPSB Case No.: 26-0017-EL-BLN

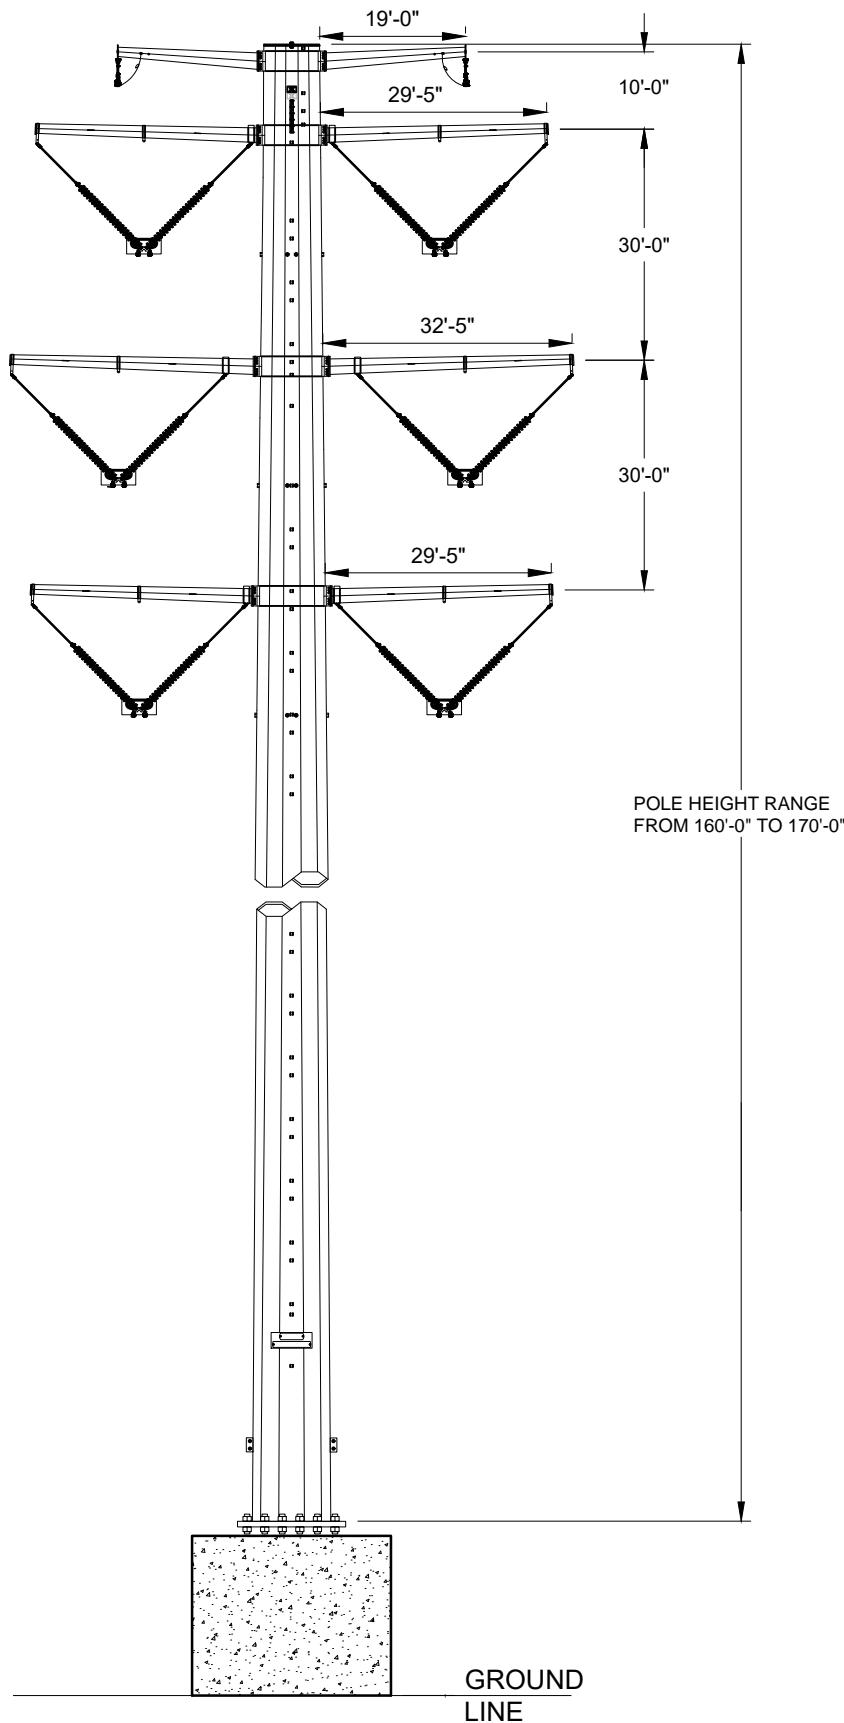
EXHIBIT 4

DOUBLE CIRCUIT
TUBULAR STEEL STRUCTURE
VERTICAL SUSPENSION SINGLE POLE

Voltage:	345 kV
Conductors:	Current – 954 kcmil 48/7 “Towhee” ACSR
	New- 954 kcmil 48/7 “Towhee” ACSR
Static Wire:	Current – 7#8 Alumoweld shield wires
	New – 7#8 Alumoweld shield wires
Insulators:	Glass
ROW Width:	100 feet: ATSI Relocated ROW
	158 feet: CEI Fee Property
Land Requirements:	New
Structure Types:	Exhibit 4: 345kV Double Circuit Tubular Steel Suspension Structure, 0-2° Line Angle (2 Structures) Exhibit 5: 345kV Double Circuit Tubular Steel Deadend Structure, 0-50° Line Angle (3 Structures)

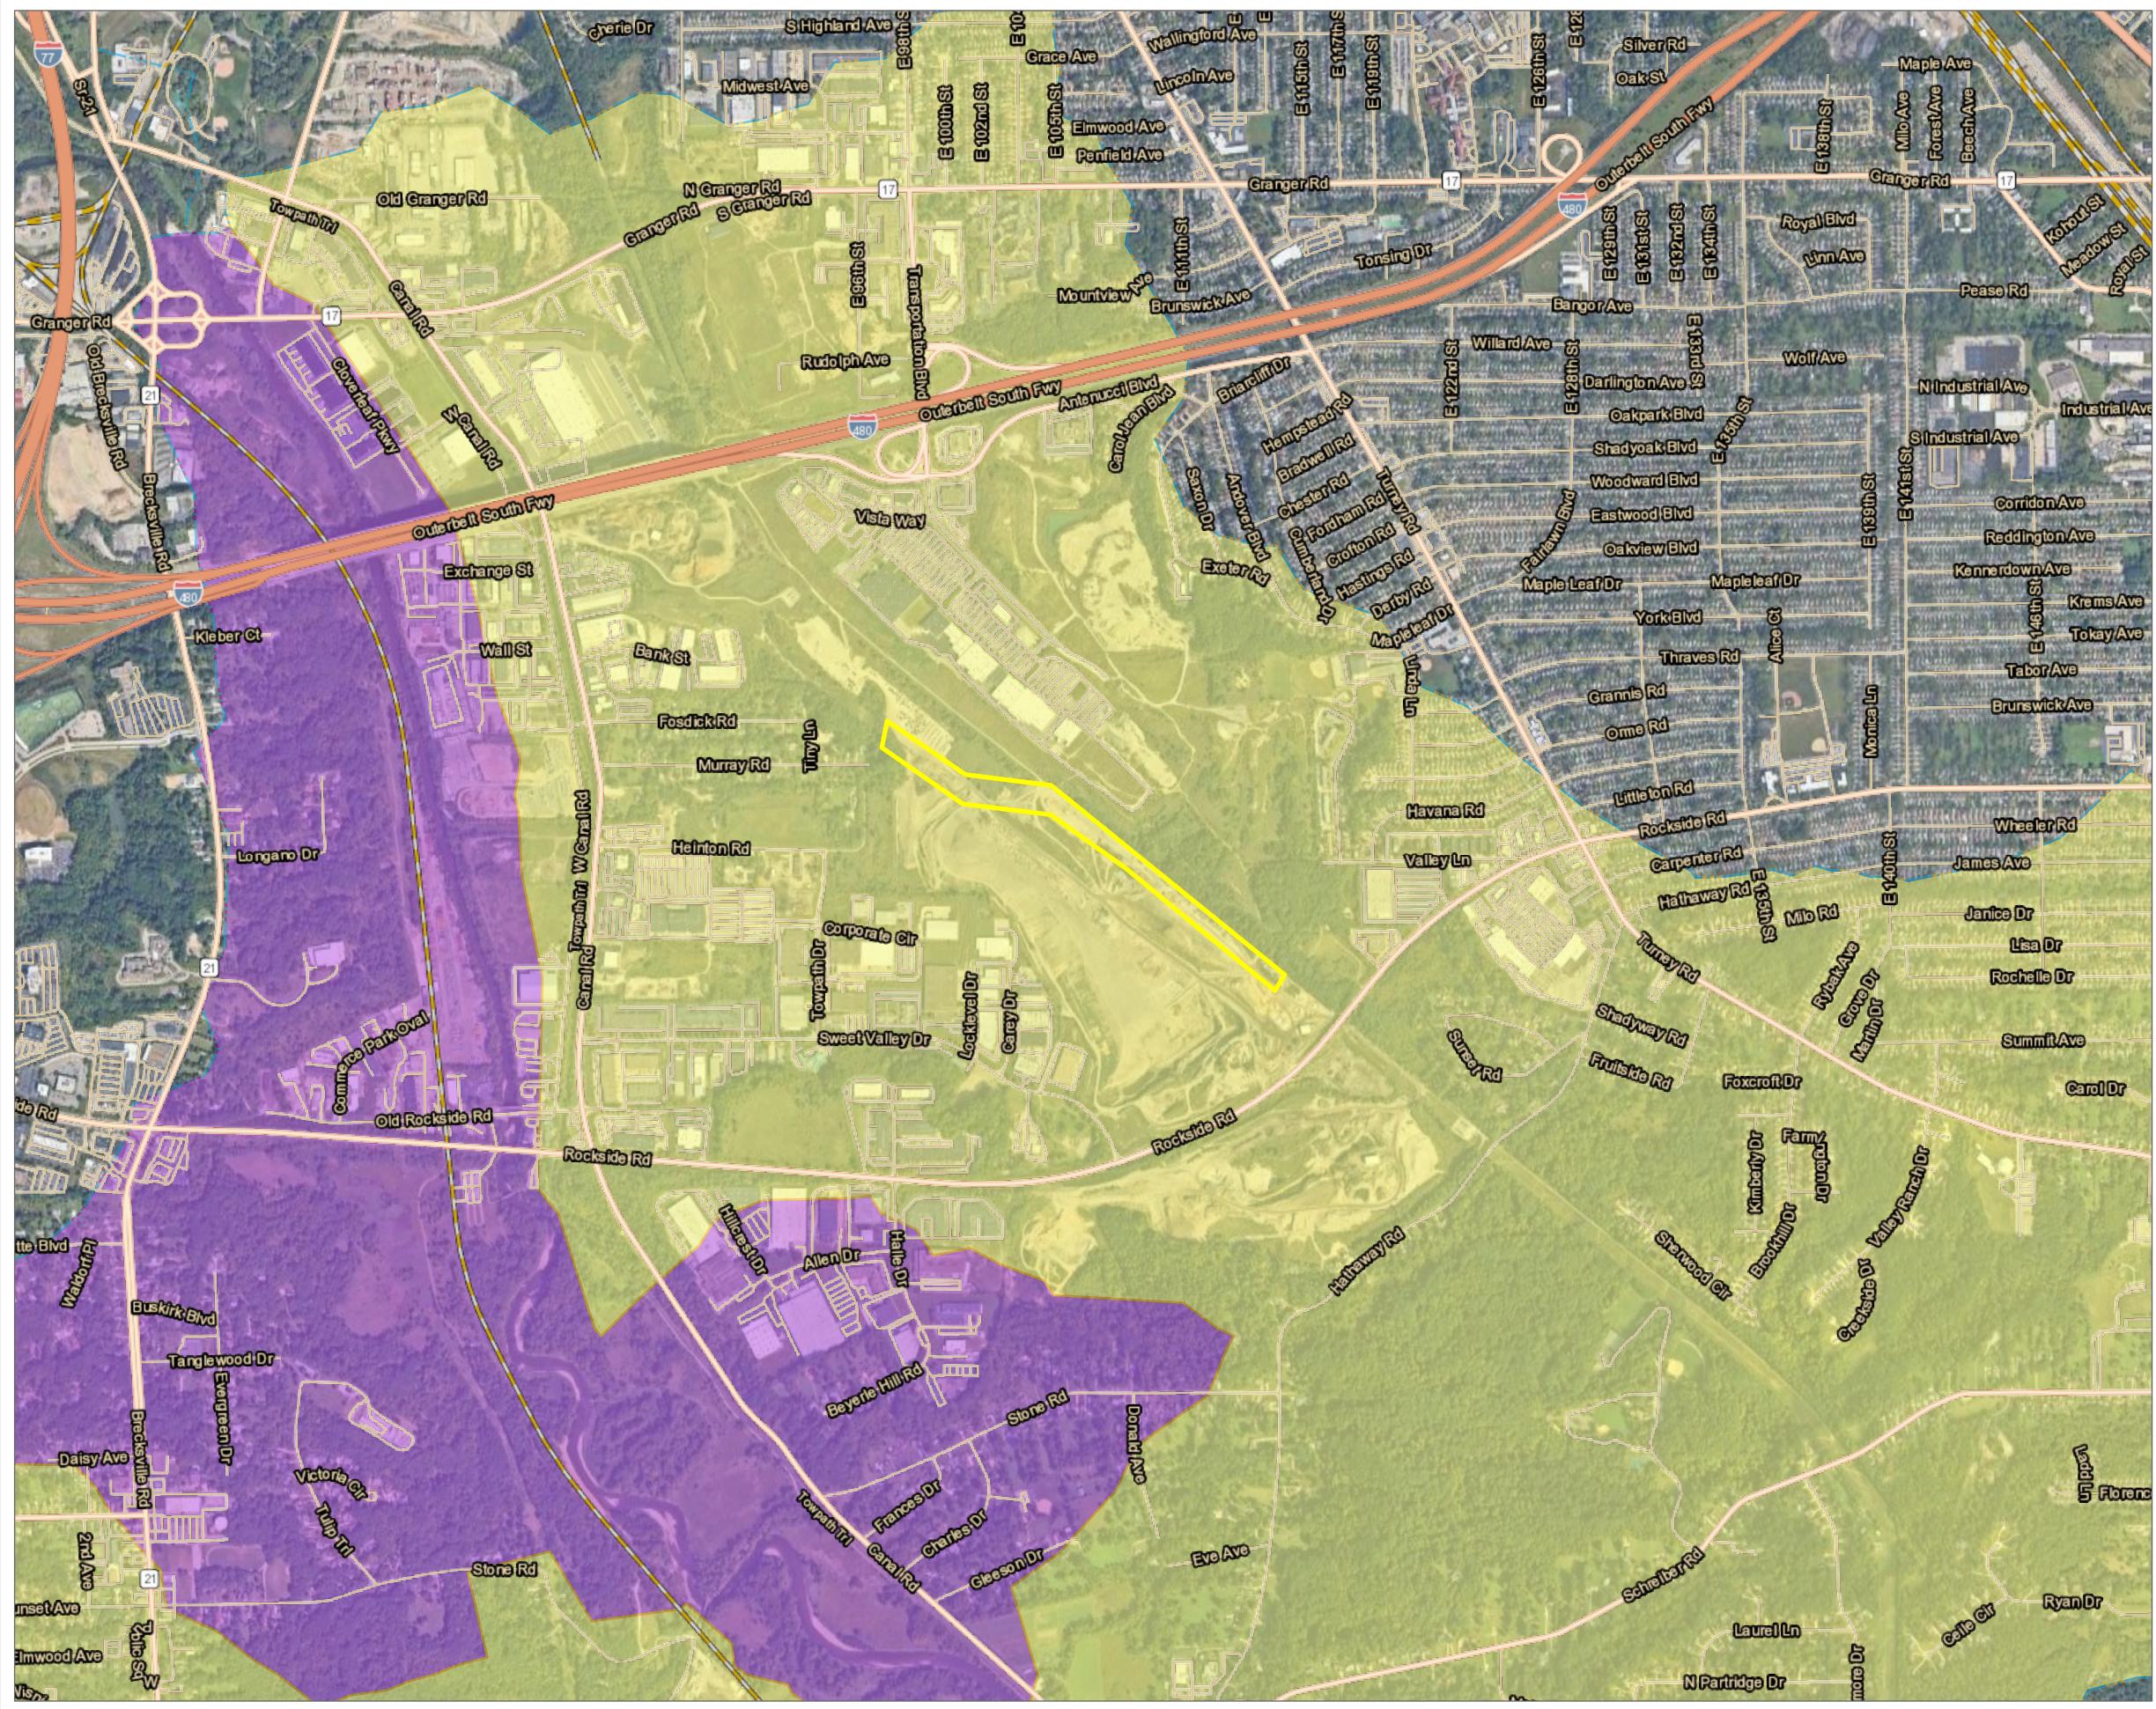
TITLE: NATIONWIDE PERMITS
STREAM ELIGIBILITY MAP

PROJECT STUDY AREA
OHIO EPA 401 WATER QUALITY CERTIFICATION FOR
NATIONWIDE PERMIT ELIGIBILITY
INELIGIBLE
POSSIBLY ELIGIBLE
ELIGIBLE

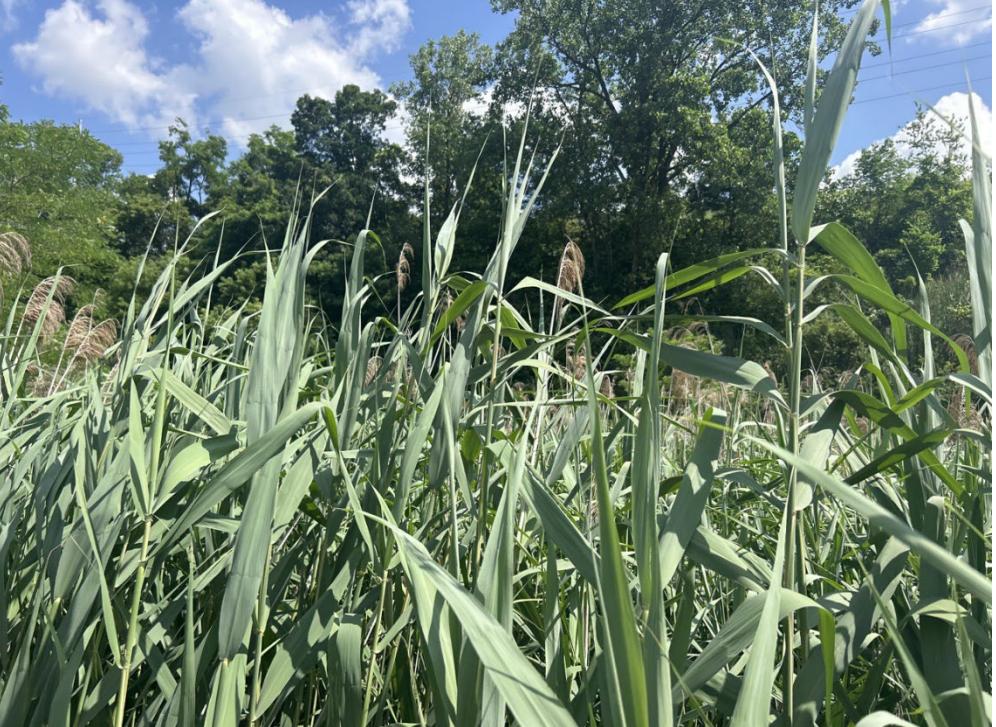
Photo No. 1.

Photo Date: 6/24/2025	
Description: Photo of Wetland W-JMS-1, facing north.

During the field investigation, one (1) palustrine emergent wetland (W-JMS-1) and one (1) intermittent stream (S-JMS-1) were identified and delineated within the Project Study Area. No other ecological resources were observed within the Project Study Area. See **Table 1** and **Table 2** on the following page for a summary of these resources observed. The delineated wetland boundaries and USACE sample points are shown on **Figure 5** in **Attachment A**. Data was collected and recorded on the USACE Wetland Determination Data Sheets – Northcentral and Northeast Region, the Ohio Environmental Protection Agency's (Ohio EPA) Ohio Rapid Assessment Method (ORAM) data form, and the Ohio EPA Headwater Habitat Evaluation Index (HHEI) data form. The USACE Wetland Determination Data Sheets, the Ohio EPA ORAM, and the Ohio EPA HHEI are provided in **Attachment C**.

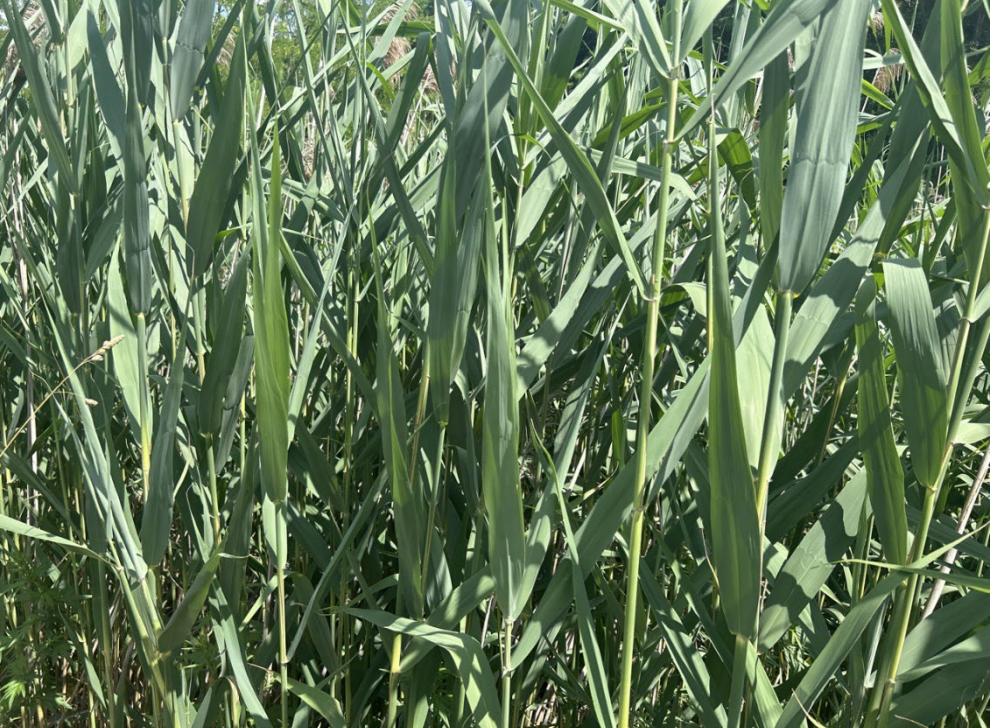
Photo No. 2.

Photo Date: 6/24/2025	
Description: Photo of Wetland W-JMS-1, facing east.

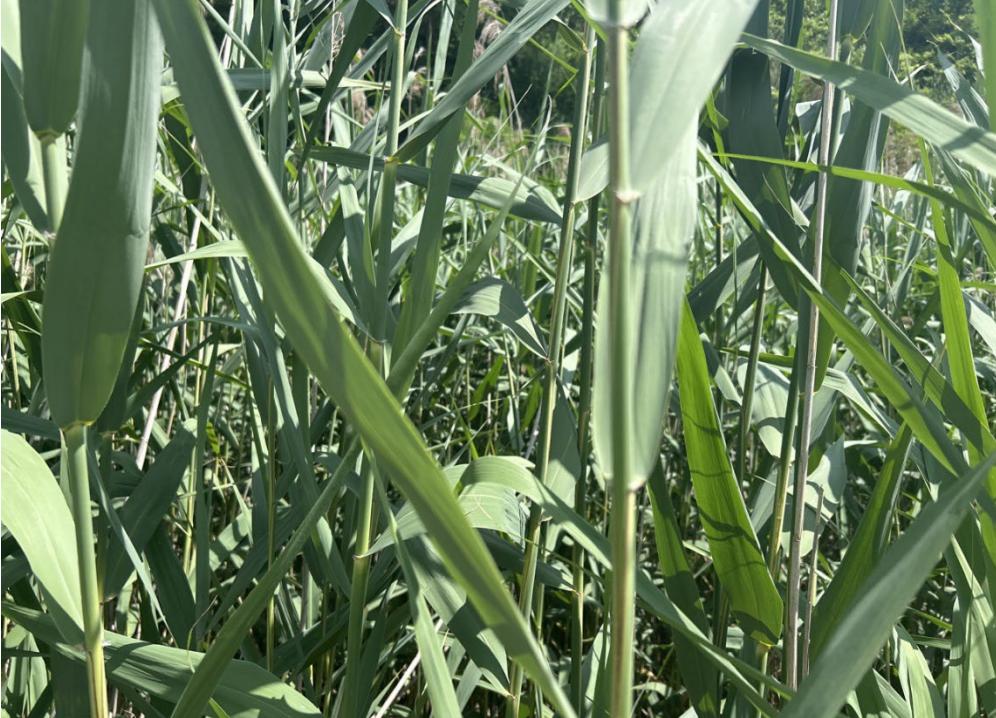
Photo No. 3.

Photo Date: 6/24/2025	
Description: Photo of Wetland W-JMS-1, facing south.

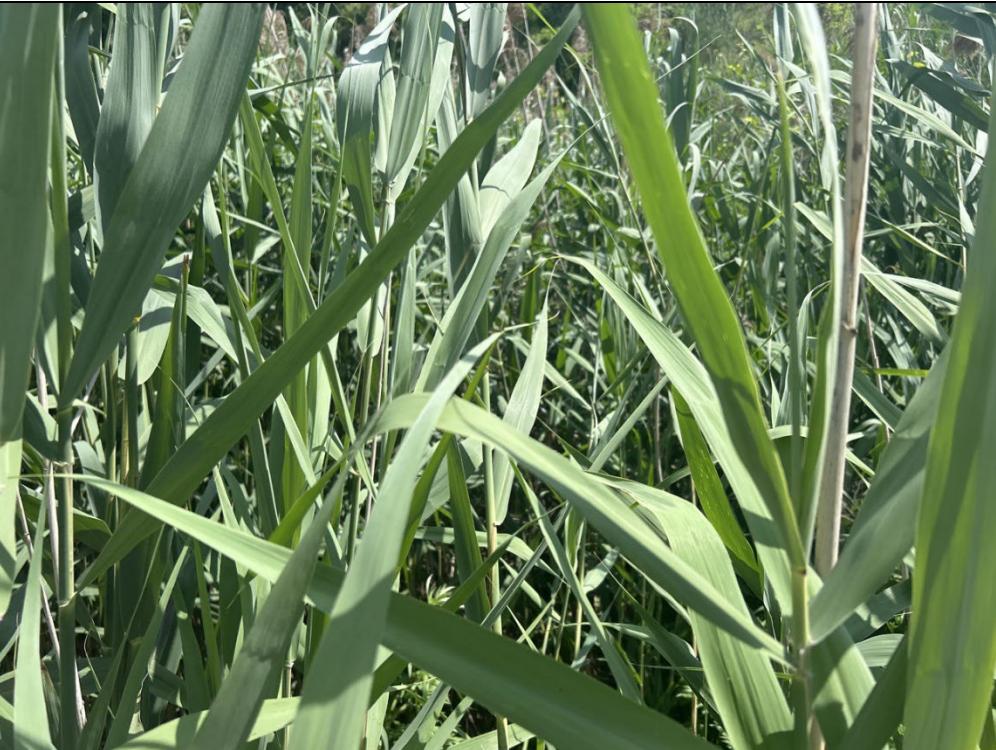
Photo No. 4.

Photo Date: 6/24/2025	
Description: Photo of Wetland W-JMS-1, facing west.

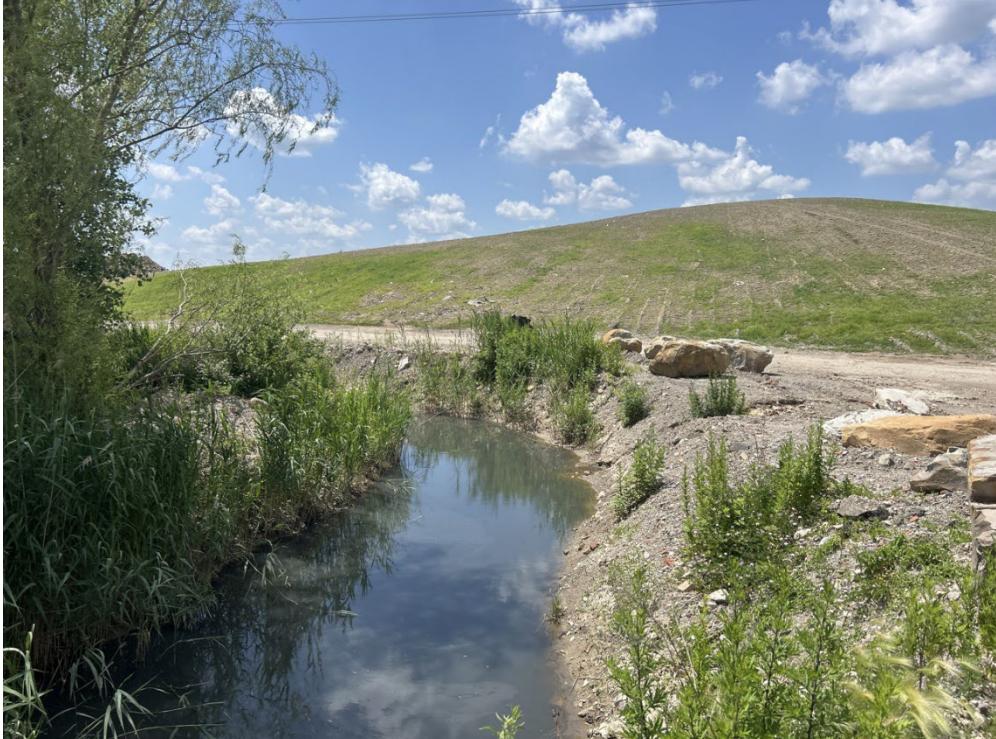
Photo No. 5.

Photo Date: 6/24/2025	
Description: Photo of Stream S-JMS-1 looking downstream, facing south.

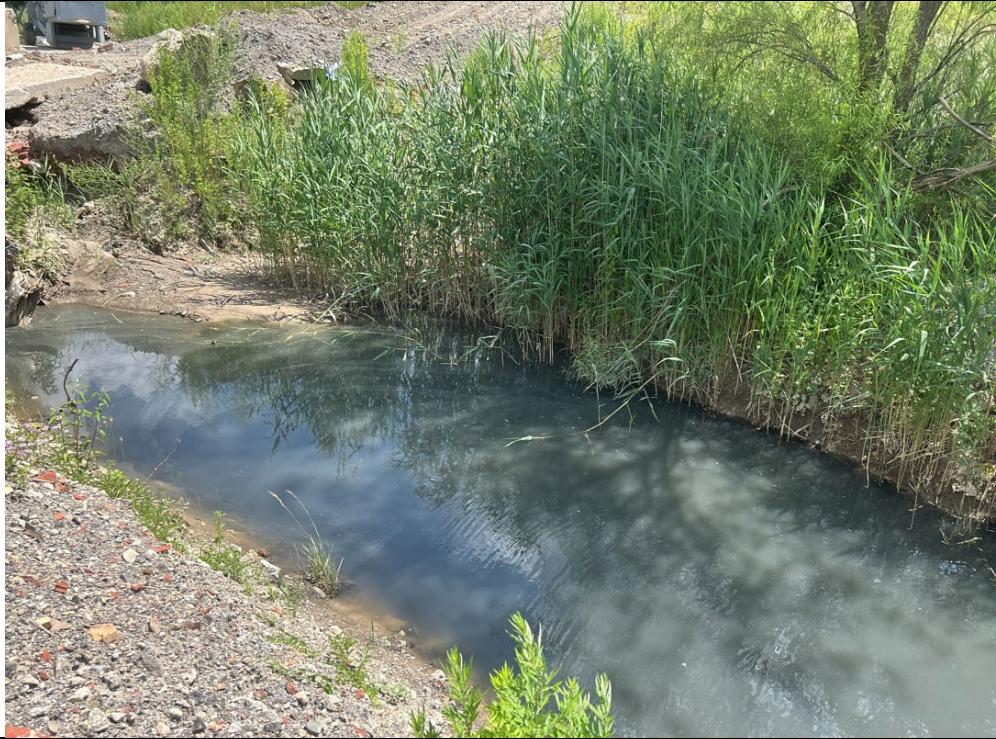
Photo No. 6.

Photo Date: 6/24/2025	
Description: Photo of Stream S-JMS-1 looking upstream, facing northeast.

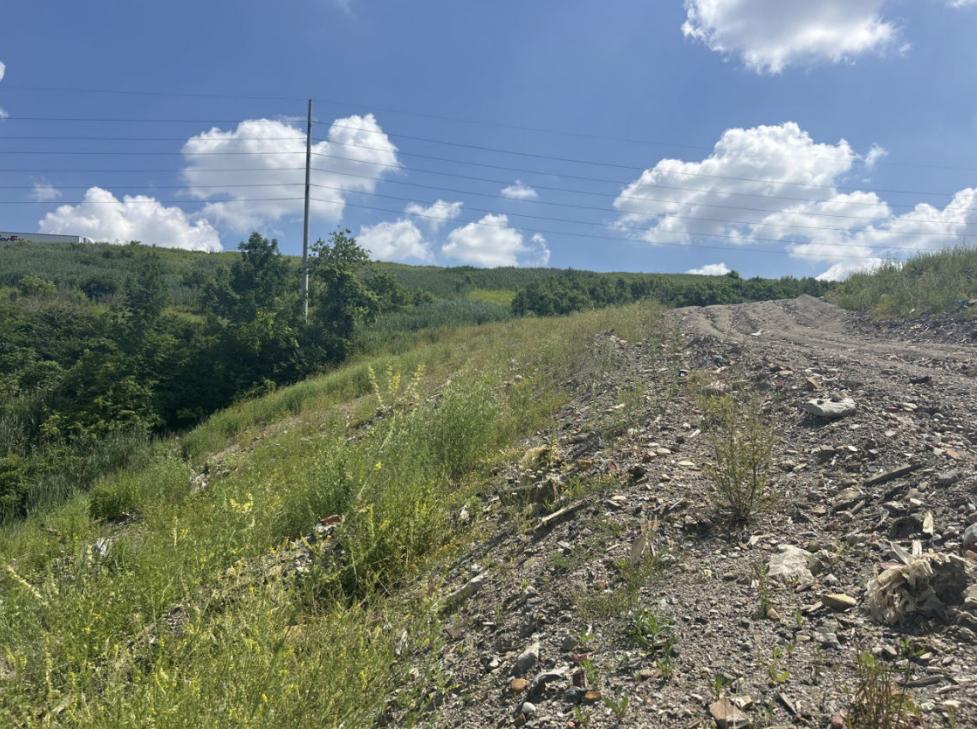
Photo No. 13.

Photo Date: 6/24/2025	
Description: Representative photo of the Project Study Area near W-JMS-1, facing east.
