**CONSTRUCTION NOTICE**

**BROADVIEW - TANGY 138 kV TRANSMISSION LINE  
SWITCH REPLACEMENT PROJECT**

**OPSB CASE NO.: 23-0829-EL-BNR**

**September 19, 2023**

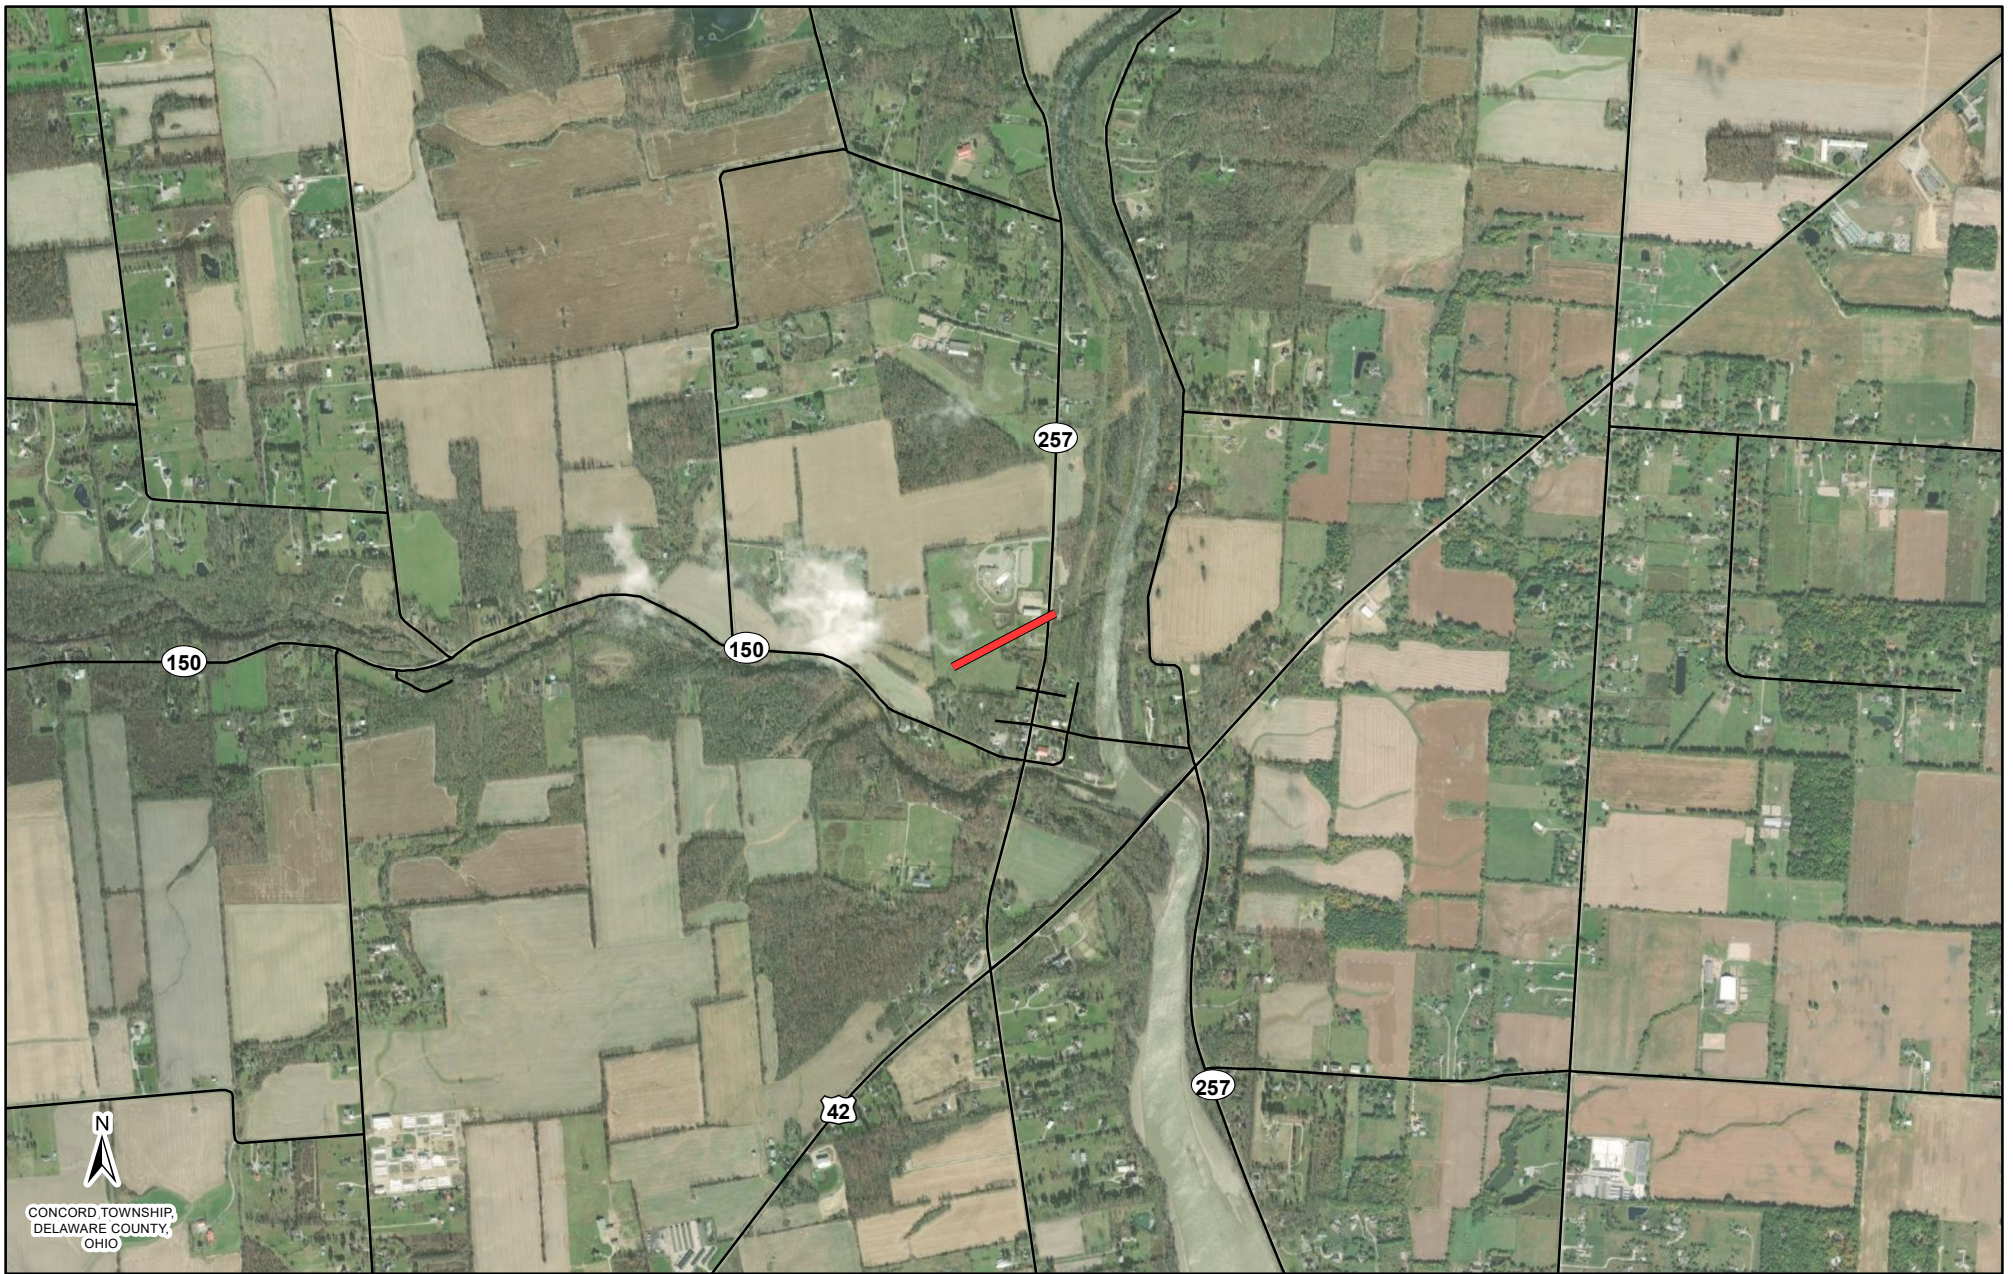
**Broadview-Tangy 138 kV Transmission Line  
Switch Replacement Project**

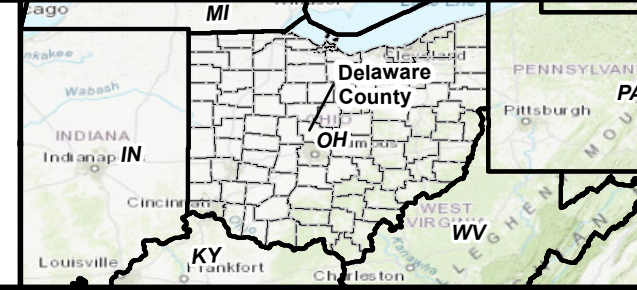
**FIGURE 1**  
OVERVIEW MAP

American Transmission Systems, Incorporated (ATSI), a FirstEnergy Company (FirstEnergy), is proposing to rebuild the existing 138kV electric transmission line as part of the Bellepoint Tap Project in Delaware County, Ohio. The Project includes the installation of a new structure/switch located between the existing Structure 5214 and State Route 257 and modifications to the existing Structures 5213, 5214, 5215, 12349, and 12350. The approximate coordinates for the start and termination points are West to East, Pole 5215 (40.248269, -83.154718) and Pole 5213 (40.249825, -83.150959) respectively as displayed on **Figure 1**.

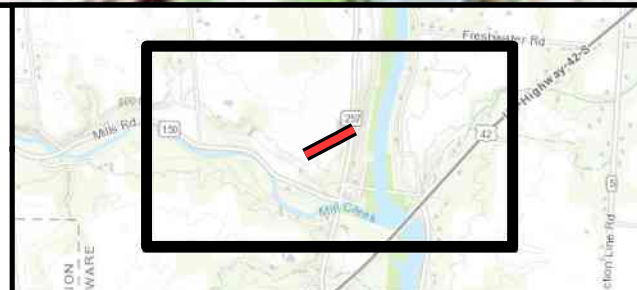
FIGURE 2  
USGS TOPOGRAPHICAL MAP

AECOM compared the Project area and ¼-mile buffer to the information provided by each of these resources and reviewed them for indications of likely underground voids. Figure 2 – USGS Topographical Map shows the Project and its ¼-mile buffer on a USGS background. Figure 3 – Known Mining Activity Map depicts the Project and its ¼-mile buffer in relation to known records of mining activity as recorded by the ODNR. Figure 4 – Karst Geology and Sinkholes Map depicts the Project and its ¼-mile buffer with known locations of karst geology and sinkholes. Aerial photography is shown as the background in Figure 3 and Figure 4.

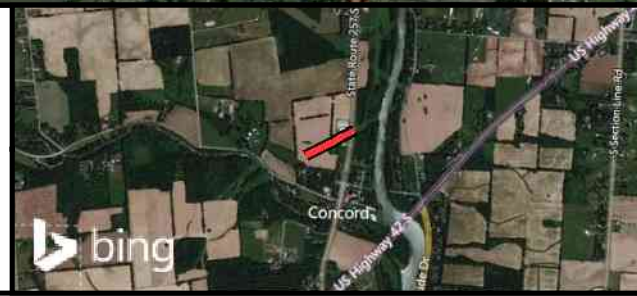
FIGURE 3  
KNOWN MINING ACTIVITY MAP

Based on the available desktop resources, no documented underground mines or mine entrances/openings are within ¼-mile of the Project. ODNR mining records indicate that Industrial Minerals, historic and active mines are present around the Project to the North; however, those features are approximately 1.0 to 1.3 miles away (Figure 3 – Known Mining Activity Map).
