LETTER OF NOTIFICATION

**DELTA-WAUSEON 138 kV TRANSMISSION LINE
TAP TO NOVA TUBE STEEL SUBSTATION PROJECT**

OPSB CASE NO.: 22-0053-EL-BLN

February 11, 2022

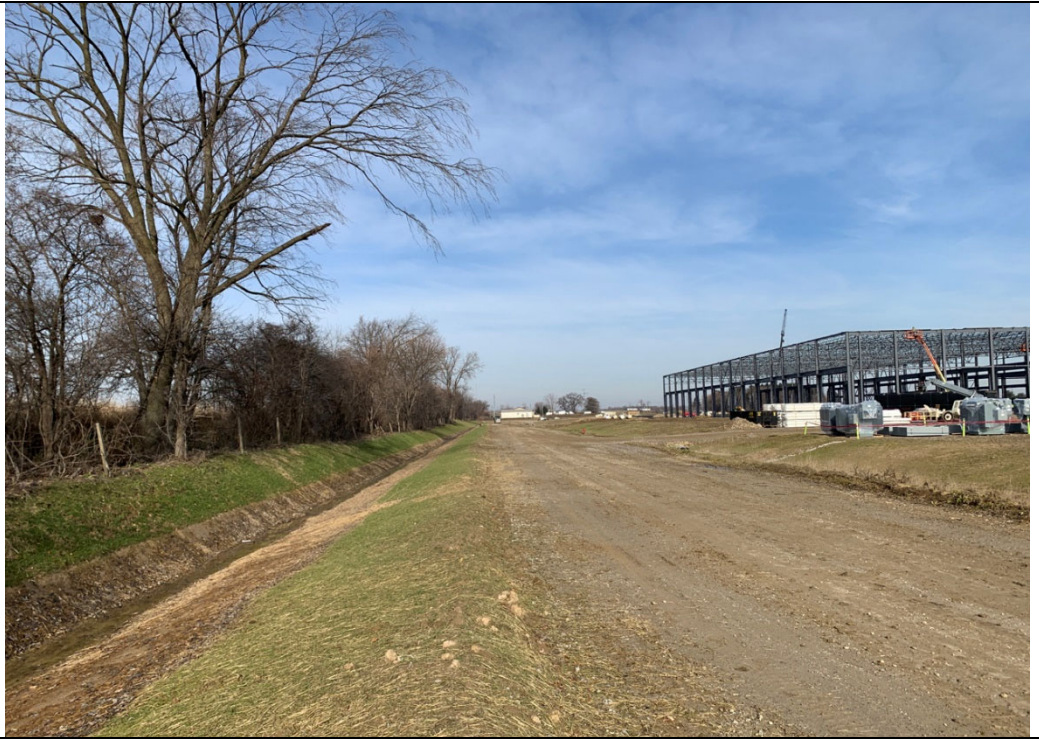
Non-jurisdictional ditch D-MRR-1 within the northern portion of the Project Study Area, looking up gradient, facing north.

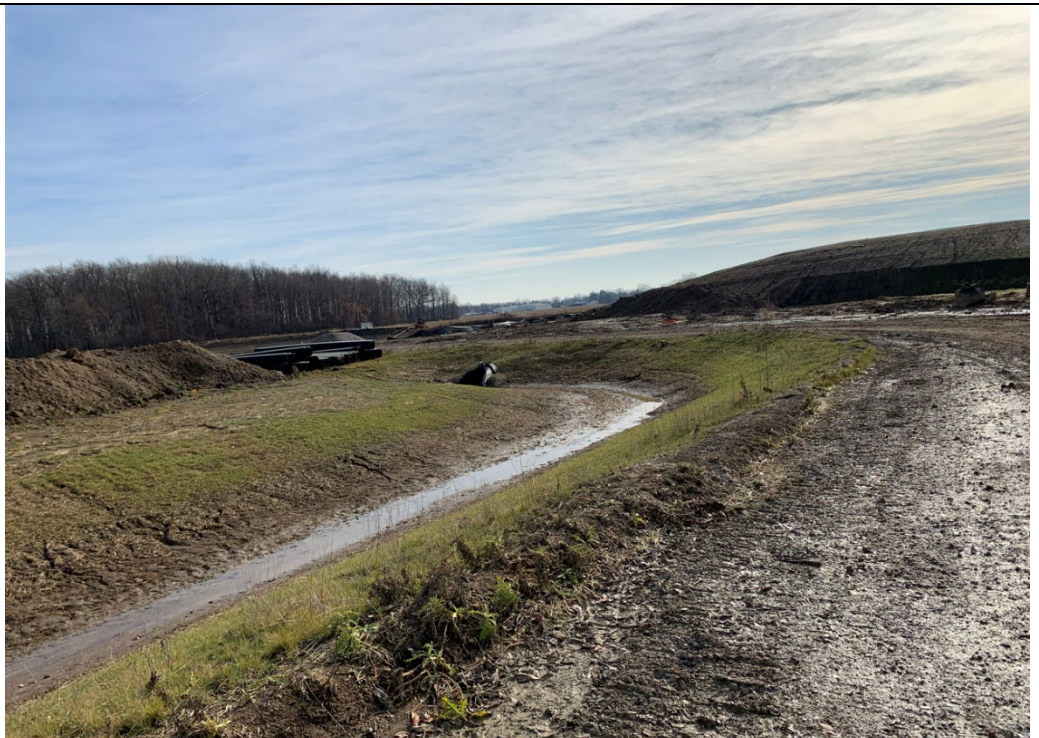
**Photo No. 6.**

Non-jurisdictional ditch D-MRR-2 within the northern portion of the Project Study Area, looking down gradient, facing southeast.

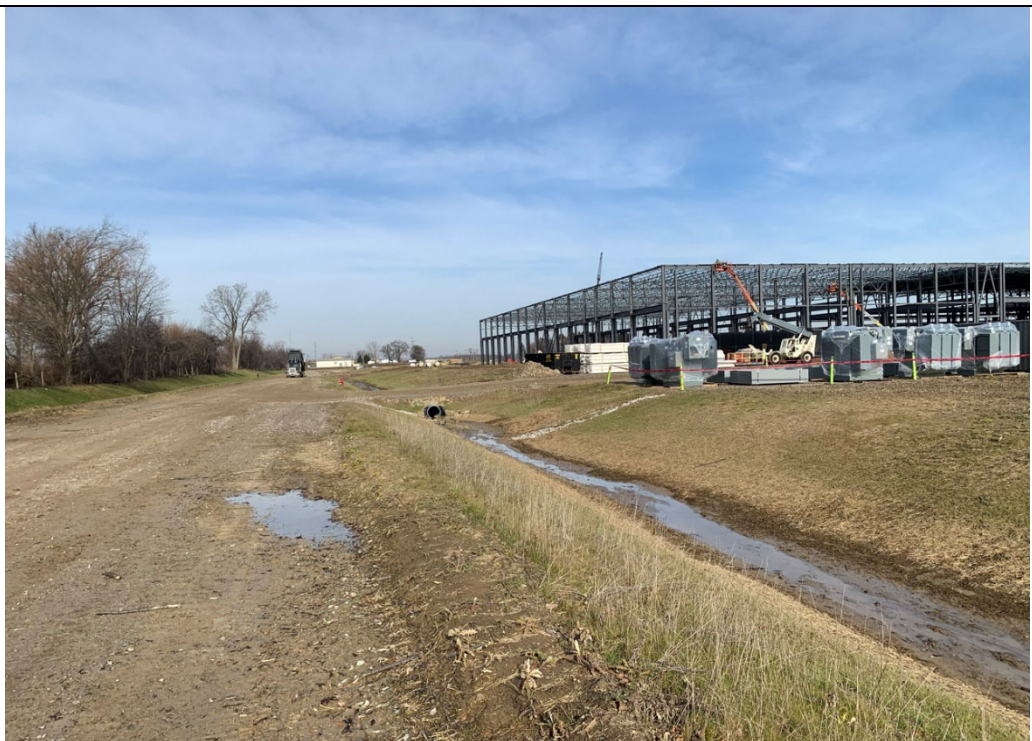
<b>Photo No. 7.</b>
<b>Date:</b> 12/14/2021
<b>Description:</b>  Non-jurisdictional ditch D-MRR-2 within the northern portion of the Project Study Area, looking up gradient, facing northwest.

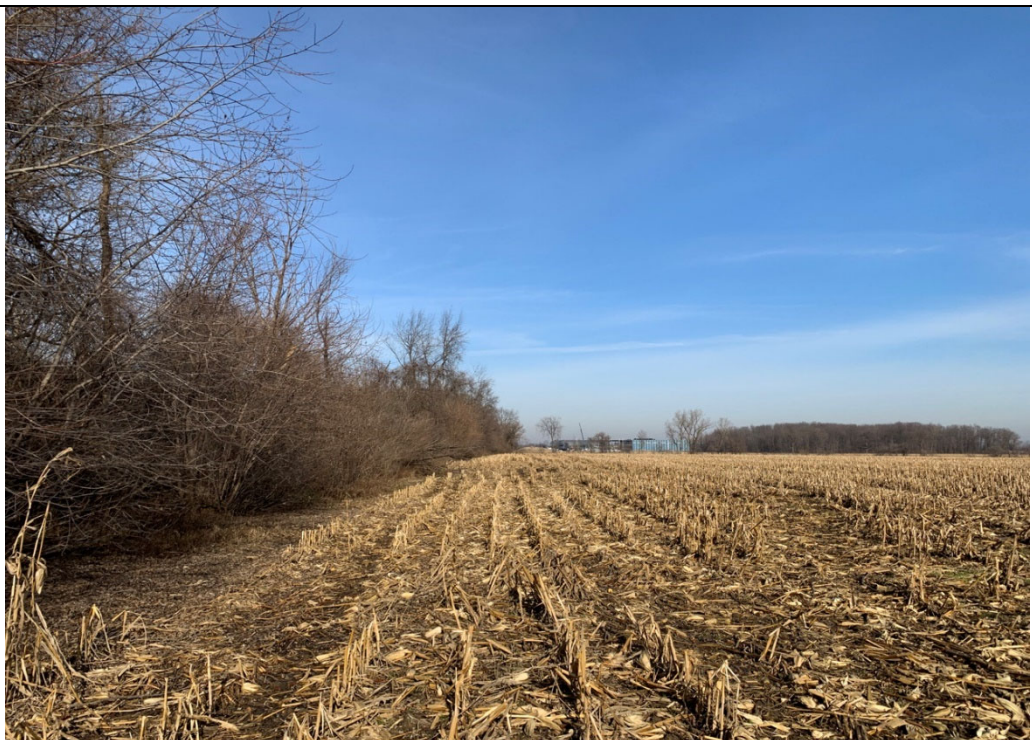
<b>Photo No. 8.</b>
<b>Date:</b> 12/14/2021
<b>Description:</b>  Photo of sample point ROP-MRR-1, facing north.

Remarks:  
 Hydrology criterion has been met. Tractor tire ruts were observed to contain surface water, in addition to the edge of the agricultural field at a toeslope.

Depth (inches)	Matrix		Redox Features				Texture	Remarks
	Color (moist)	%	Color (moist)	%	Type ¹	Loc ²		
0-16	10YR 3/2	100					Loamy/Clayey	
16-22	10YR 5/1	98	7.5YR 5/6	2	C	M	Loamy/Clayey	Prominent redox concentrations

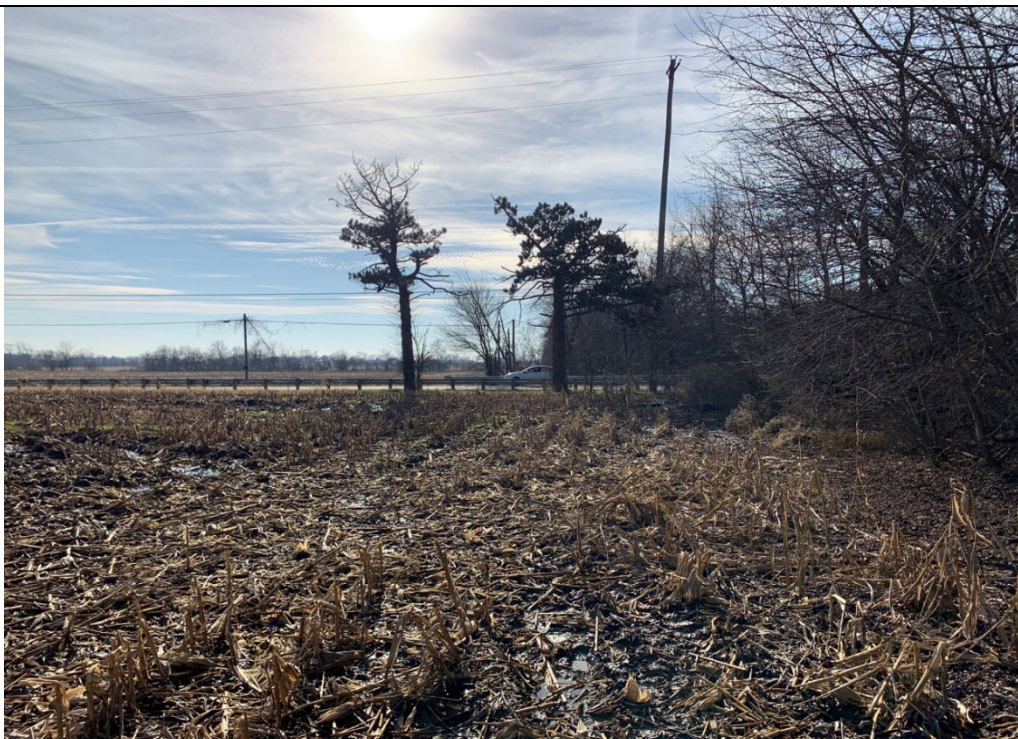
Photo of sample point  
ROP-MRR-1, facing  
south.

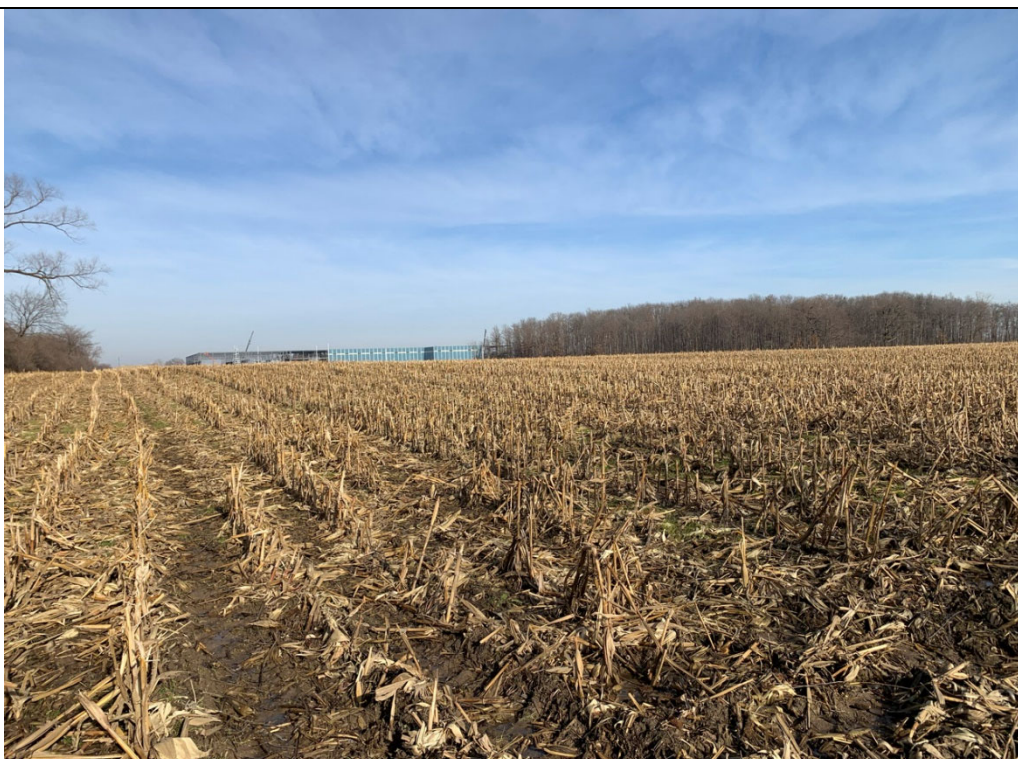
**Photo No. 10.**

Photo of sample point  
ROP-MRR-2, facing  
north.

Remarks:  
 Hydrology criterion has been met. Tractor tire ruts were observed to contain surface water, in addition to the edge of the agricultural field at a toeslope.

Depth (inches)	Matrix		Redox Features				Texture	Remarks
	Color (moist)	%	Color (moist)	%	Type ¹	Loc ²		
0-16	10YR 3/2	100					Loamy/Clayey	
16-22	10YR 5/1	98	10YR 5/8	2	C	M	Loamy/Clayey	Prominent redox concentrations

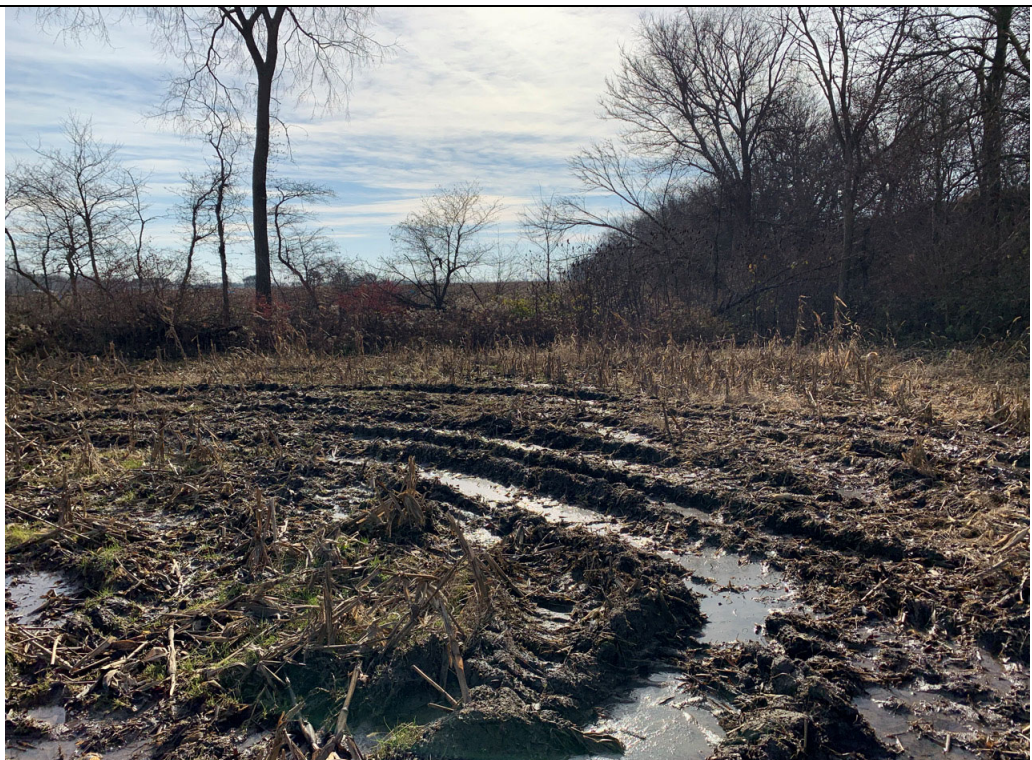
<b>Photo No. 11.</b>
<b>Date:</b> 12/14/2021
<b>Description:</b>  Photo of sample point ROP-MRR-2, facing south.
