CONSTRUCTION NOTICE

**EAST AKRON-EVANS 138 KV TRANSMISSION LINE
SWITCH REPLACEMENT PROJECT**

OPSB CASE NO.: 26-0266-EL-BNR

EAST AKRON – EVANS 138kV
SWITCH #A-281 REPLACEMENT

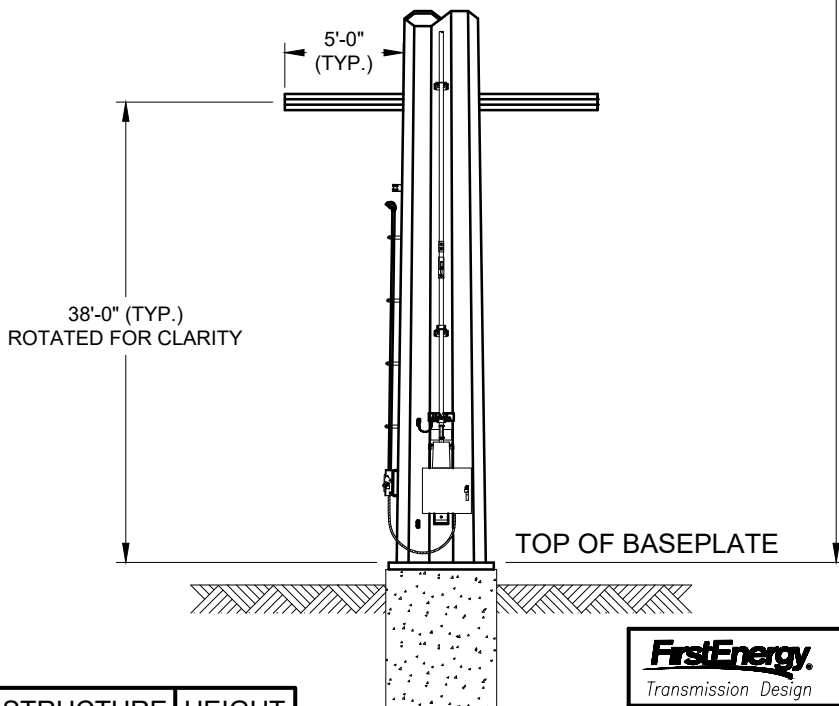
STRUCTURE	HEIGHT
9177	100'-0"

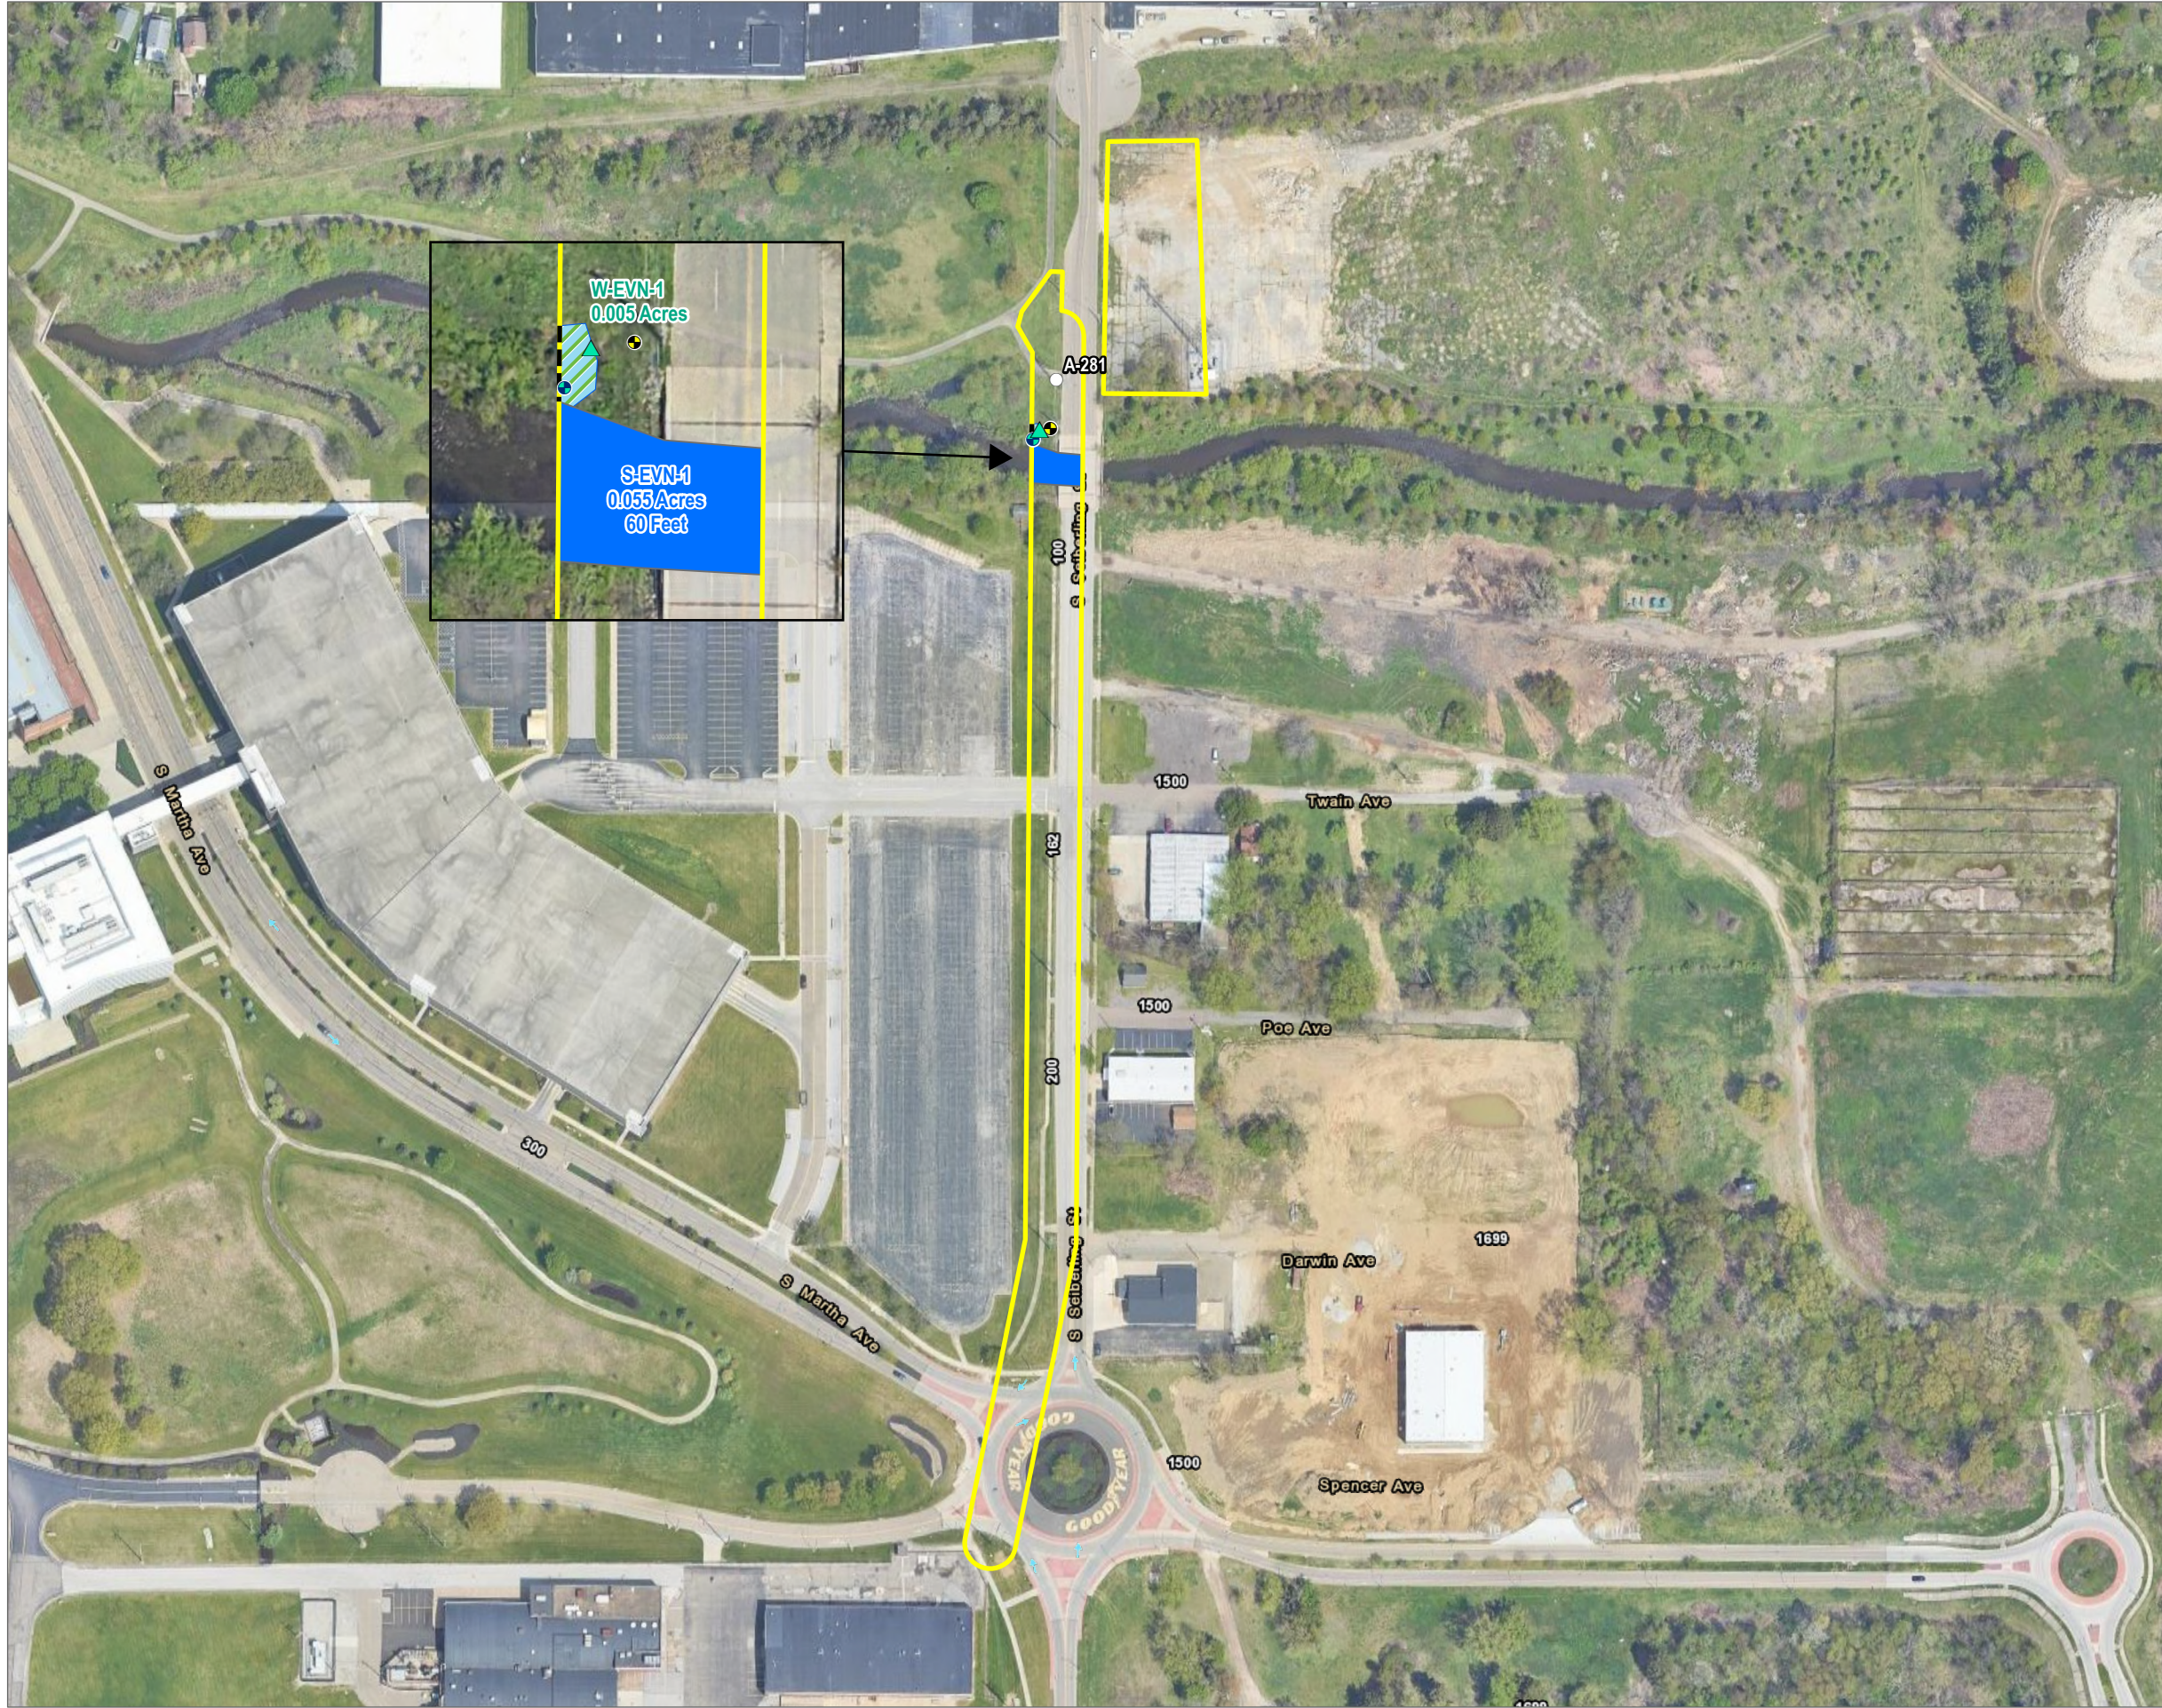
- PROJECT STUDY AREA
- EXISTING STRUCTURE
- ▲ CULVERT
- PERENNIAL STREAM
- PEM WETLAND
- WETLAND CONTINUES
- WETLAND DATA POINT
- UPLAND DATA POINT

BASE MAP: GOOGLE MAPS.
 DATA SOURCES: TRC WETLAND DELINEATION COMPLETED MARCH 10, 2026.

During the field investigation, one (1) palustrine emergent wetland, W-EVN-1, and one (1) perennial stream, S-EVN-1 (Little Cuyahoga River), were identified and delineated within the Project Study Area and are shown on **Figure 5** in **Attachment A**. No other ecological resources were observed within the Project Study Area. See **Table 1** and **Table 2** on the following page for summaries of the observed resources. Wetland data was collected and recorded on the USACE Wetland Determination Data Sheets – Northcentral and Northeast Region and the Ohio Environmental Protection Agency's (Ohio EPA) Ohio Rapid Assessment Method (ORAM) data forms. Stream data was collected and recorded on the Ohio EPA Qualitative Habitat Evaluation Index (QHEI) data form. All wetland and stream data forms are provided in **Attachment C**.

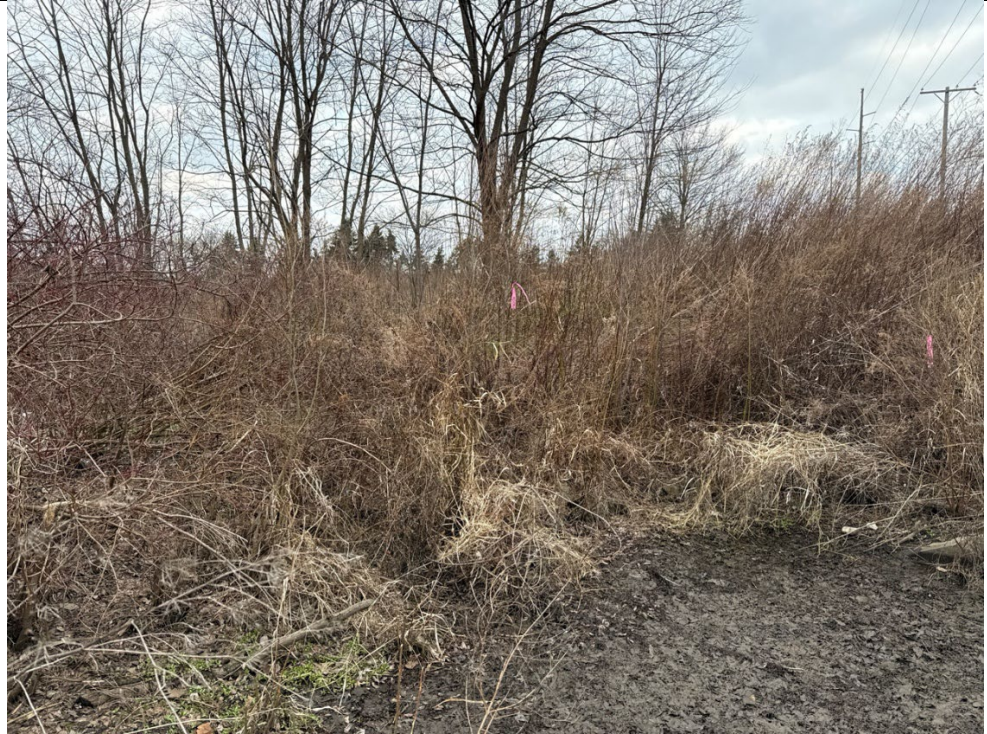
Photo of emergent wetland W-EVN-1, facing north.

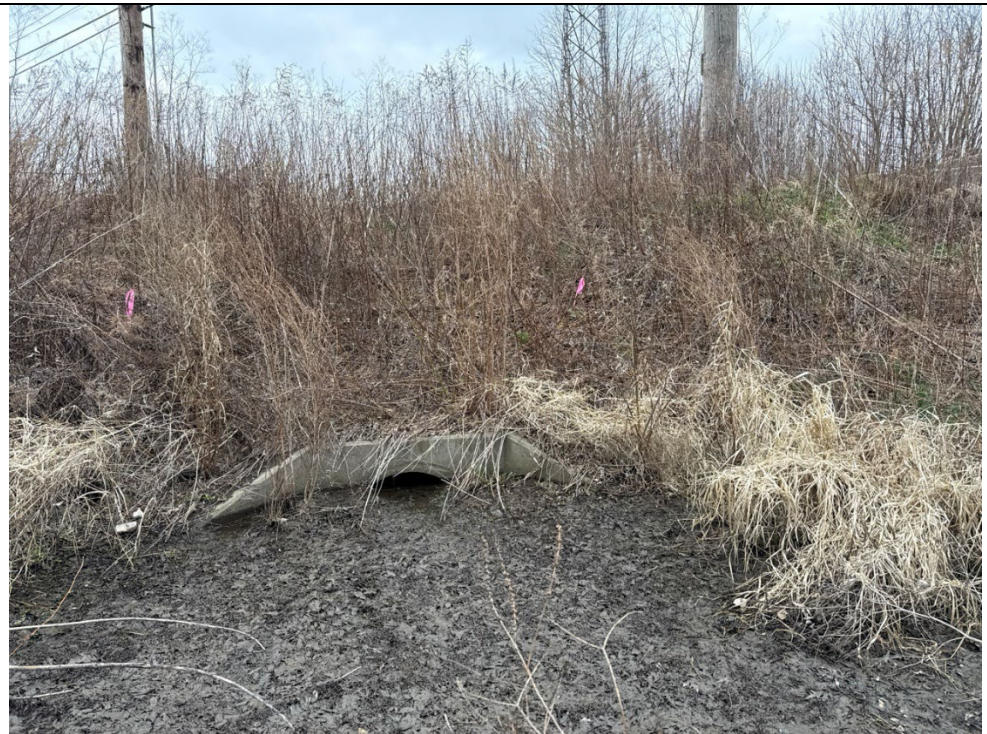
Photo No. 2.

Photo of emergent wetland W-EVN-1, facing east.

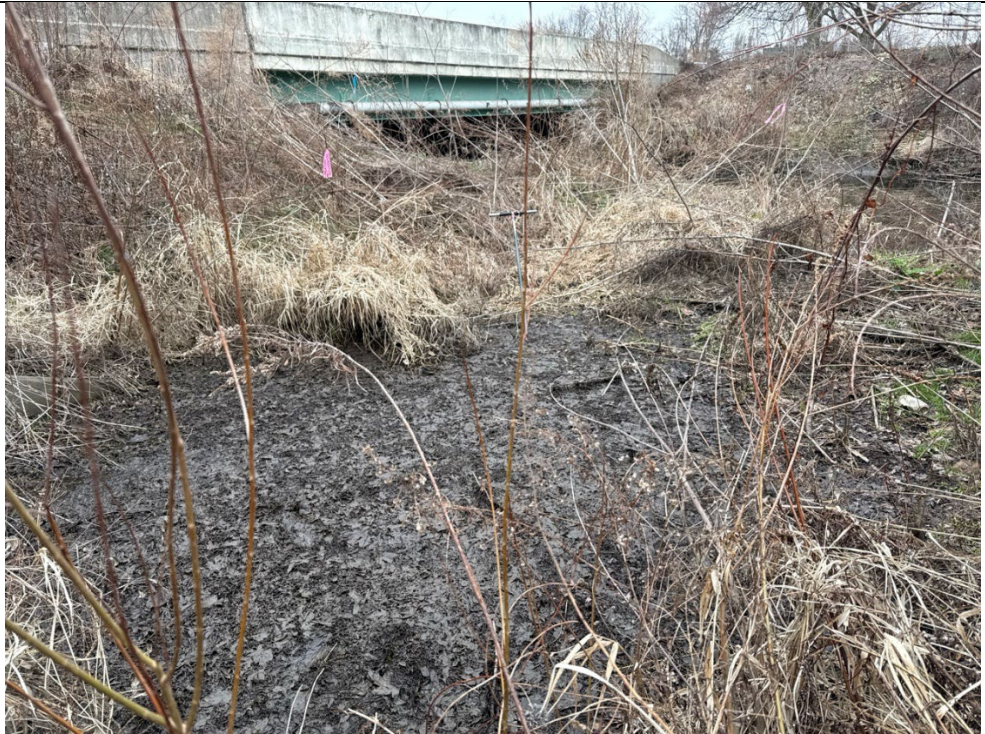
Photo No. 3.

Description:
Photo of emergent wetland W-EVN-1, facing south.

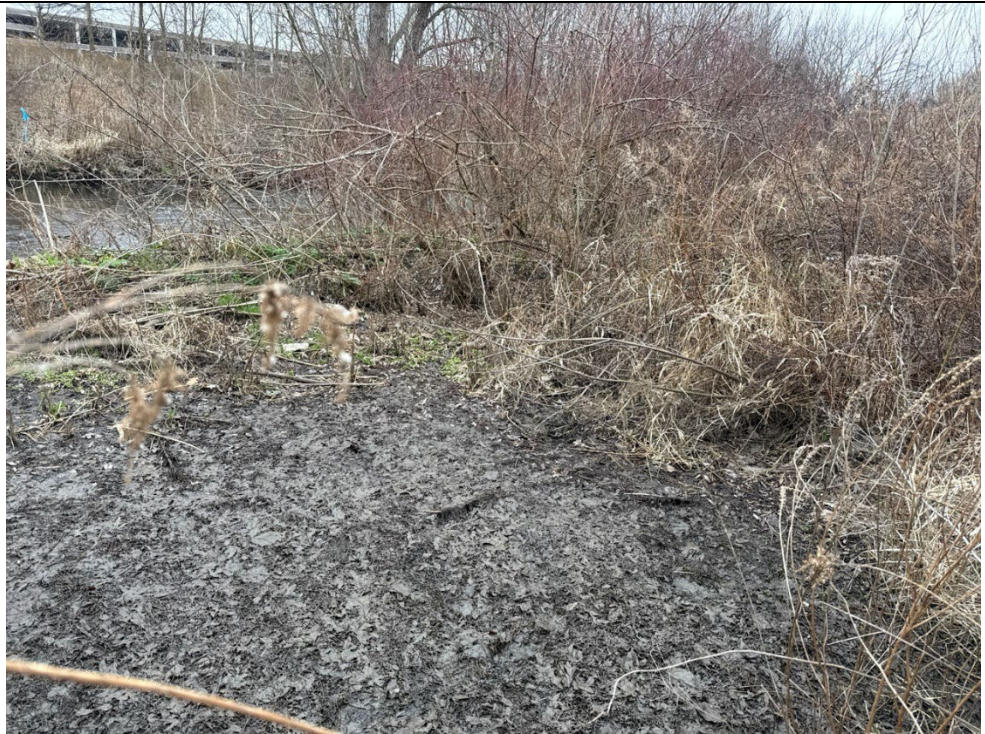
Photo No. 4.

Description:
Photo of emergent wetland W-EVN-1, facing west.

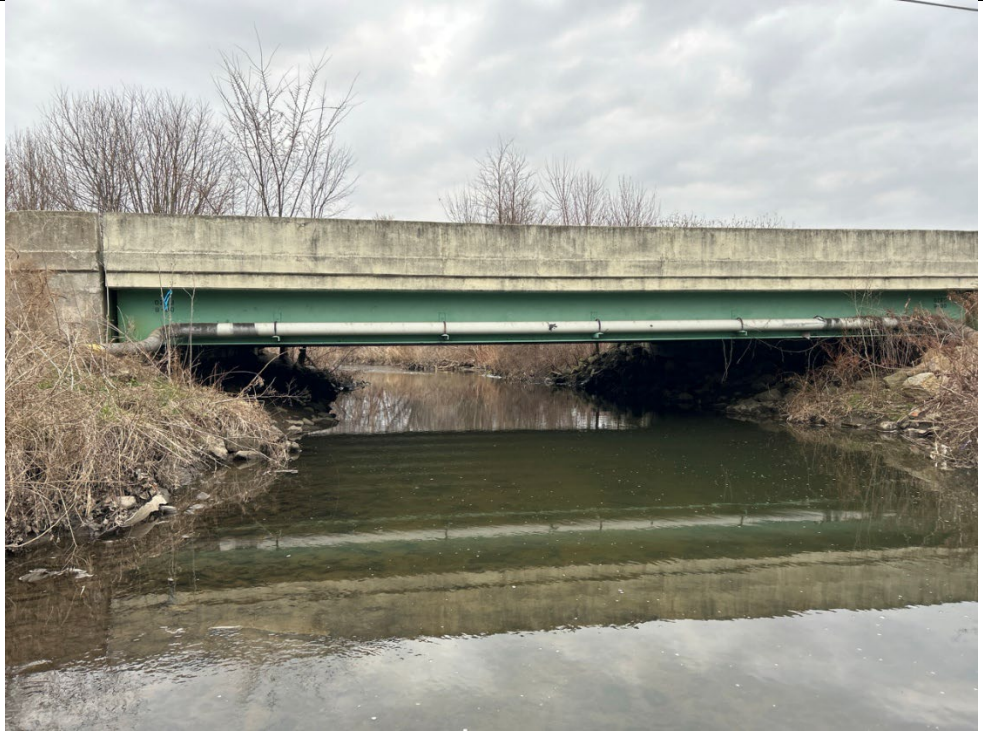
Photo of perennial stream S-EVN-1 (Little Cuyahoga River) looking upstream, facing east.

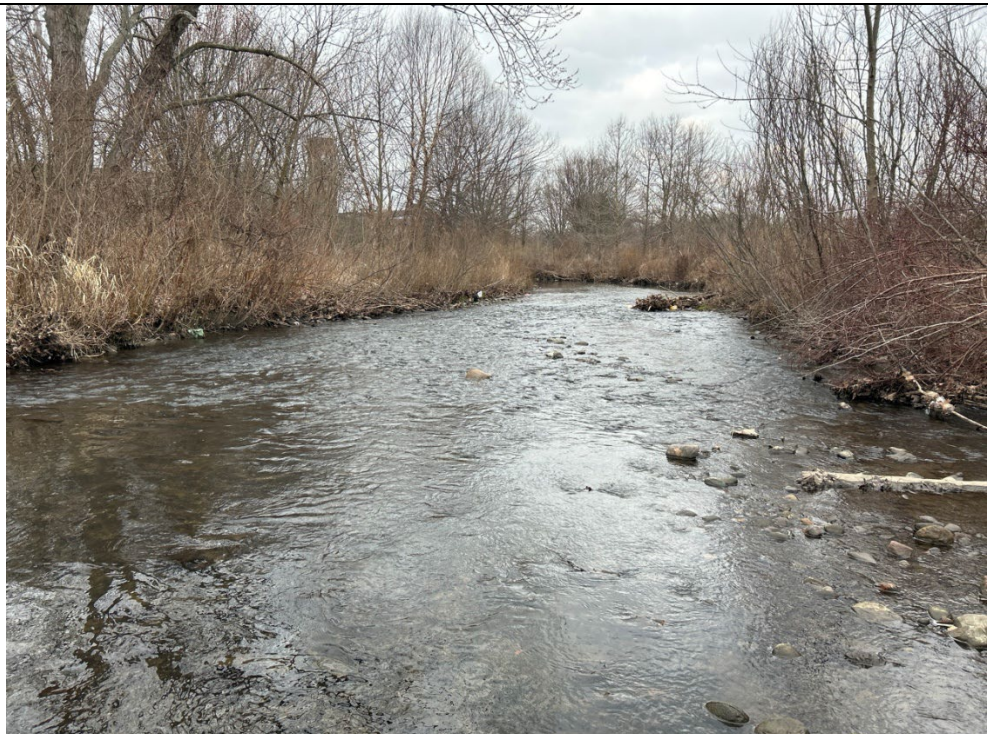
Photo No. 6.

Photo of perennial stream S-EVN-1 looking downstream, facing west.

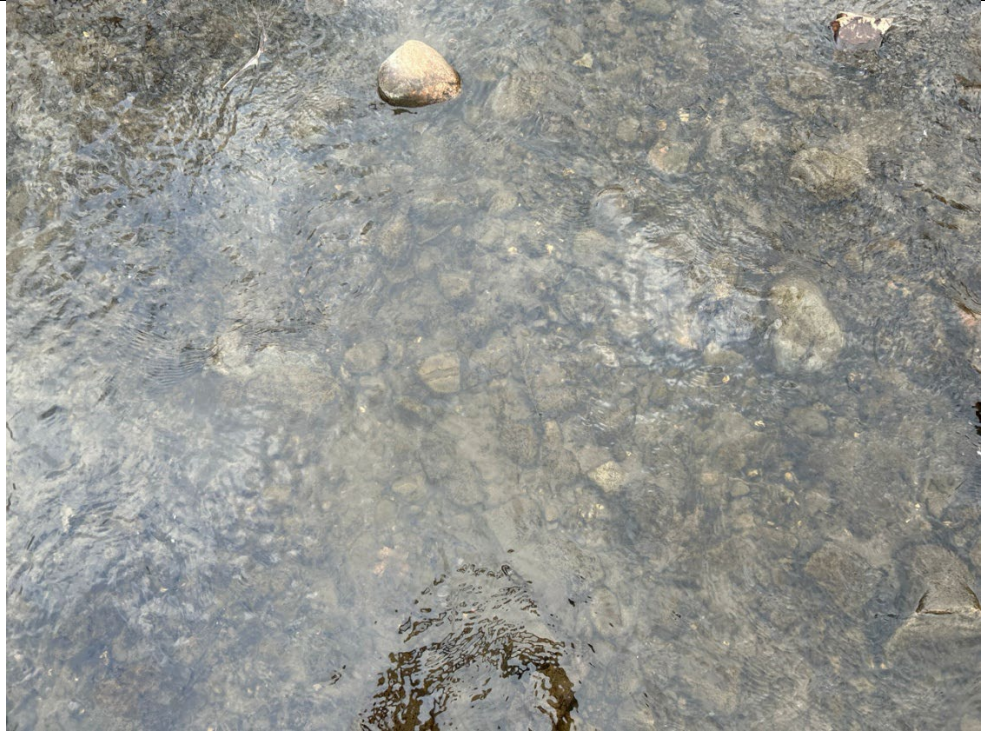
Photo of stream S-EVN-1, view looking down at the observed substrate.
