**AMERICAN TRANSMISSION SYSTEMS,  
INCORPORATED  
A FIRSTENERGY COMPANY**

**CONSTRUCTION NOTICE**

**GREENFIELD-LAKEVIEW 138 kV TRANSMISSION  
LINE RECONDUCTOR PROJECT**

**OPSB CASE NO.: 21-1178-EL-BNR**

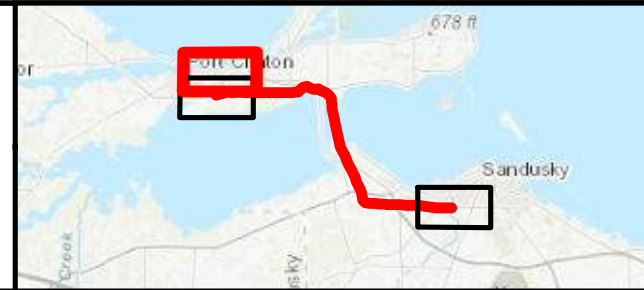
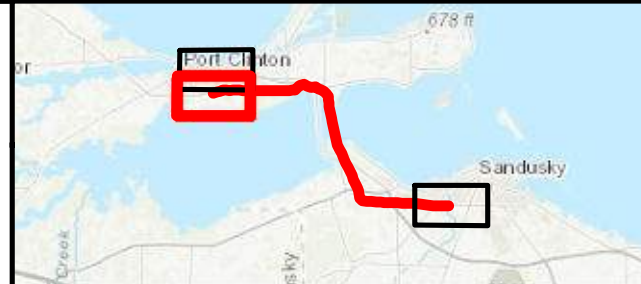
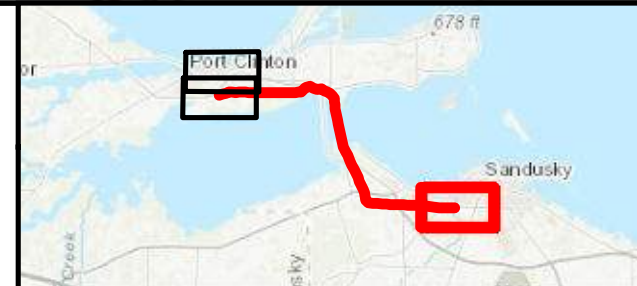
FIGURE 4  
USGS TOPOGRAPHICAL MAP

AECOM reviewed the information provided by each of these resources within ¼-mile of the environmental study area for indications of likely underground voids. **Appendix A, Figure 4 – USGS Topographical Map** shows the Project and it's ¼-mile buffer on a USGS background. **Appendix A, Figure 5 – Known Mining Activity Map** depicts the Project and it's ¼-mile buffer in relation to known records of mining activity as recorded by the ODNR. **Appendix A, Figure 6 – Karst Geology and Sinkholes Map** depicts the Project and it's ¼-mile buffer with known locations of karst geology and sinkholes. Aerial photography is shown as the background in **Appendix A, Figure 5 – Known Mining Activity Map** and **Figure 6 – Karst Geology and Sinkholes Map**.

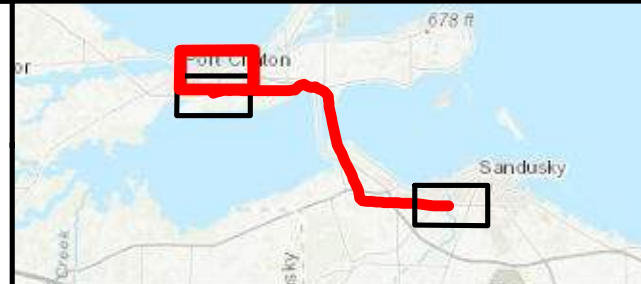
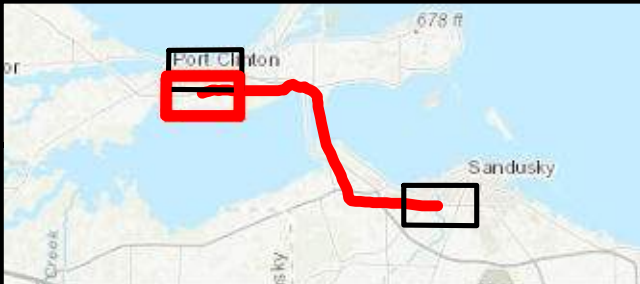
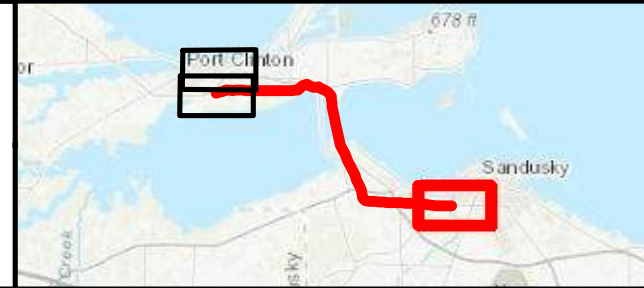
**FIGURE 5**  
**KNOWN MINING ACTIVITY MAP**

Based on the available desktop resources, no documented underground mines, mine entrances/openings, or karst features are present within ¼-mile of the Project. ODNR mining records indicate that several underground and surface mine features are present to the east of the Project in Ottawa County but are not within ¼-mile of the Project area (**Figure 5 – Known Mining Activity Map**). Surface mines to the southeast

and southwest of the Project area in Erie County are approximately 0.6 to 2.0 miles away, beyond the visible extent on **Figure 5 – Known Mining Activity Map**.

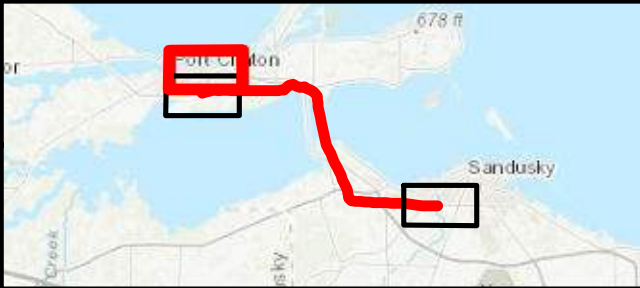
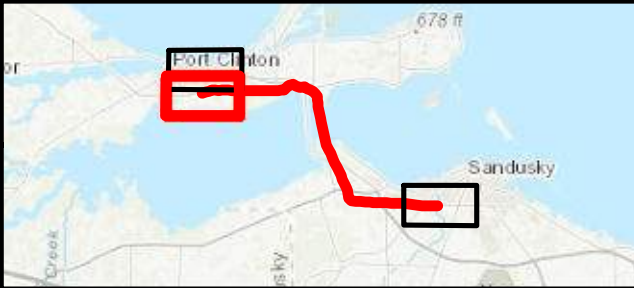
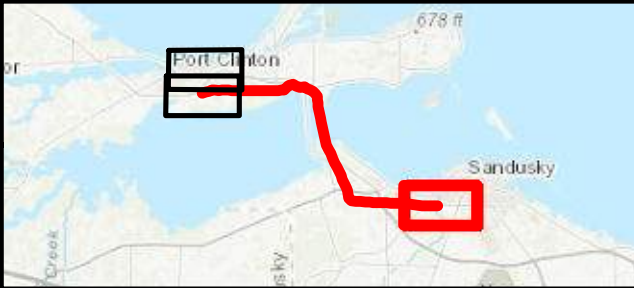
**FIGURE 6**  
KARST GEOLOGY AND SINKHOLES MAP

Karst geology is associated with approximately the western half of Ohio, and not the portion of the state in which the Project is located. Review of the ODNR Karst Interactive Map did not reveal any karst geology or sinkholes within the Project vicinity (**Figure 6 – Karst Geology and Sinkholes Map**). Furthermore, no underground voids or openings were observed in the field during previous environmental surveys conducted for the Project.

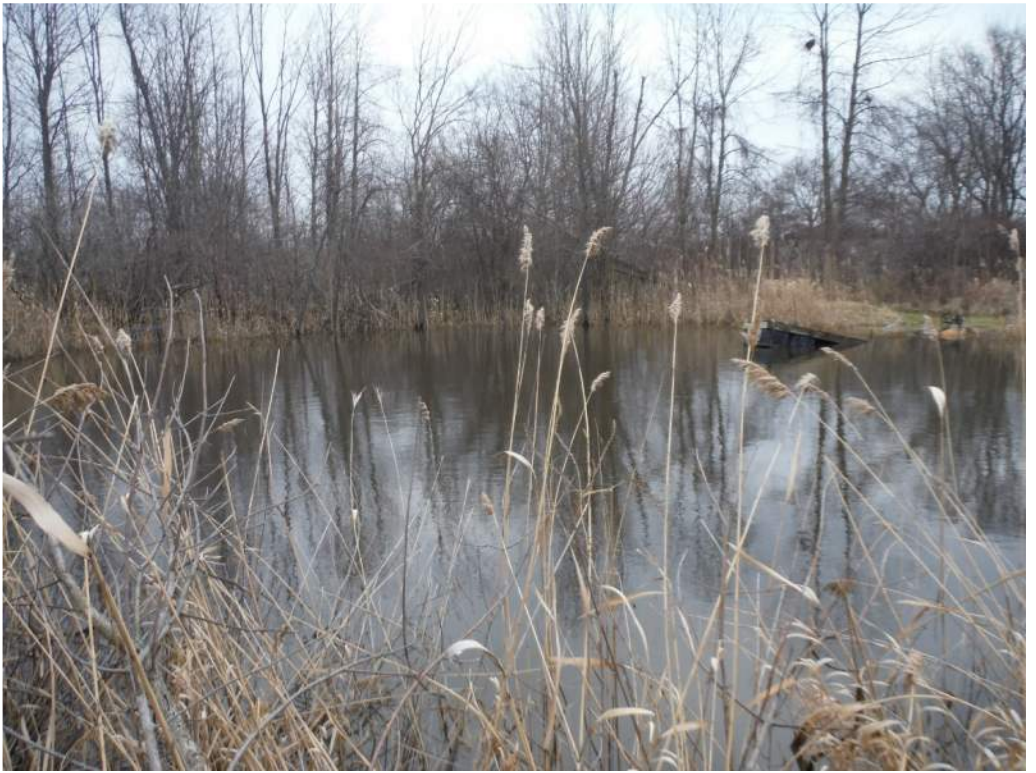
<b>Photo No. 13</b>

<b>Date/Location:</b> January 14, 2020	
<b>Description:</b>  Photo Location 7  View of a wetland complex (Wetland LO-09) located within the existing electric right-of-way. The wetland has a PUB section that is surrounded by both PEM and PSS wetland types.  Facing East

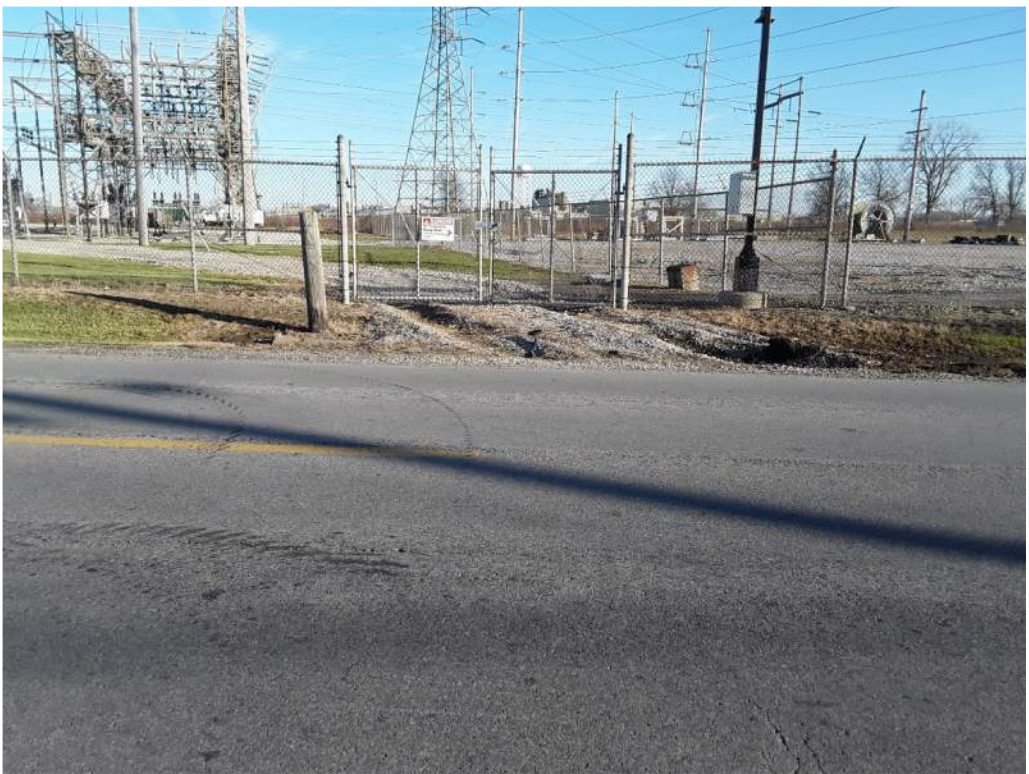
<b>Photo No. 26</b>

<b>Date/Location:</b> November 18, 2020	
<b>Description:</b>  Photo Location 13  Access to the existing Greenfield Substation from Old Railroad Road.  Facing East

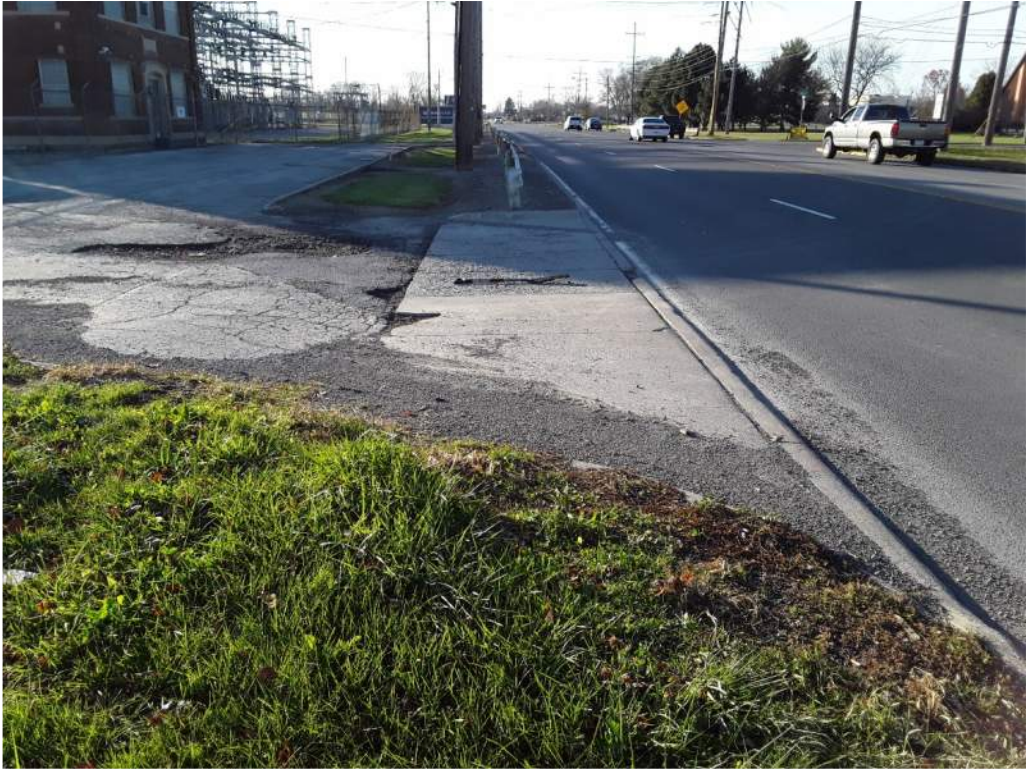
<b>Photo No. 29</b>

<b>Date/Location:</b> November 18, 2020	
<b>Description:</b>  Photo Location 15  Access to the existing Greenfield Substation from West Perkins Avenue.  Facing West

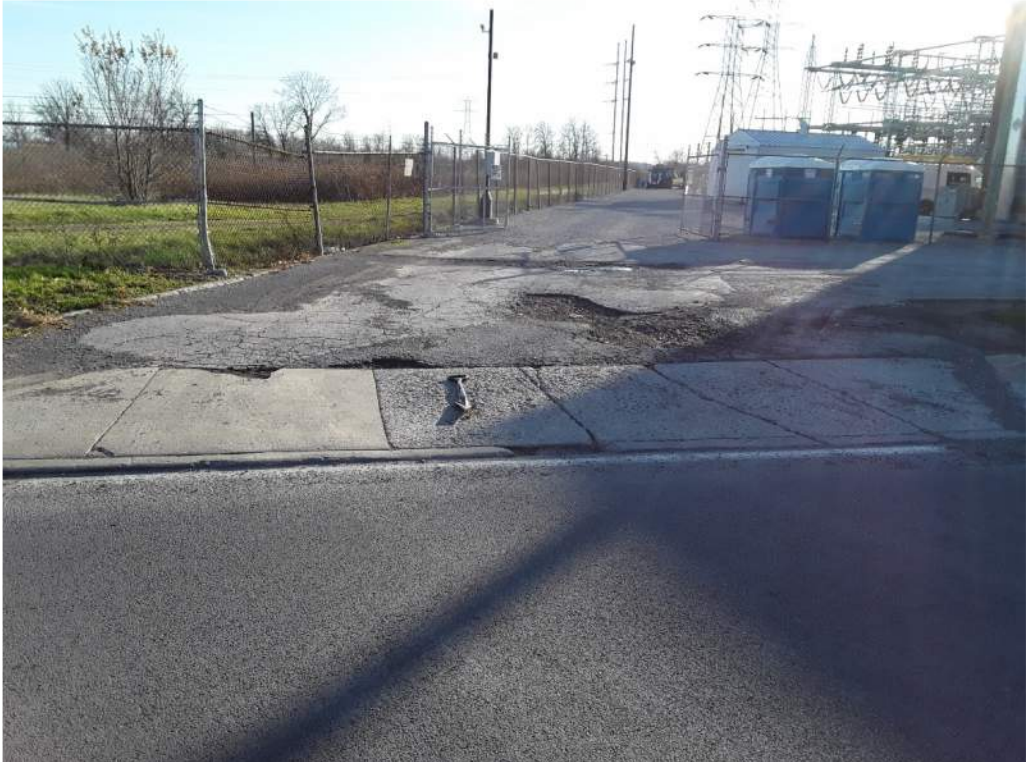
<b>Photo No. 30</b>

<b>Date/Location:</b> November 18, 2020	
<b>Description:</b>  Photo Location 15  Access to the existing Greenfield Substation from West Perkins Avenue.  Facing South

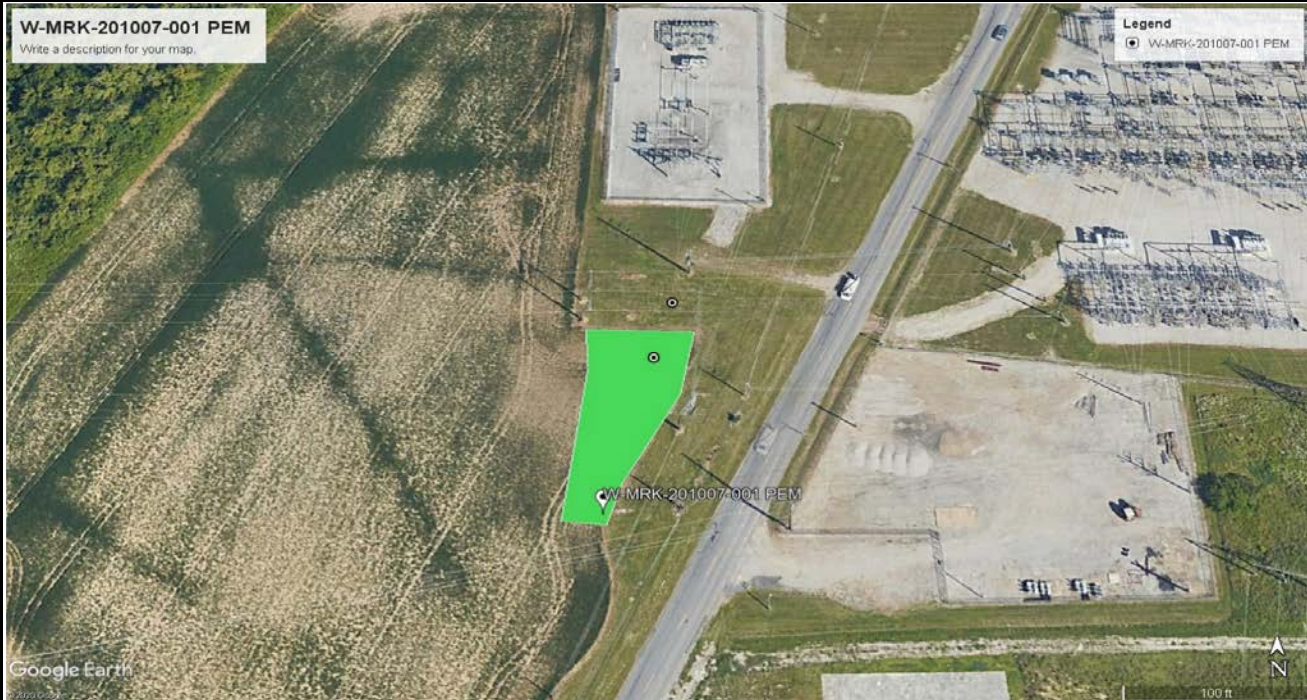
Name of Wetland:	LG-01		
Wetland Size (delineated acres):	0.16	Wetland Size (Estimated total acres):	0.16
Sketch: Include north arrow, relationship with other surface waters, vegetation zones, etc.			
<div><div>W-MRK-201007-001 PEM</div><div>Write a description for your map.</div><div>

</div></div>			
Comments, Narrative Discussion, Justification of Category Changes:			
<p>This PEM wetland is located within an isolated depression surrounded by agriculture. The depression is collecting surface runoff from the surrounding hay field. The wetland boundary follows edge of depression and hydrophytic vegetation dominated by <i>Setaria pumila</i>.</p>			
Final score:	14	Category:	1

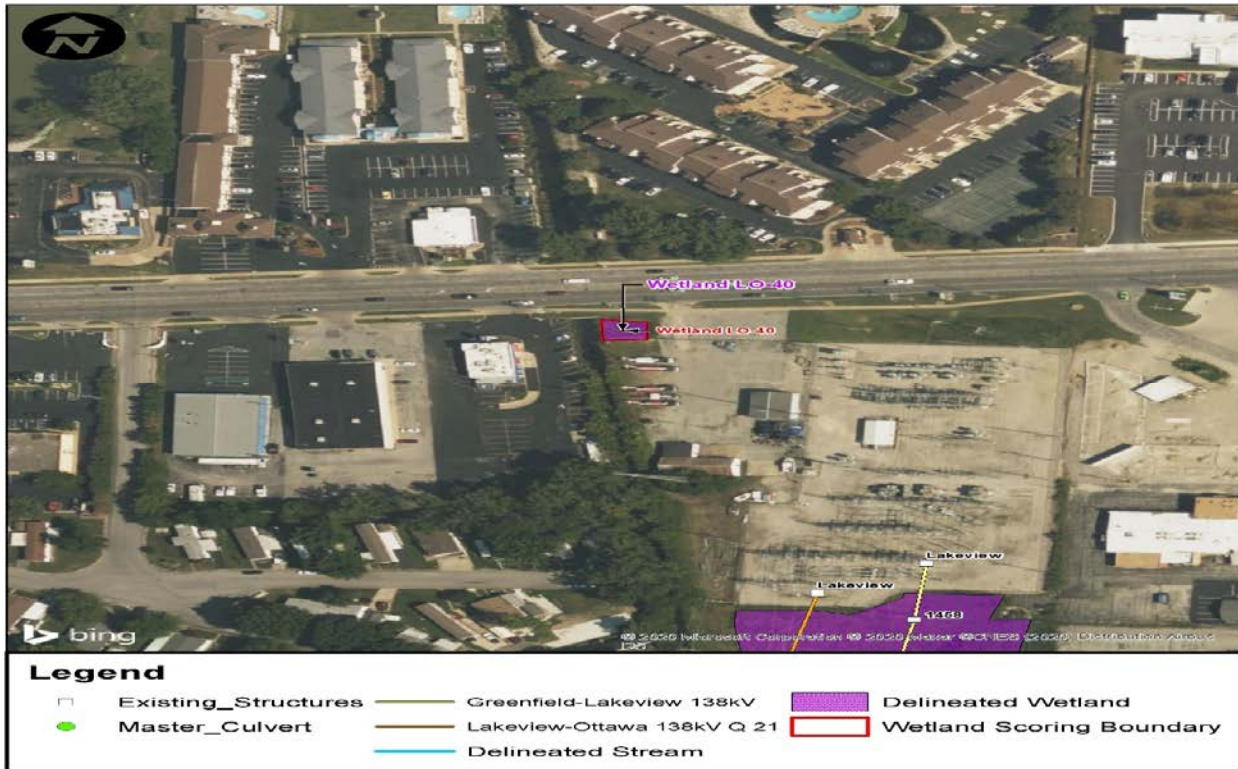
Name of Wetland:	LO-40		
Wetland Size (delineated acres):	0.01	Wetland Size (Estimated total acres):	0.01

A small PEM wetland located in a depression located on the edge of an existing substation paved entrance and south of E Parry Street. The wetland is located in a frequently mowed lawn and the boundary of the wetland was fully delineated. The source of hydrology is from precipitation and surface runoff from the nearby developed/impervious surfaces that collect within this depressional area.
