**AMERICAN TRANSMISSION SYSTEMS,
INCORPORATED
A FIRSTENERGY COMPANY**

LETTER OF NOTIFICATION

**NAPOLEON-RICHLAND-STRYKER 138 kV
TRANSMISSION LINE OPEN ARM PROJECT**

OPSB CASE NO.: 19-1765-EL-BLN

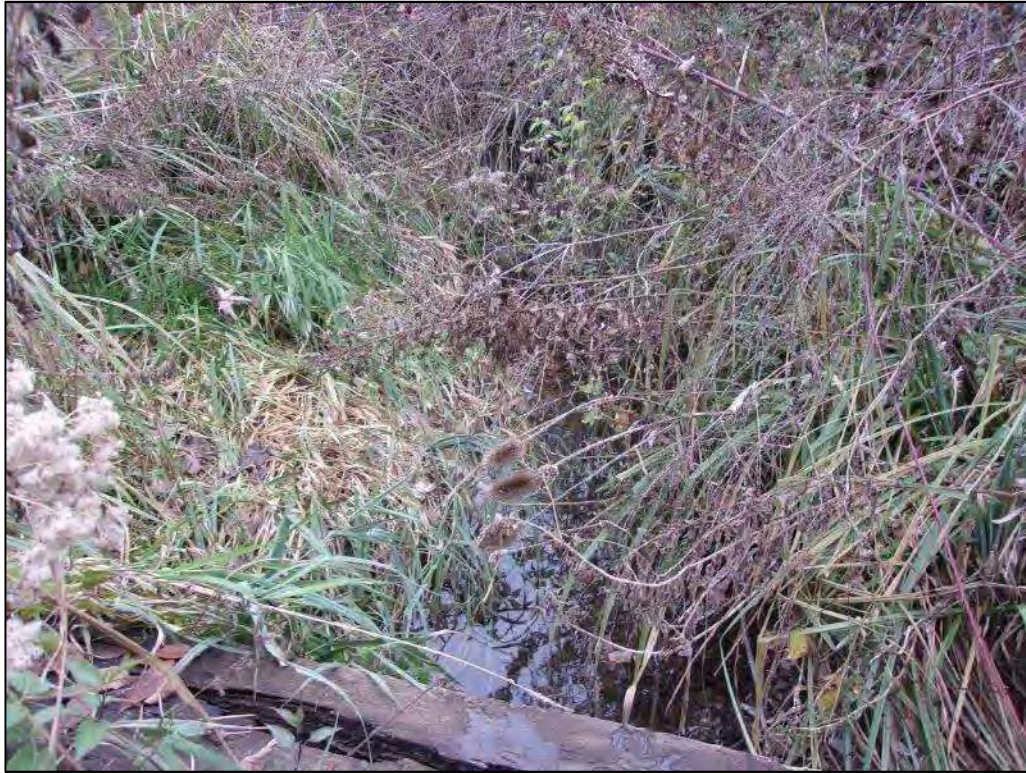
PHOTOGRAPH 1

Stream NRS - 01 (intermittent) facing upstream on November 12, 2008. Map Page 3A.

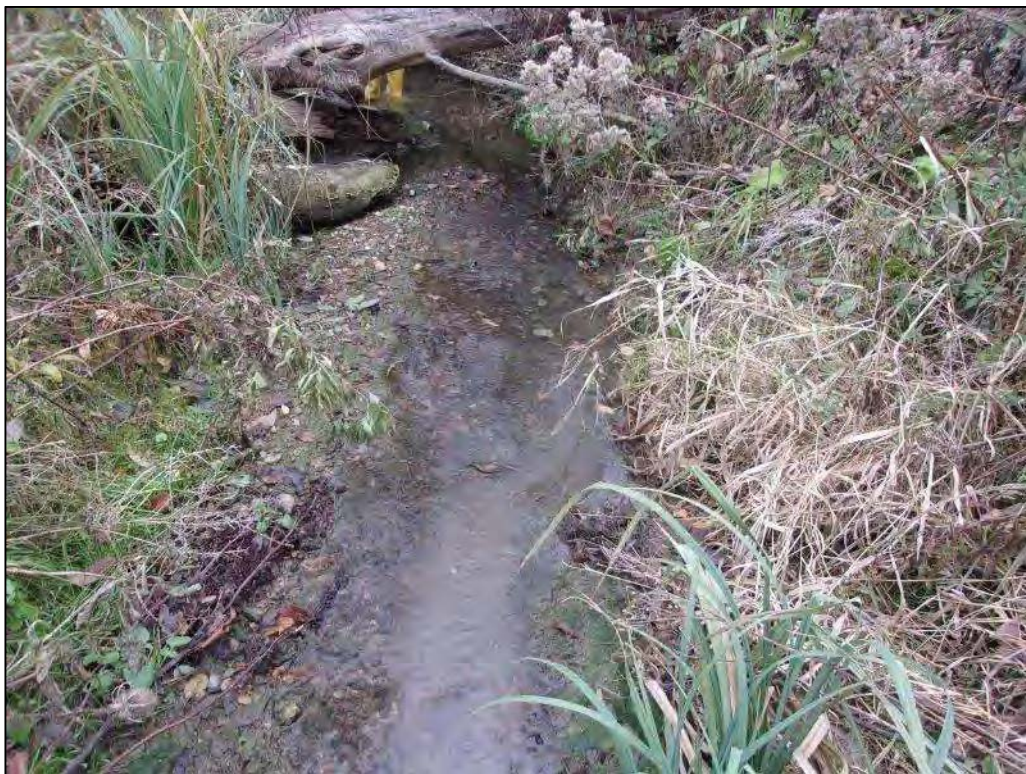
PHOTOGRAPH 2

Stream NRS - 01 (intermittent) facing downstream on November 12, 2018. Map Page 3A.

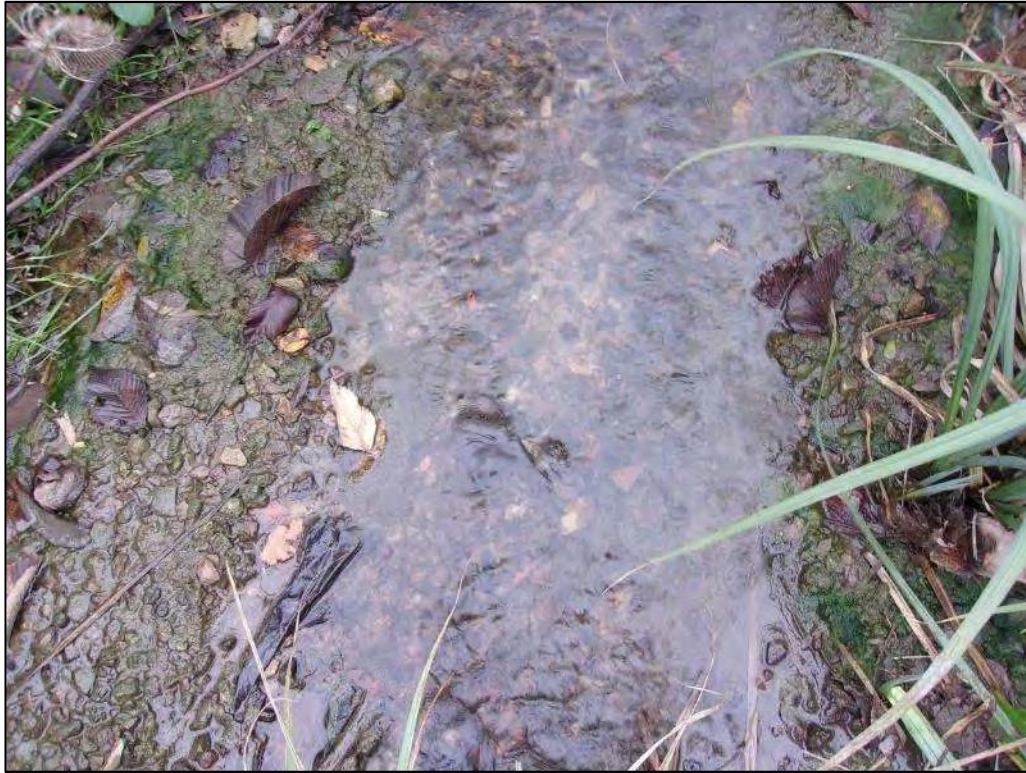
PHOTOGRAPH 3

Stream NRS - 01 (intermittent) substrate on November 12, 2018. Map Page 3A.

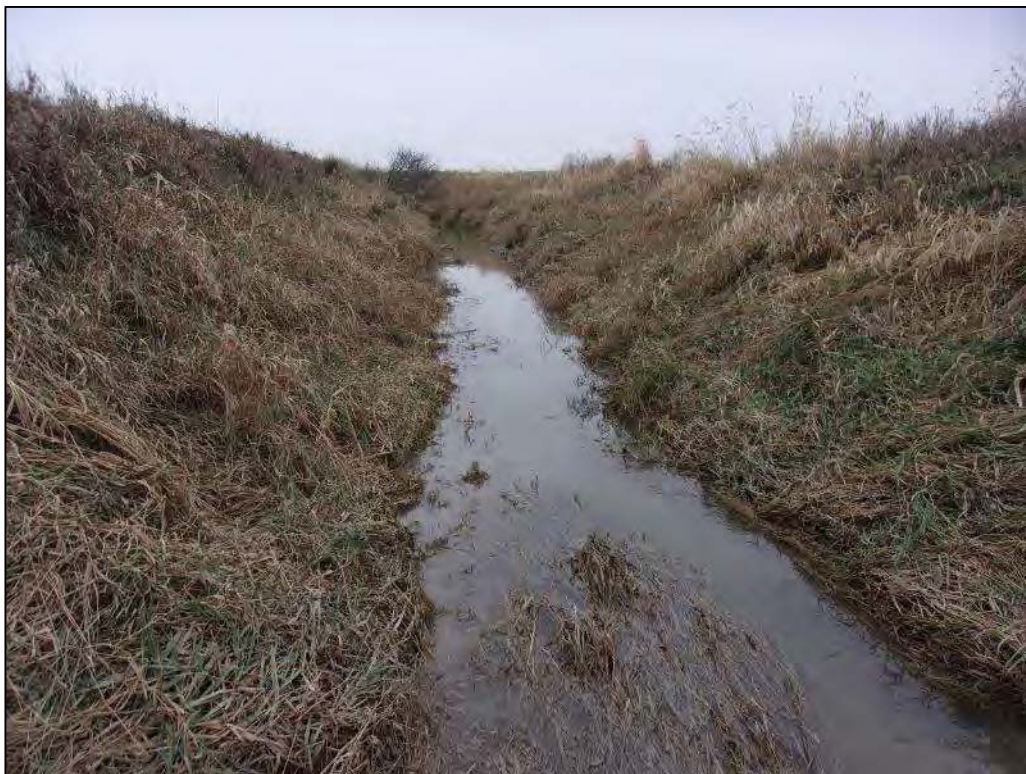
PHOTOGRAPH 4

Stream NRS - 02 (perennial) facing upstream on November 12, 2018. Map Page 3I.

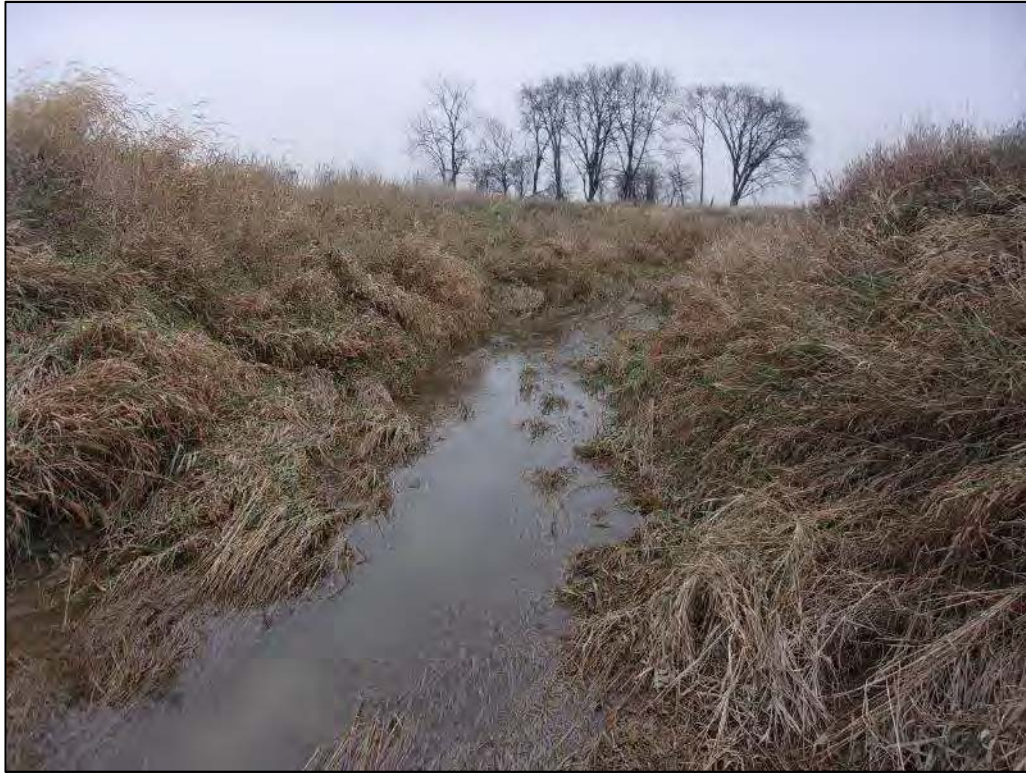
PHOTOGRAPH 5

Stream NRS - 02 (perennial) facing downstream on November 12, 2018. Map Page 3I.

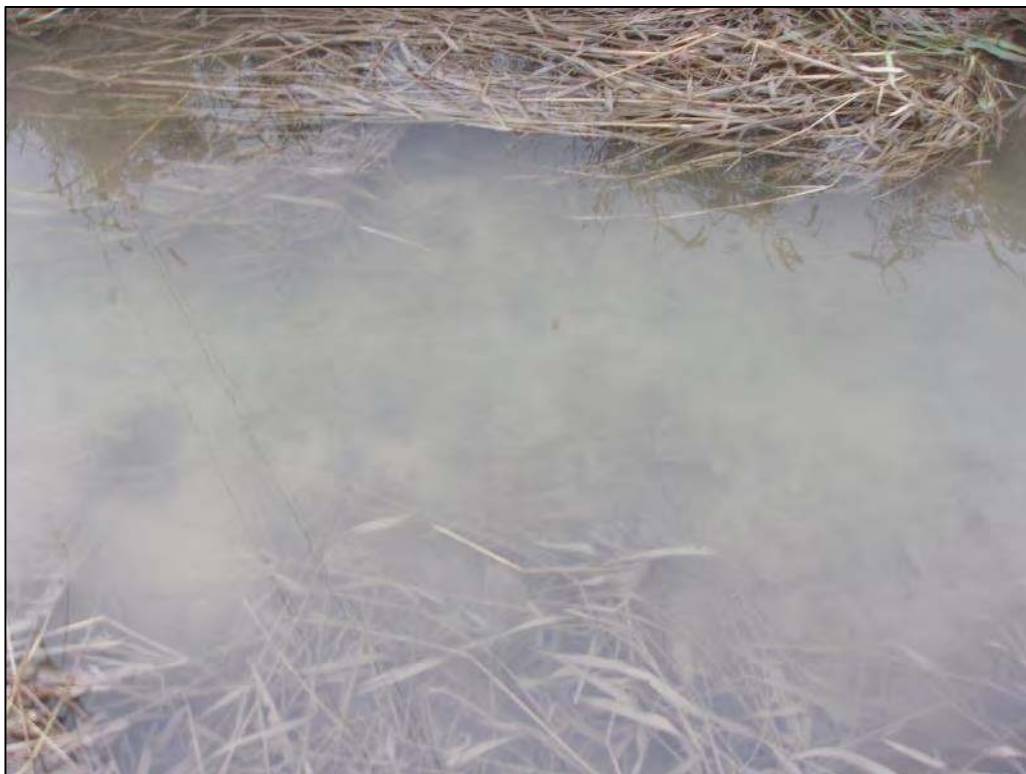
PHOTOGRAPH 6

Stream NRS - 02 (perennial) substrate on November 12, 2018. Map Page 3I.

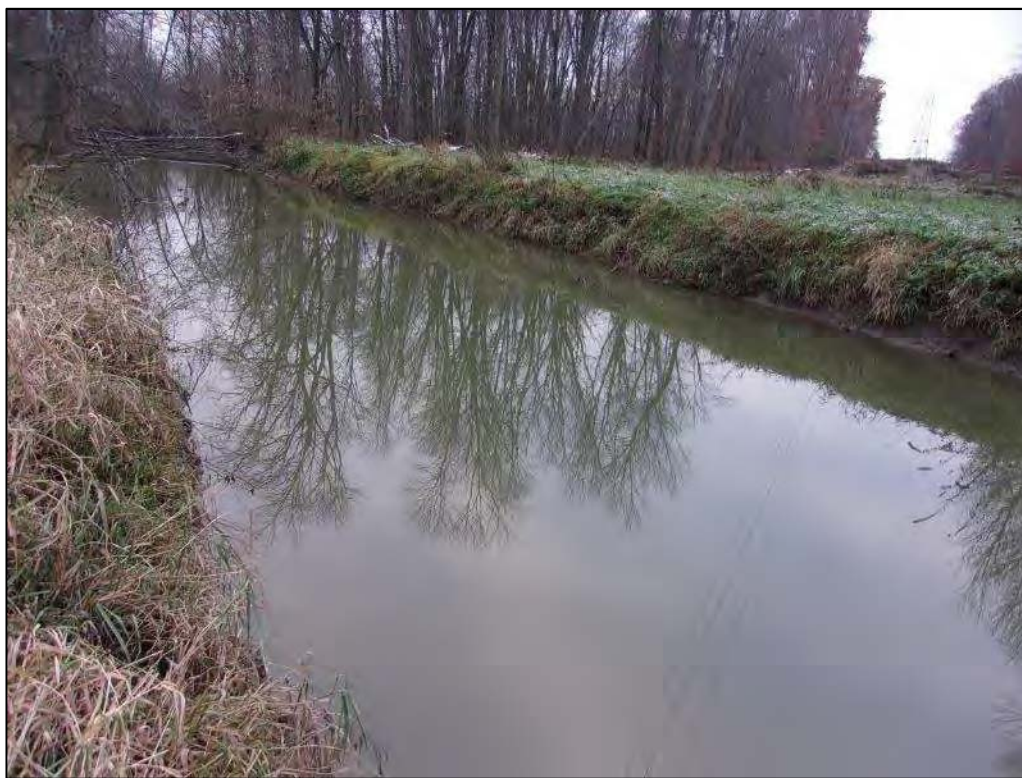
PHOTOGRAPH 7

Stream NRS - 03 (perennial) facing upstream on November 13, 2018. Map Page 3L.

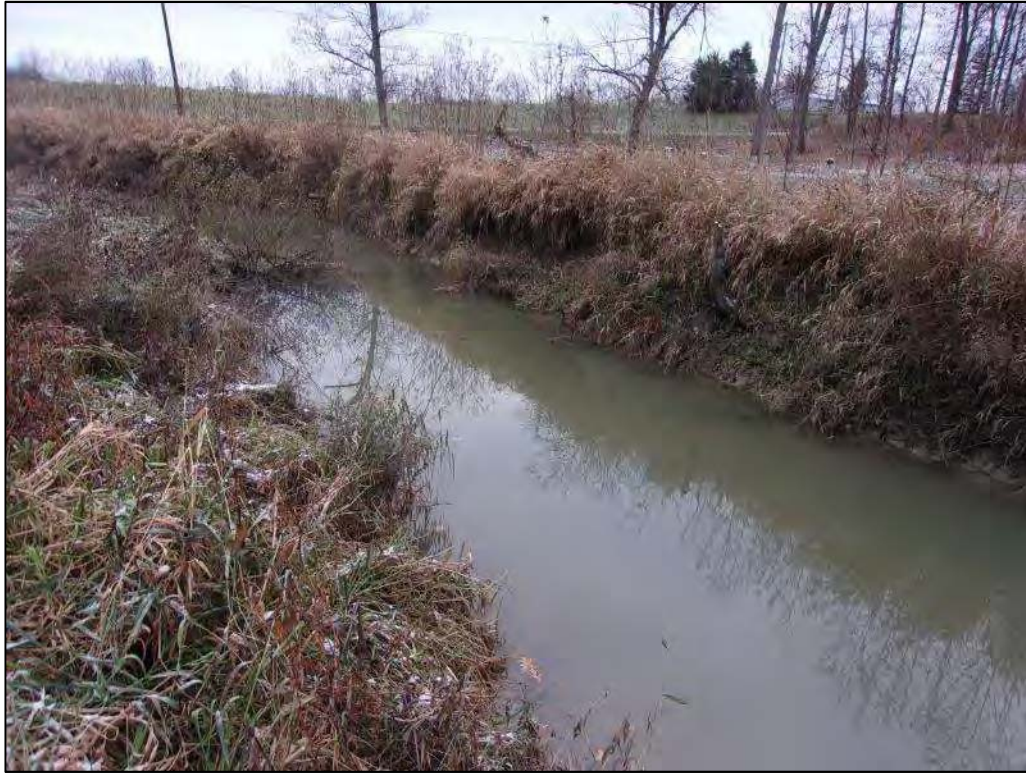
PHOTOGRAPH 9

Stream NRS - 04 (perennial) facing upstream on November 13, 2018. Map Page 3L.

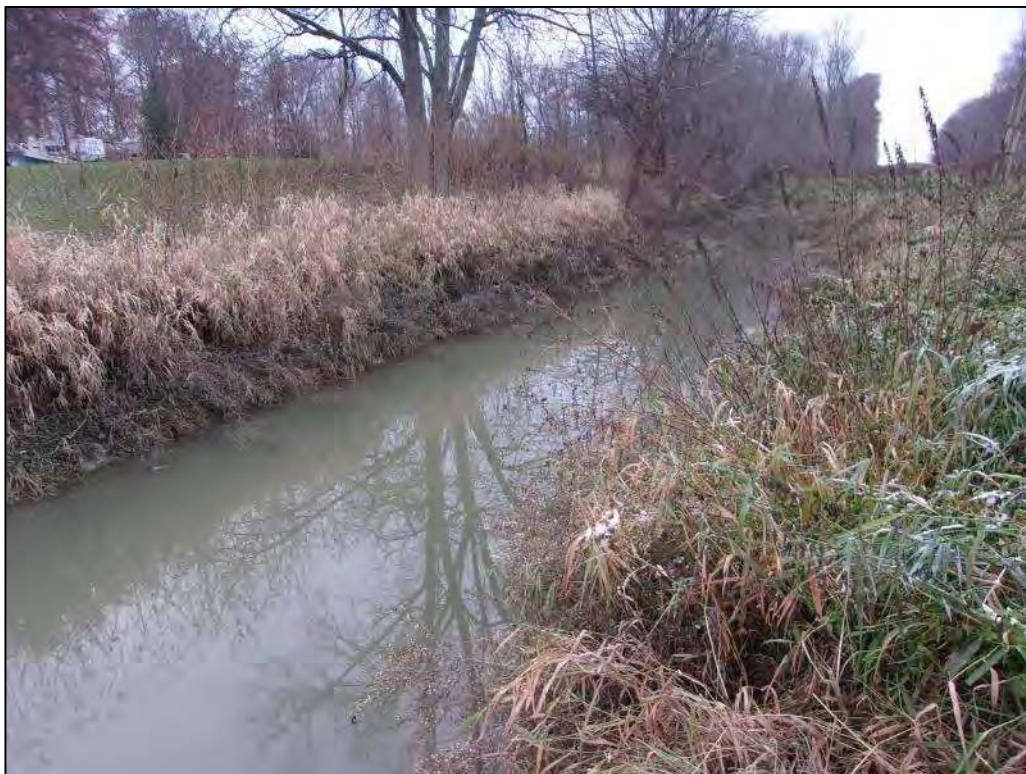
PHOTOGRAPH 10

Stream NRS - 04 (perennial) facing downstream on November 13, 2018. Map Page 3L.

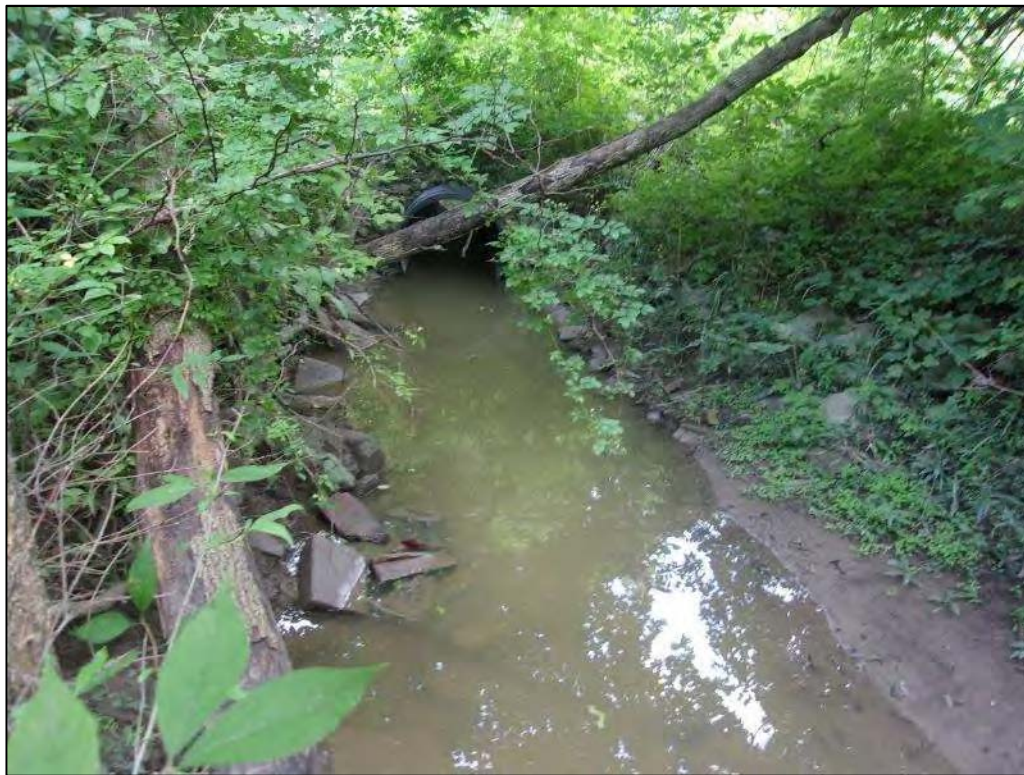
PHOTOGRAPH 11

Stream NRS - 05 (intermittent) facing upstream on July 31, 2019. Map Page 3L.

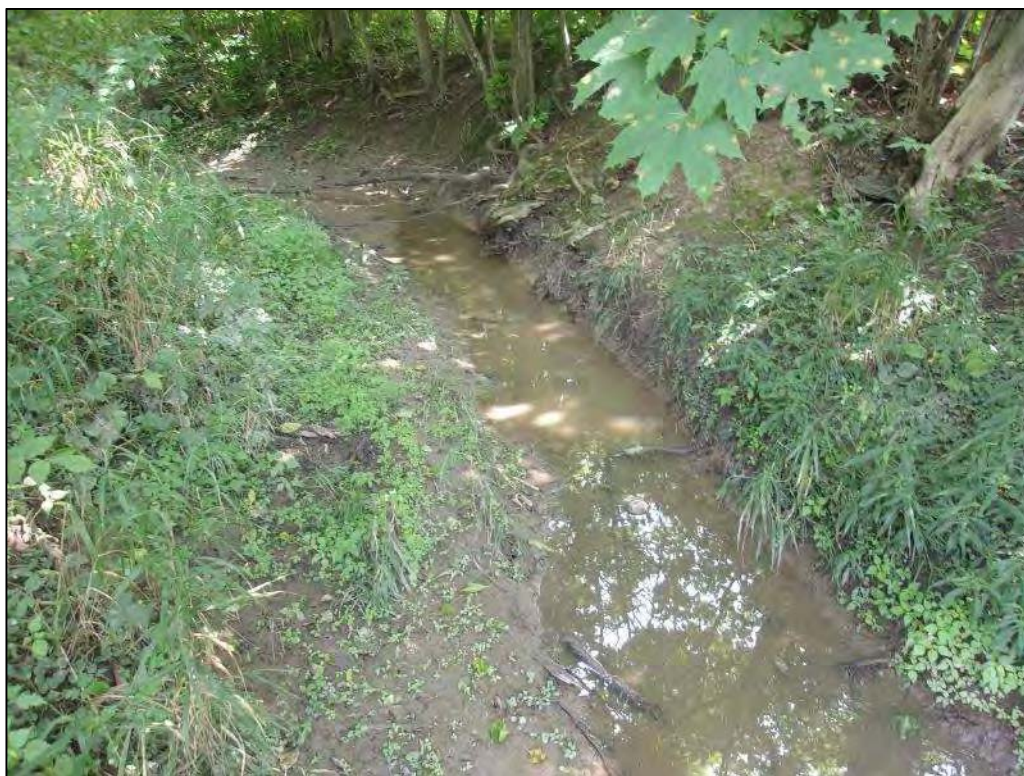
PHOTOGRAPH 12

Stream NRS - 05 (intermittent) facing downstream on July 31, 2019. Map Page 3L.

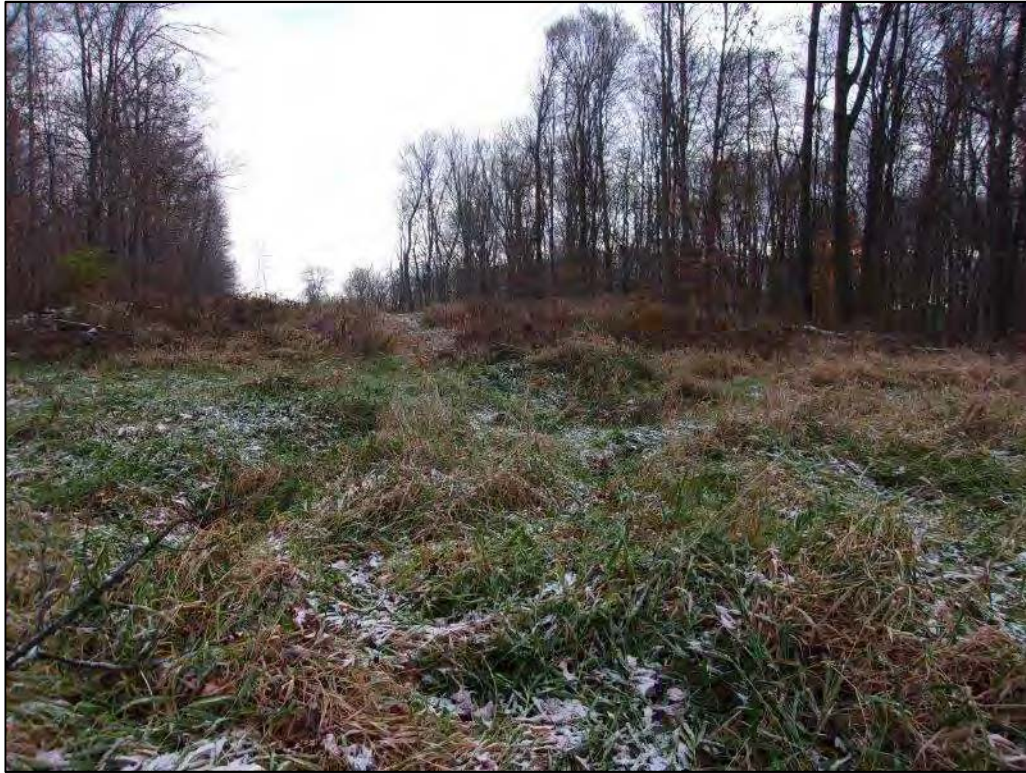
PHOTOGRAPH 13

Wetland NRS - 01 (PEM) facing west on November 13, 2018. Map Page 3K.

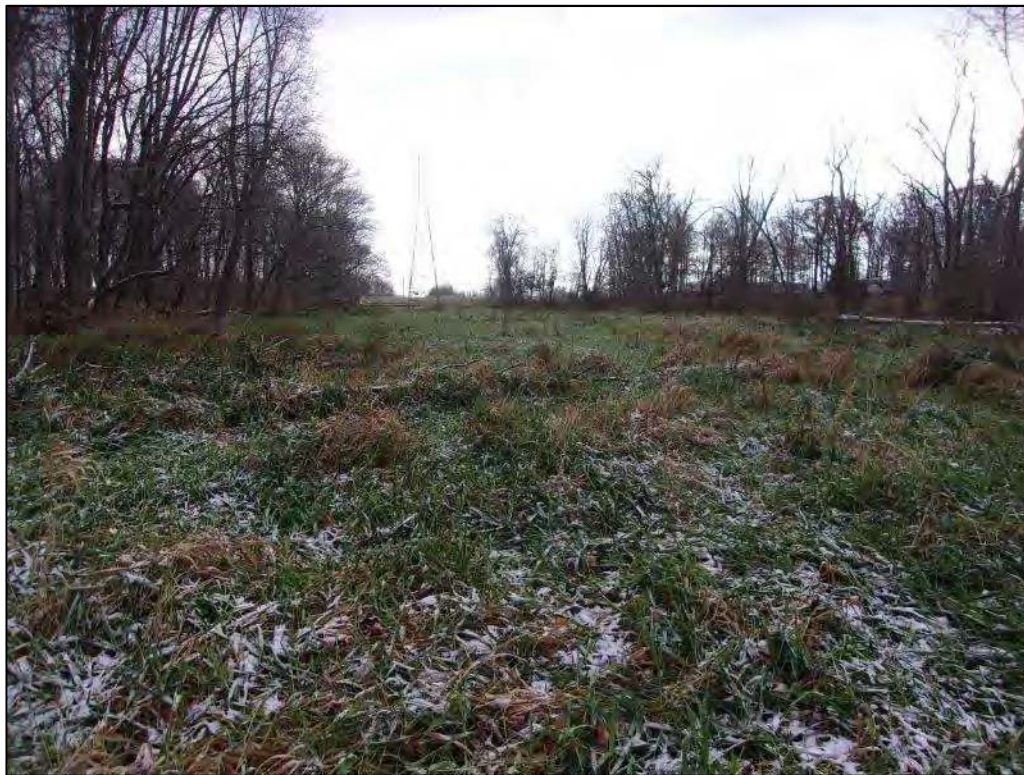
PHOTOGRAPH 15

Wetland NRS - 02 (PEM) facing east on November 13, 2018. Map Page 3L.

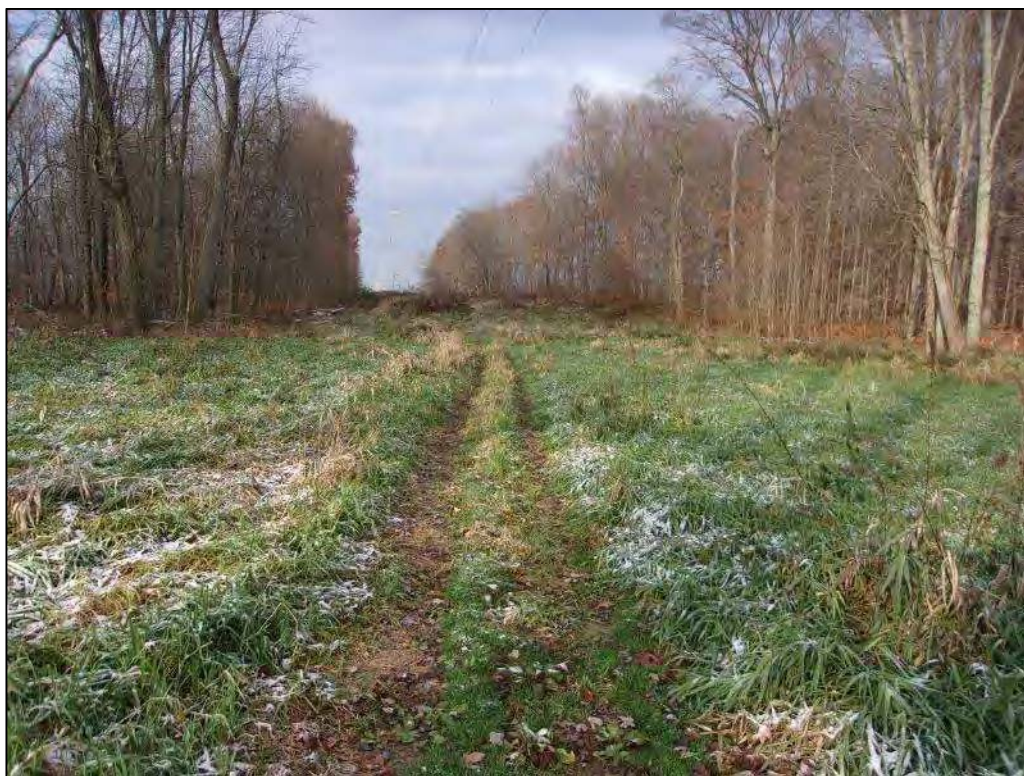
PHOTOGRAPH 16

Wetland NRS - 02 (PEM) facing west on November 13, 2018. Map Page 3L.

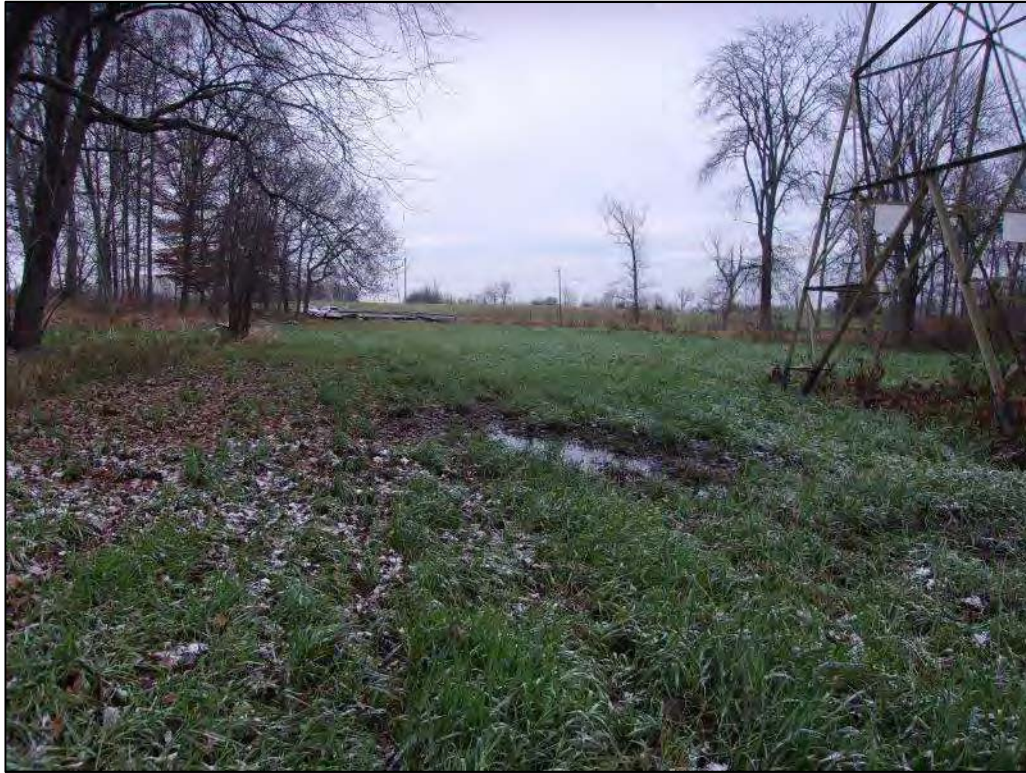
PHOTOGRAPH 17

Wetland NRS - 03 (PEM) facing east on November 13, 2018. Map Page 3L.

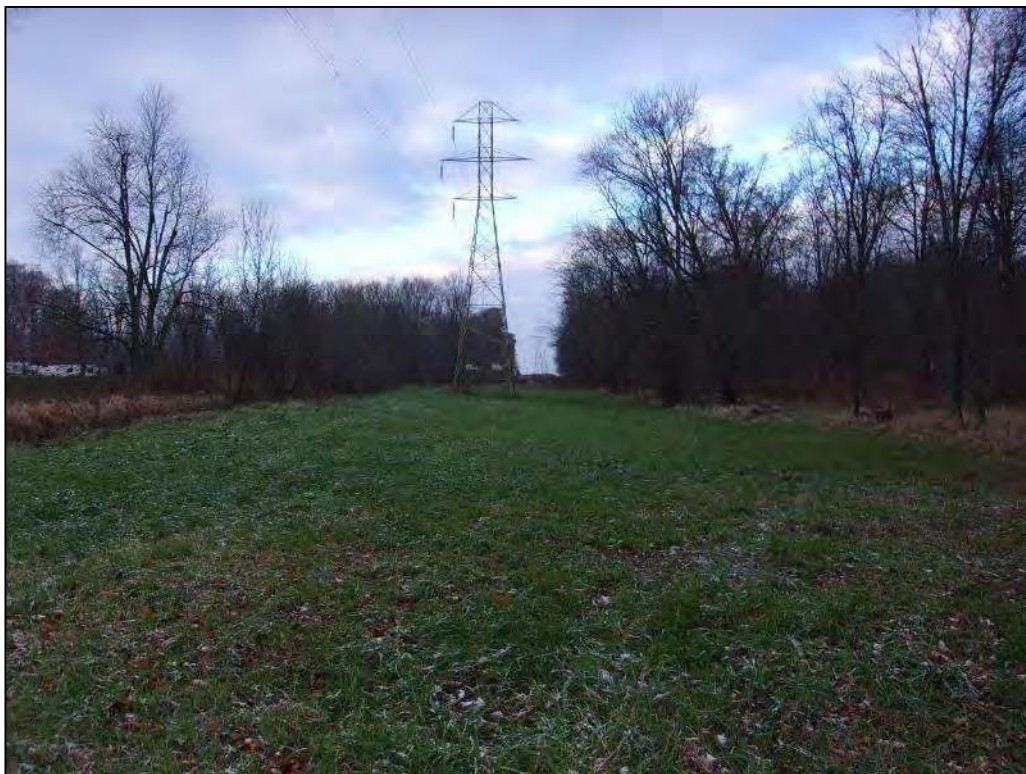
PHOTOGRAPH 18

Wetland NRS - 03 (PEM) facing west on November 13, 2018. Map Page 3L.

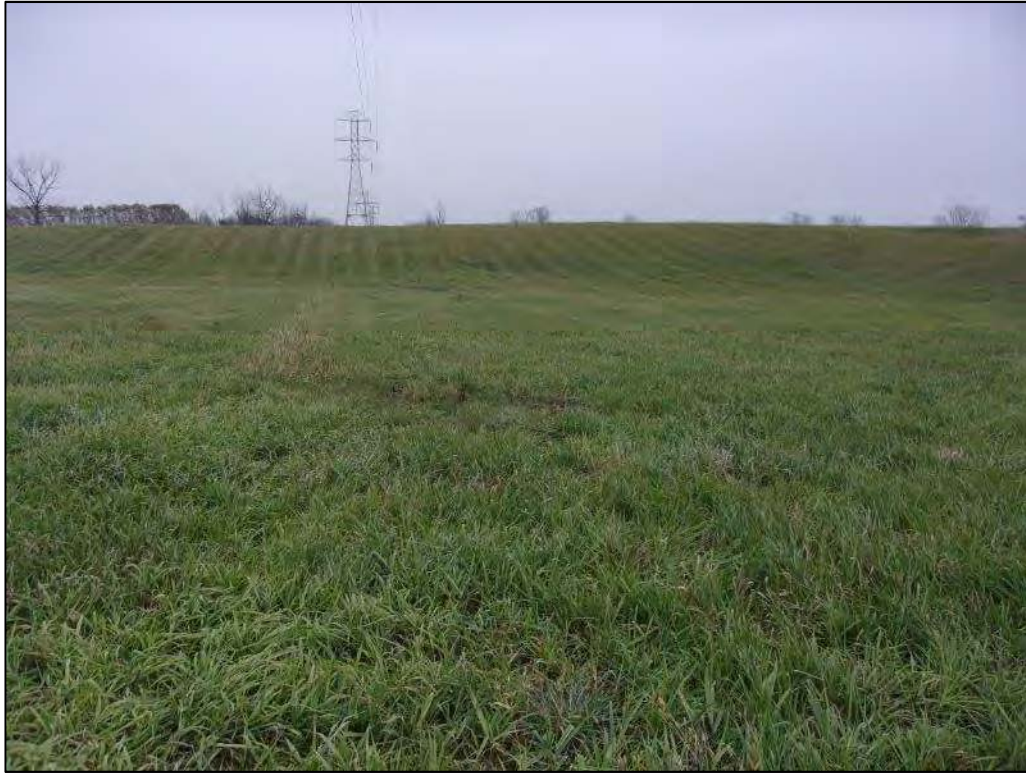
PHOTOGRAPH 19

Wetland NRS - 04 (PEM) facing east on November 12, 2018. Map Page 3L.

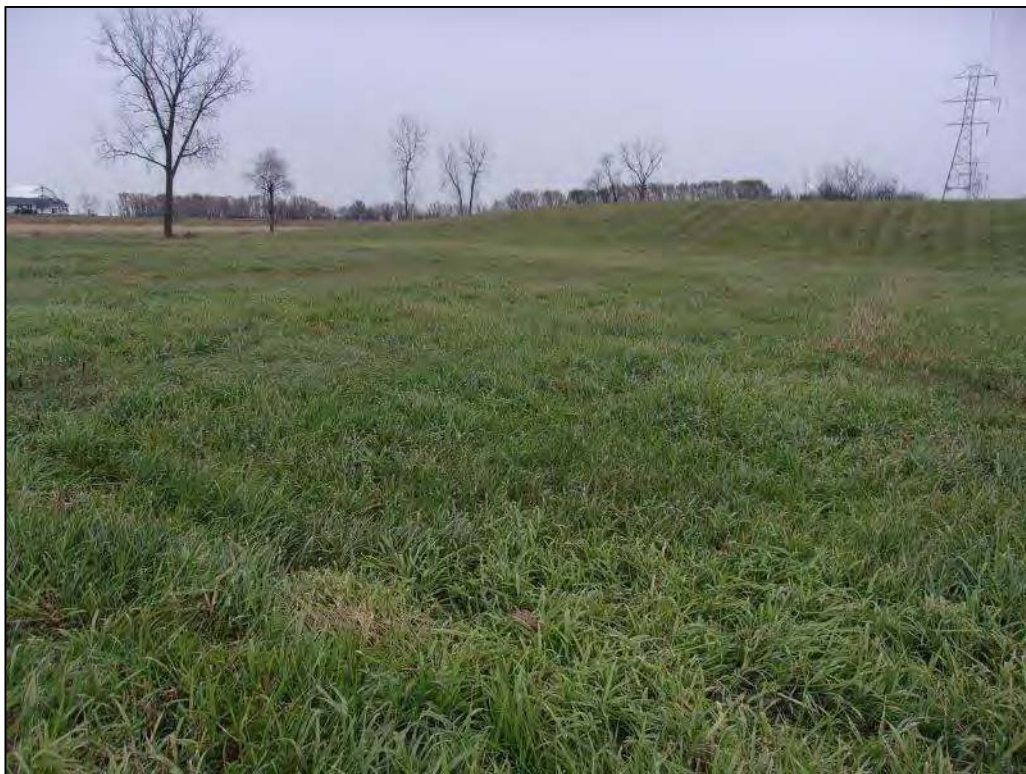
PHOTOGRAPH 20

Wetland NRS - 04 (PEM) facing west on November 12, 2018. Map Page 3L.

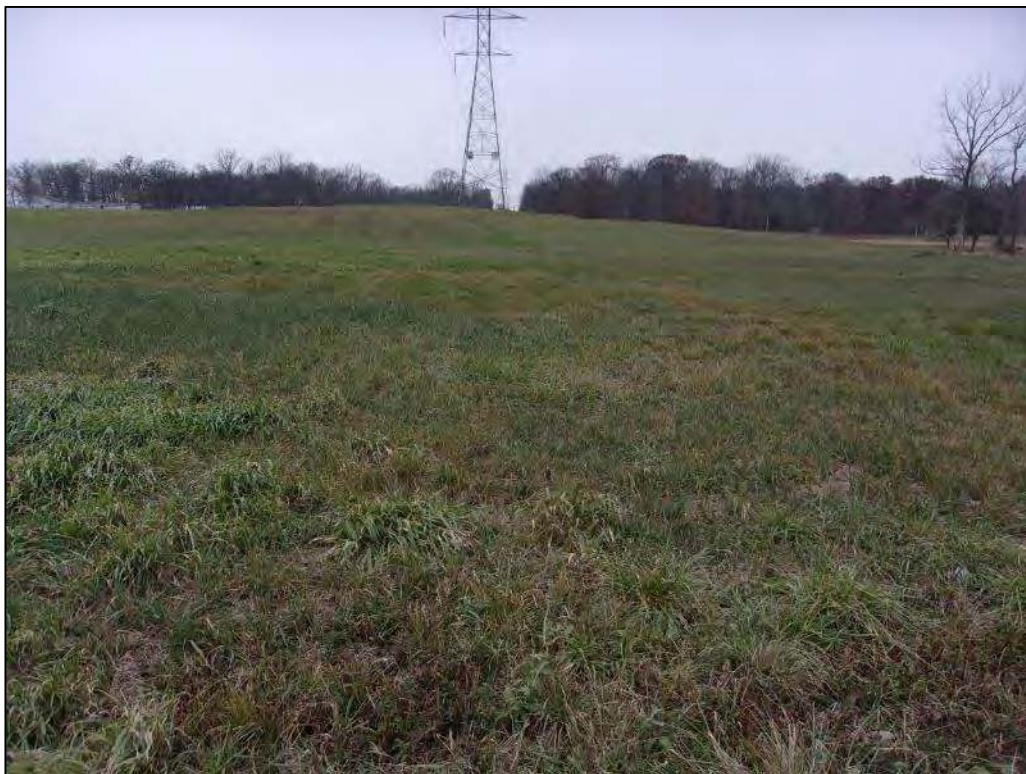
PHOTOGRAPH 22

Wetland NRS - 05 (PEM) facing west on November 12, 2018. Map Page 3L.

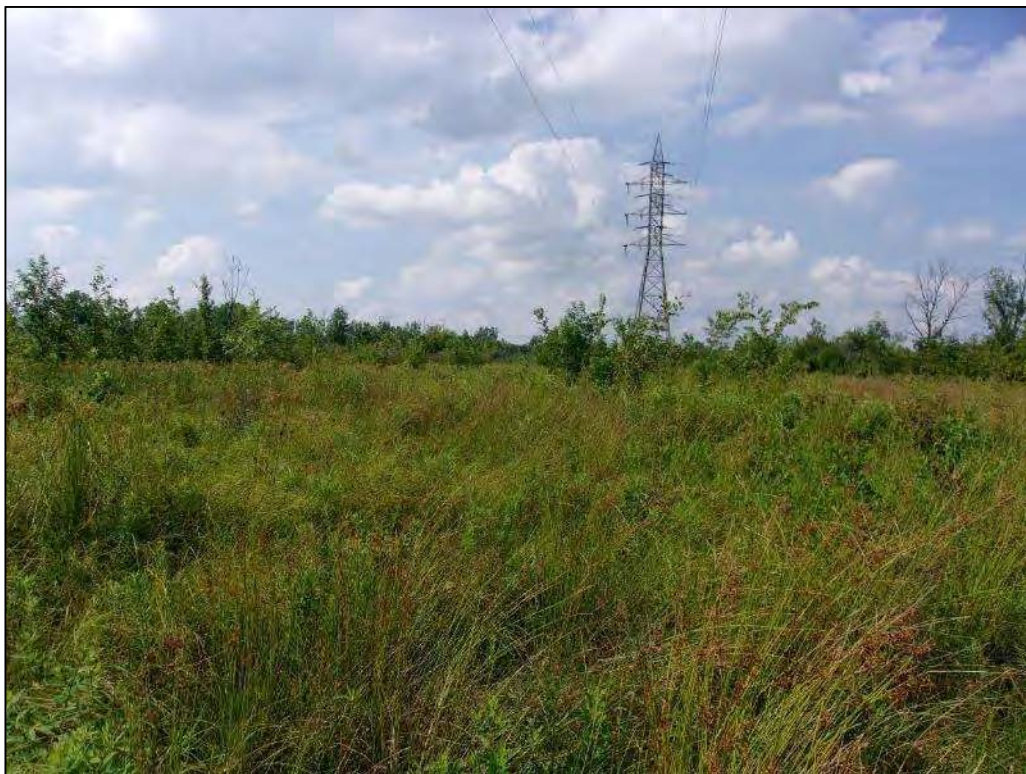
PHOTOGRAPH 24

Wetland NRS - 06 (PEM) facing south on July 31, 2019. Map Page 3L.
