LETTER OF NOTIFICATION

**PINE-WADSWORTH MUNI 138 kV TRANSMISSION
LINE-STRUCTURE REPLACEMENT AND REROUTE
PROJECT**

OPSB Case No. : 26-0140-EL-BLN

Name of Project: Pine-Wadsworth Muni 138 kV Transmission Line-Structure Replacement and Reroute Project (“Project”)

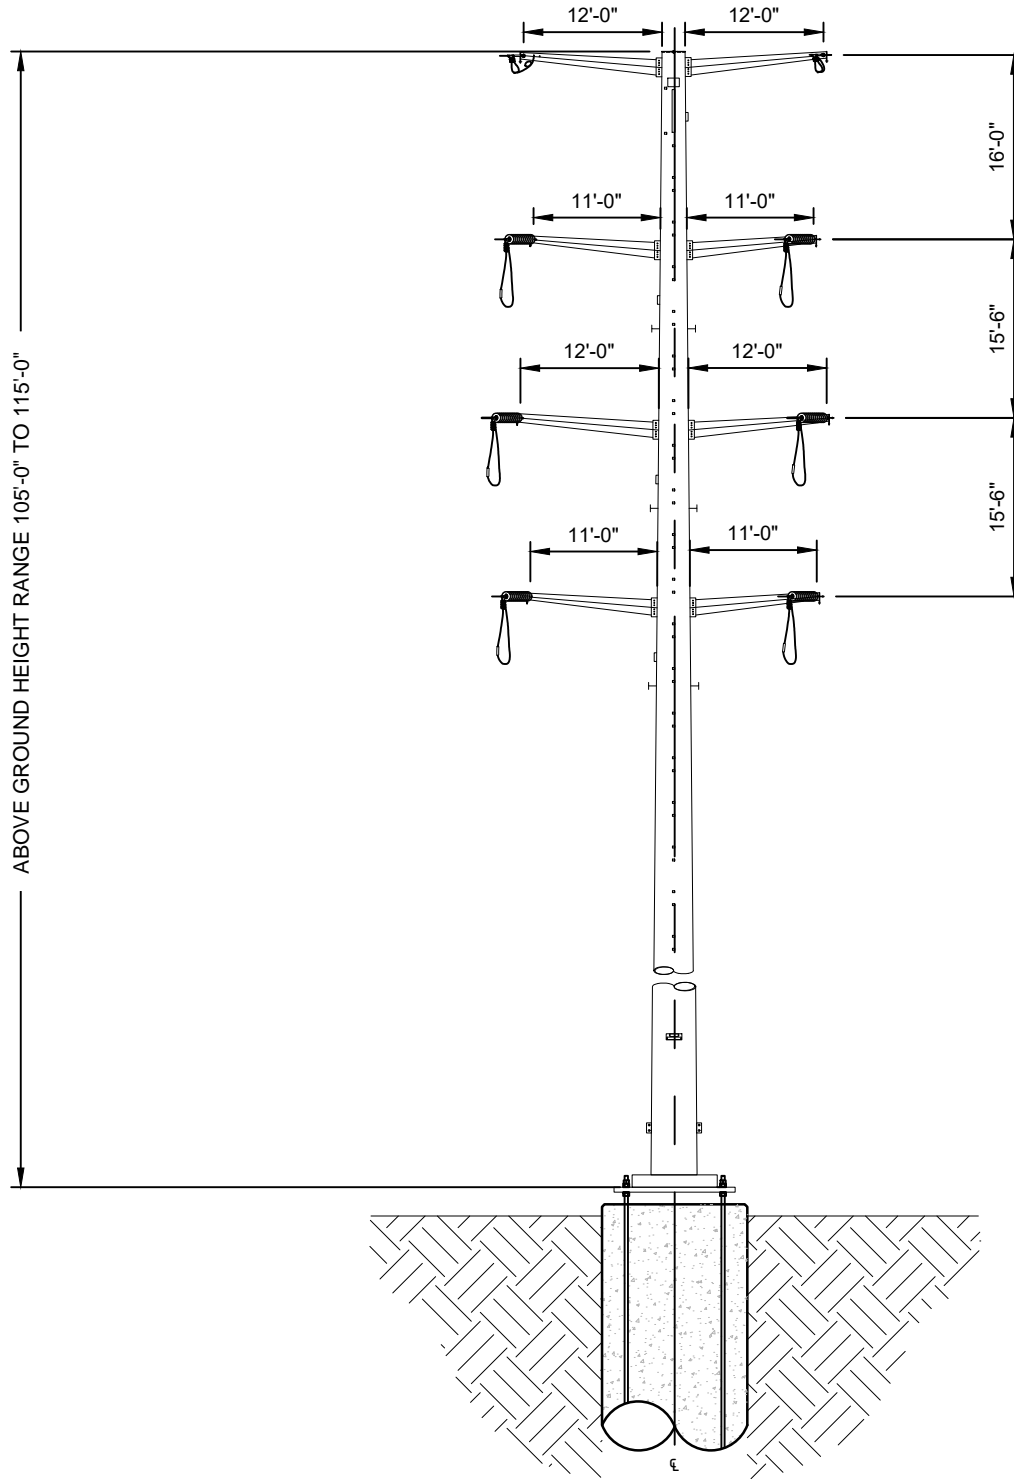
EXHIBIT 4A

138 kV DOUBLE CIRCUIT STEEL TAPERED TUBE
DEADEND SINGLE POLE 0 DEG TO 50 DEG

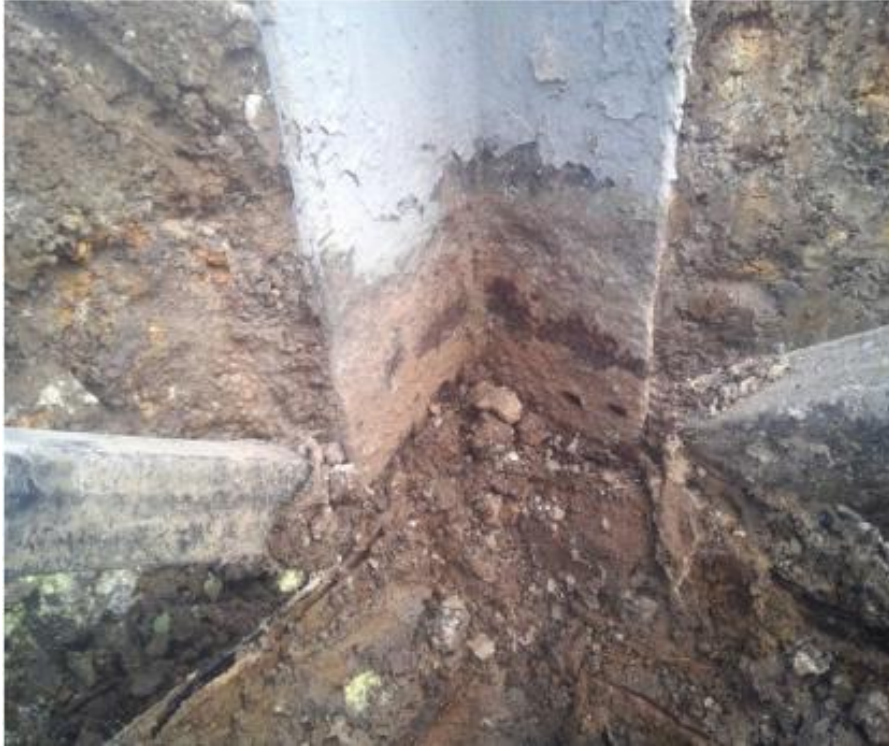
Photo 1. Priority 1 condition on leg 1 of tower 6699.

The Project is needed as a result of a 2022 steel structure inspection. Two legs on Tower No. 6699 are showing greater than 50% loss of steel and the other two legs are showing greater than 25% loss of steel due to deterioration. All four legs on Tower No. 6698 are showing similar corrosion, rust, and some minor pitting. Given that these towers are on PVS Chemical Solutions property, it is believed that the soil contains high concentrations of unnatural elements causing accelerated steel loss on the tower

legs; see **Exhibit A**. Additionally, a railroad spur with tank cars carrying hazardous and flammable materials passes beneath the energized conductors, and a multi-story metal building is located within the transmission line corridor, increasing safety risk in the event of a conductor failure. To alleviate the combination of degradation due to the soil conditions as well as the inclusions in the transmission line ROW, the realignment of the 0.4 miles of transmission line provides a safe and reliable solution. As compared to the existing steel lattice structures, in which two were installed in 1924 (#6700, #6697) and the other two in 1954 (#6699, #6698), the proposed monopoles meets the statutory definition of “advanced transmission technology” because it is “hardware technologies that increase the *** reliability or safety of an existing *** transmission system.” R.C. 4906.01(M) (as amended by House Bill 15).

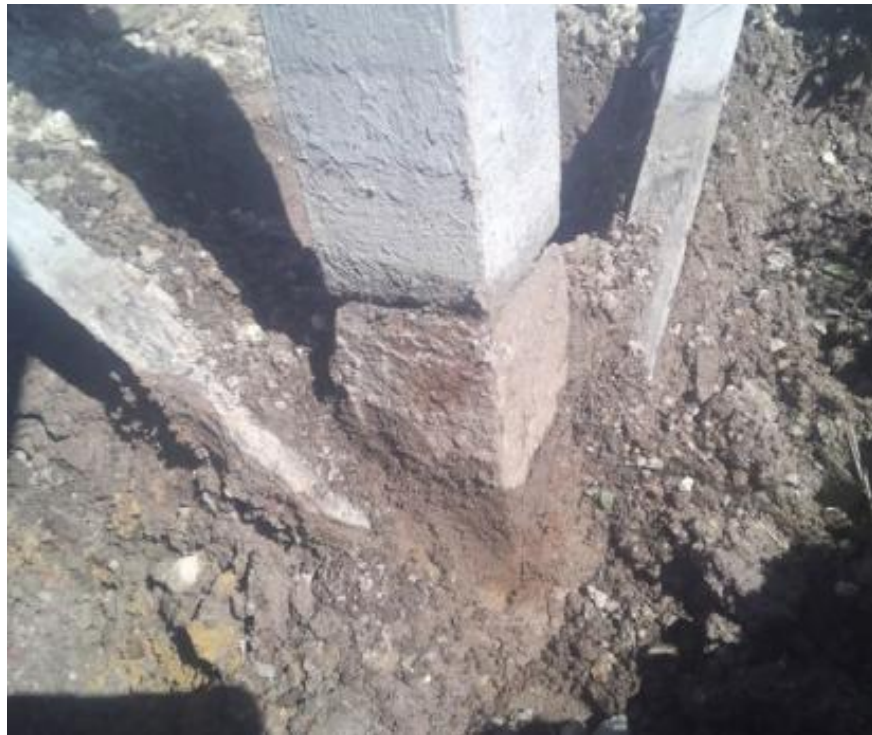
Photo 2. Priority 1 condition on leg 3 of tower 6699.

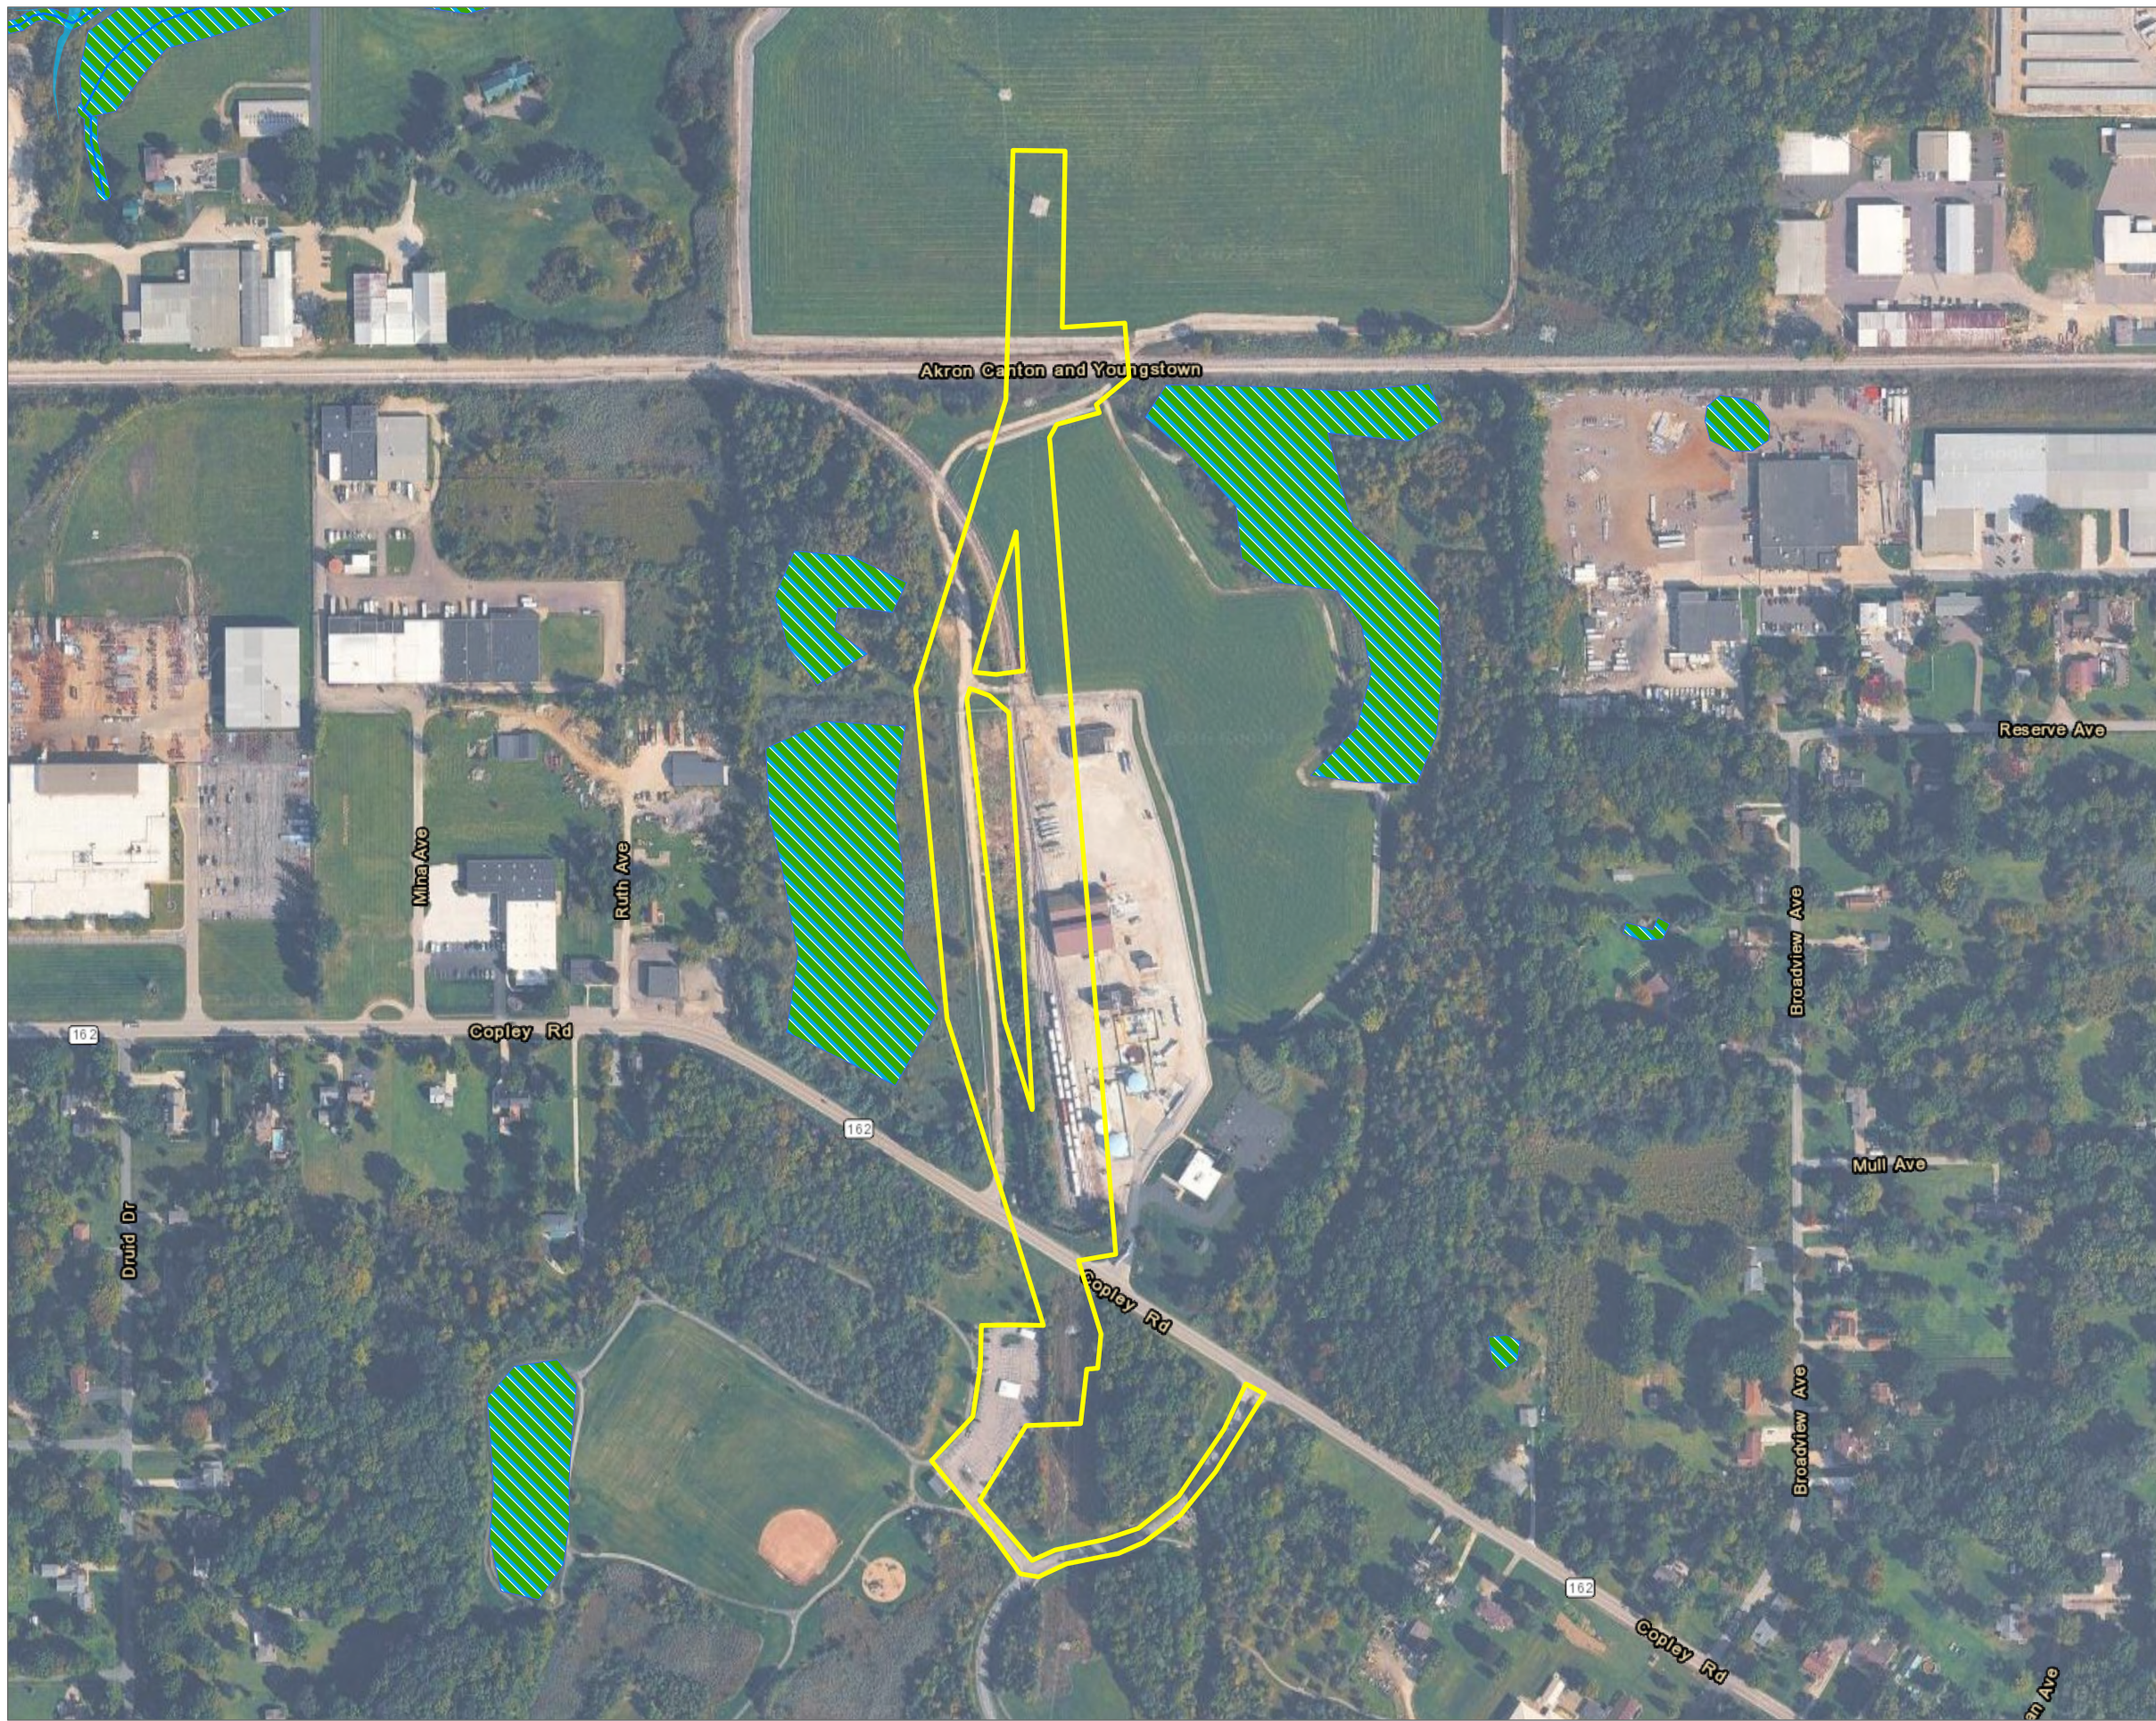
- PROJECT STUDY AREA
- NATIONAL HYDROGRAPHY DATASET (NHD) STREAM
- NATIONAL WETLANDS INVENTORY (NWI) FEATURE
- 100-YEAR FLOOD ZONE

BASE MAP: GOOGLE MAPS.
 DATA SOURCES: WETLAND DATA ACQUIRED FROM U.S. FISH & WILDLIFE SERVICE, NATIONAL WETLANDS INVENTORY (NWI). STREAM DATA ACQUIRED FROM USGS, NATIONAL HYDROGRAPHY DATASET (NHD). FLOOD DATA ACQUIRED FROM FEMA, NATIONAL FLOOD HAZARD LAYER (NFHL).

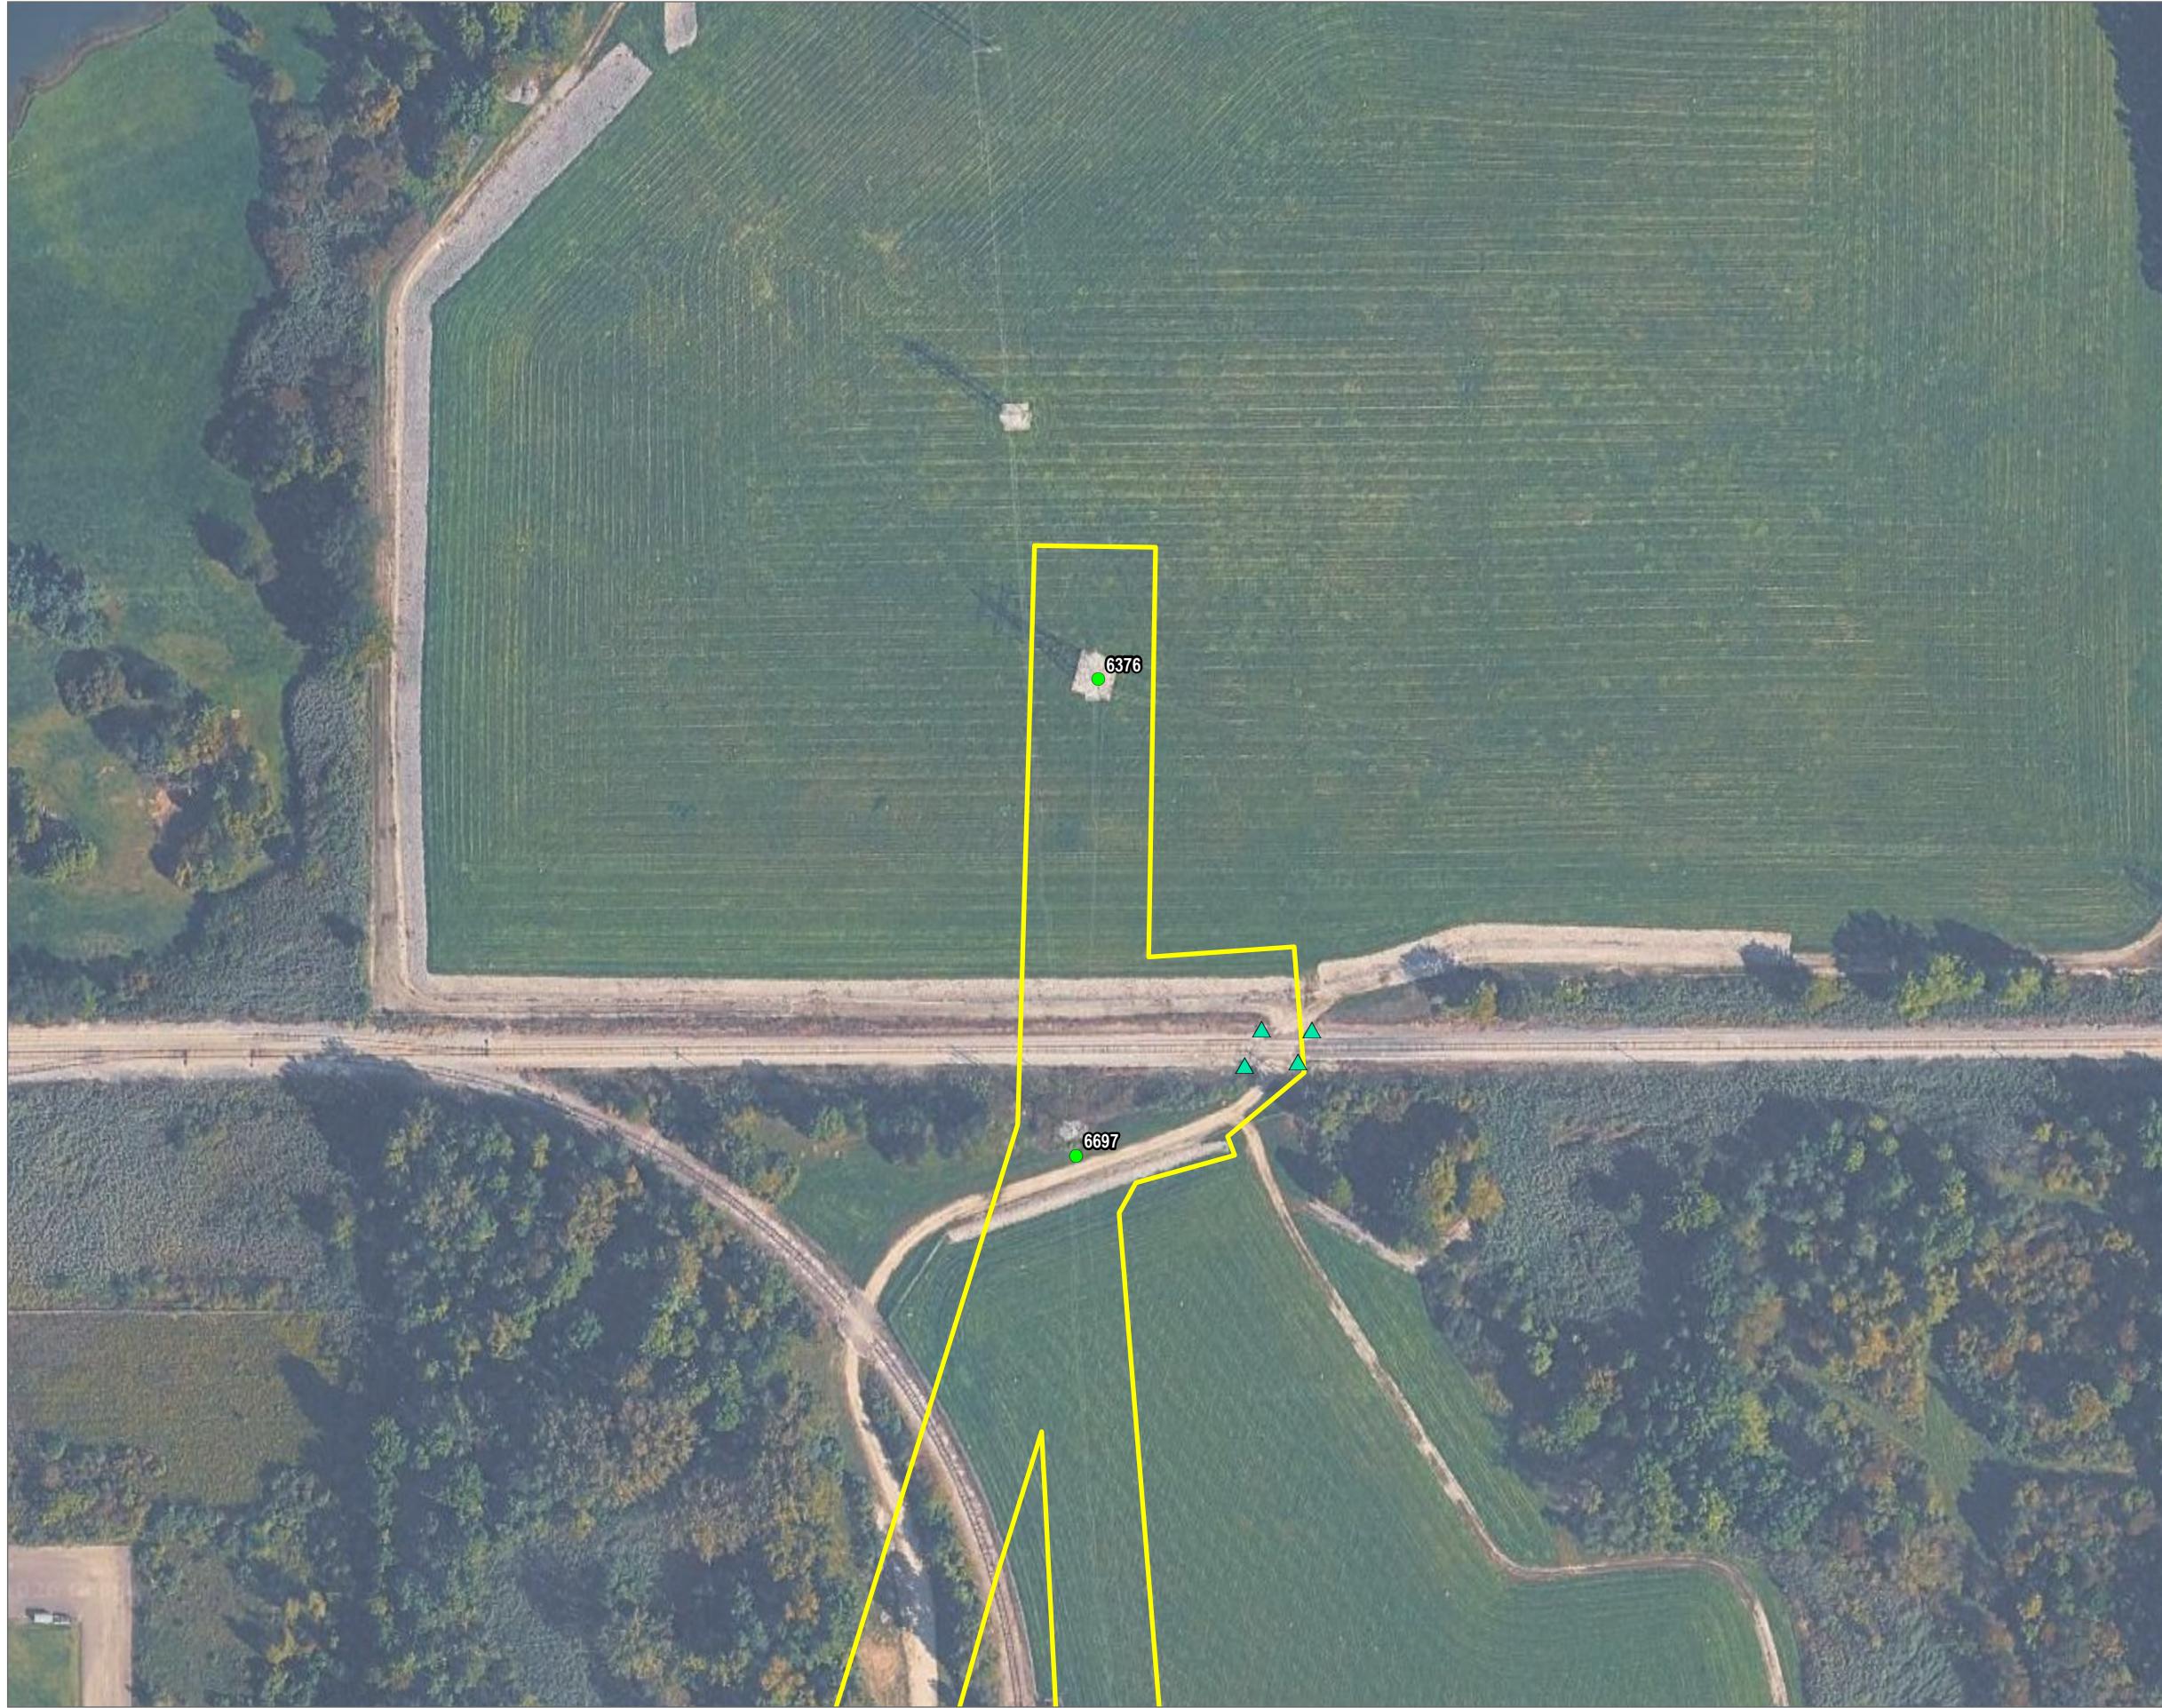
- PROJECT STUDY AREA
- EXISTING STRUCTURE
- PROPOSED STRUCTURE
- ▲ CULVERT
- PEM WETLAND
- WETLAND CONTINUES
- WETLAND DATA POINT
- UPLAND DATA POINT

BASE MAP: GOOGLE MAPS.
 DATA SOURCES: TRC WETLAND DELINEATION COMPLETED SEPTEMBER 16, 2025 & APRIL 1, 2026.

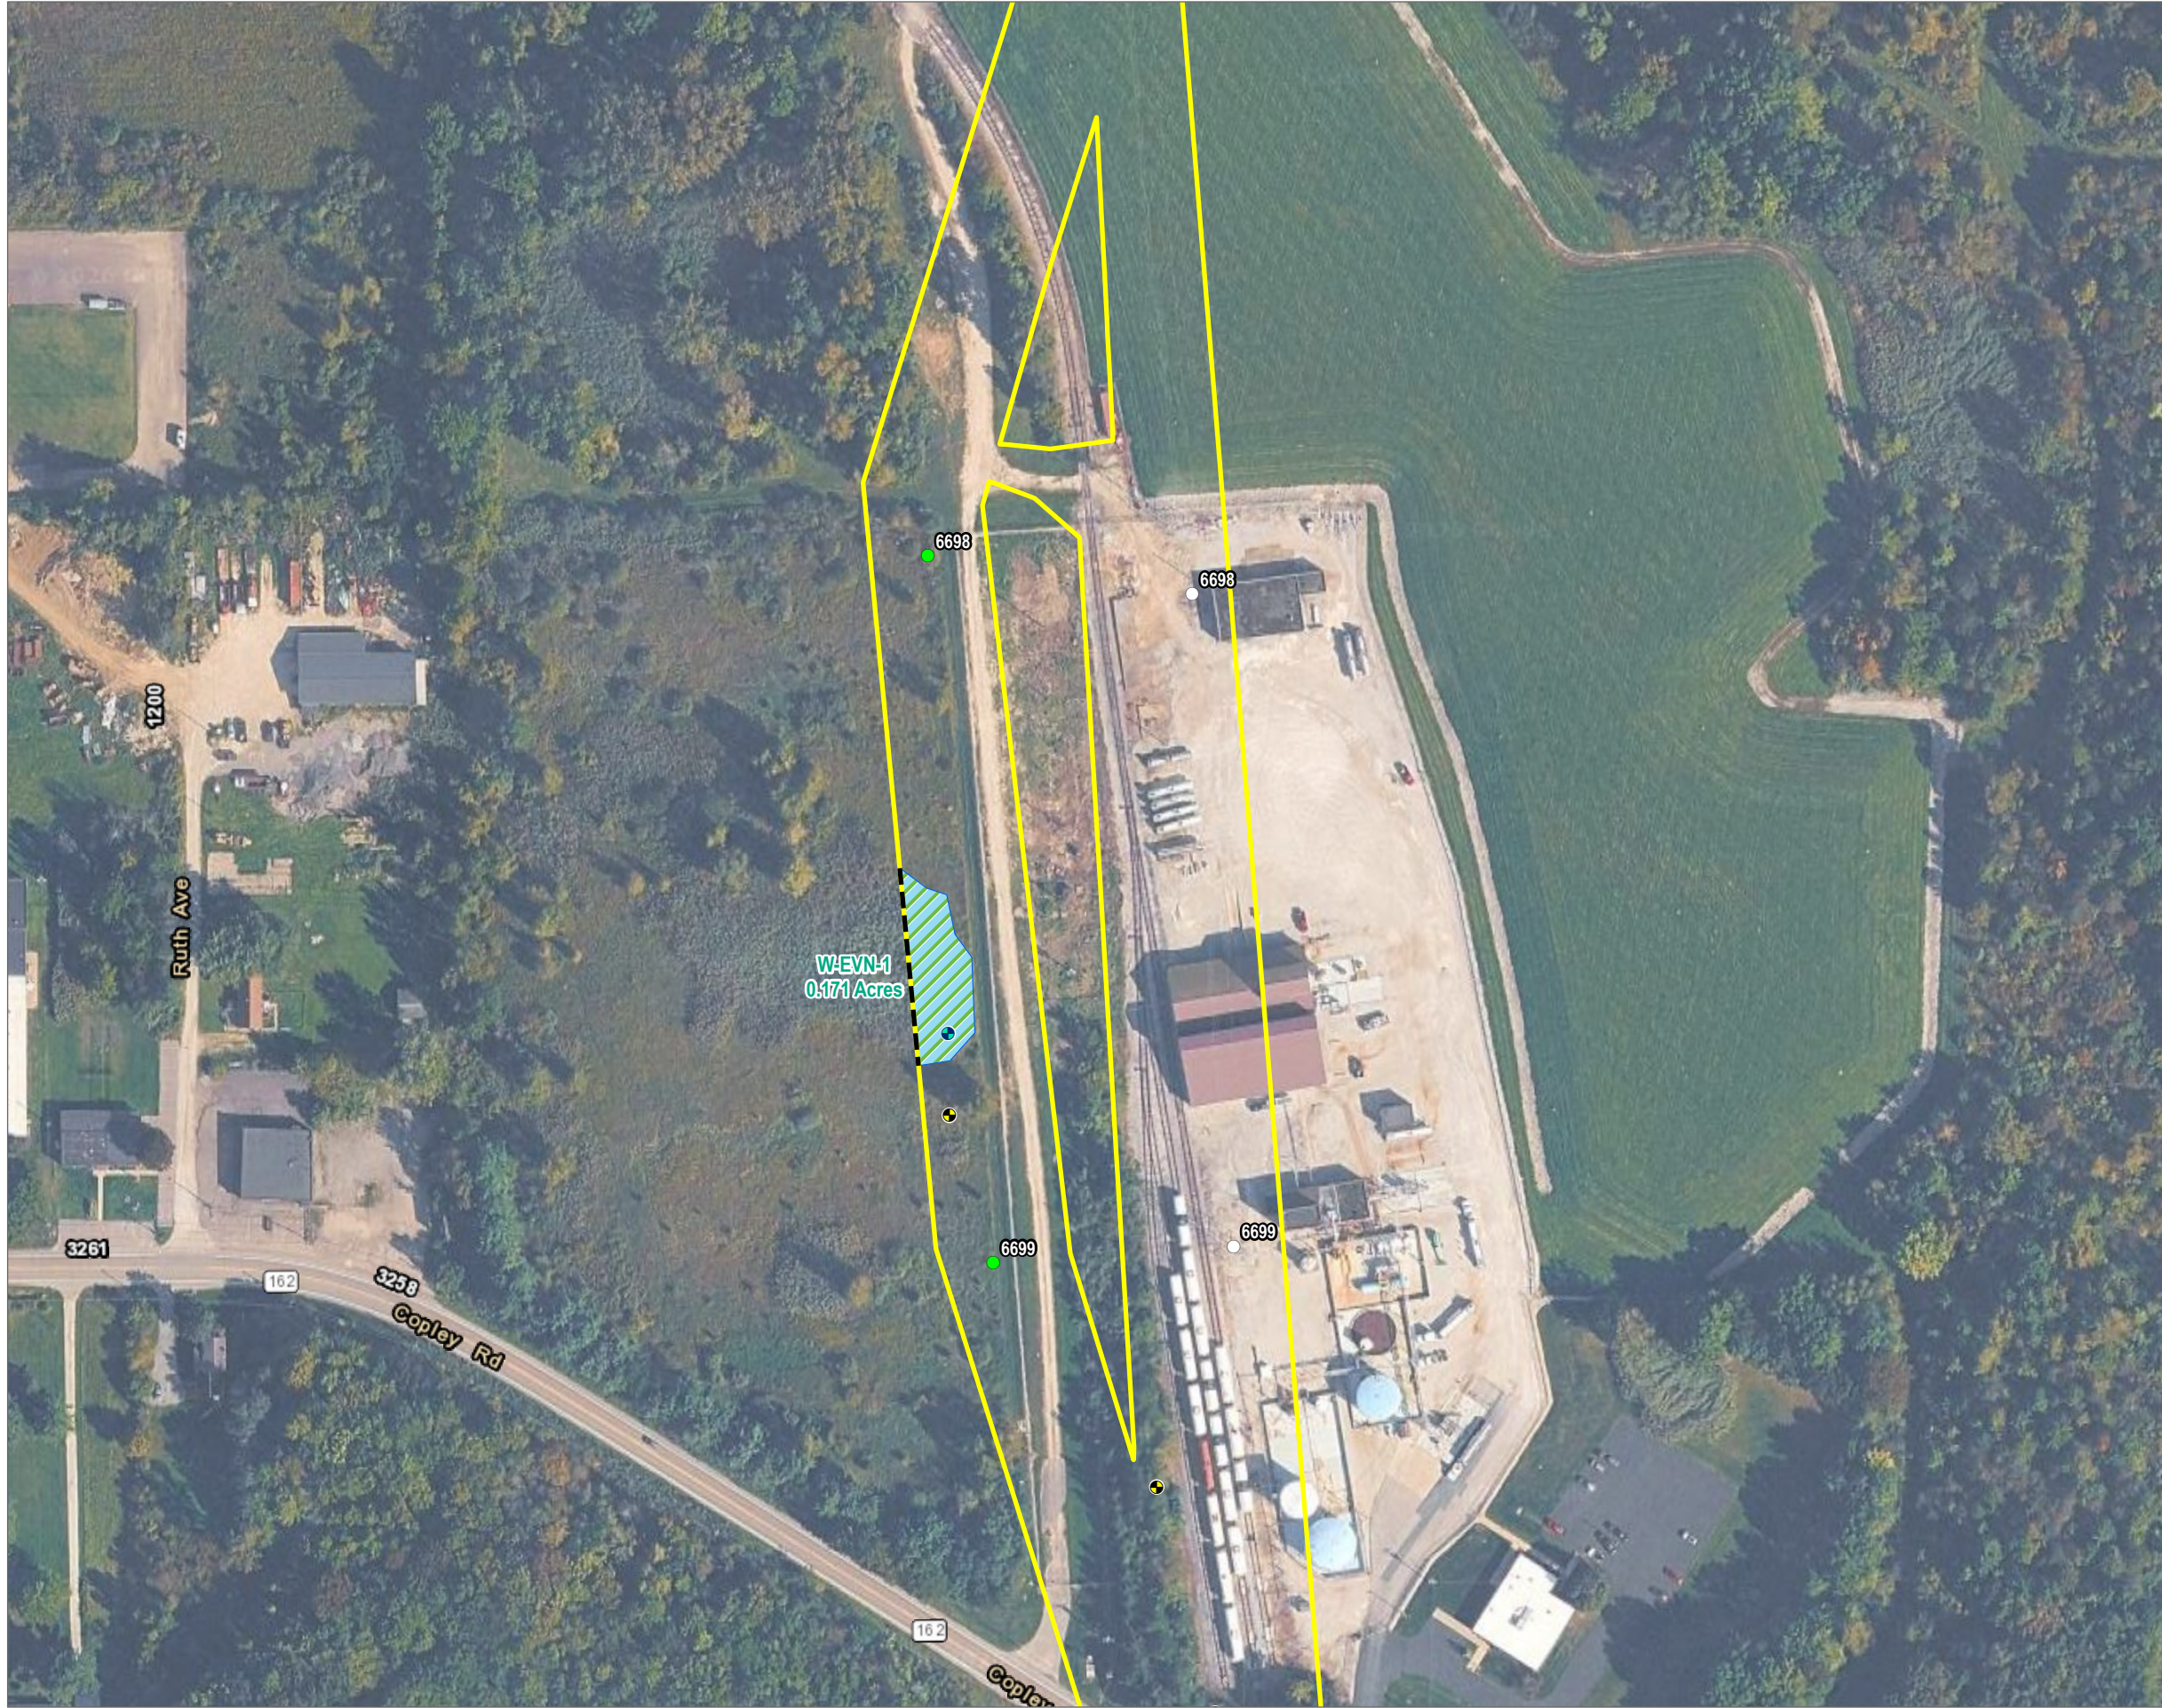
During the field investigations, two (2) wetlands were identified and delineated within the Project Study Area. The delineated wetland boundaries and sample points are shown on **Figure 5** in **Appendix A**. Representative photographs of sample points and other areas of interest are provided in **Appendix C**. Data were collected and recorded on the USACE Wetland Determination Data Forms – Northcentral and Northeast Region (**Appendix D**) and wetland functional assessments were completed for each delineated wetland using the ORAM (**Appendix D**). Delineated wetlands within the Project Study Area are summarized in **Table 2**.

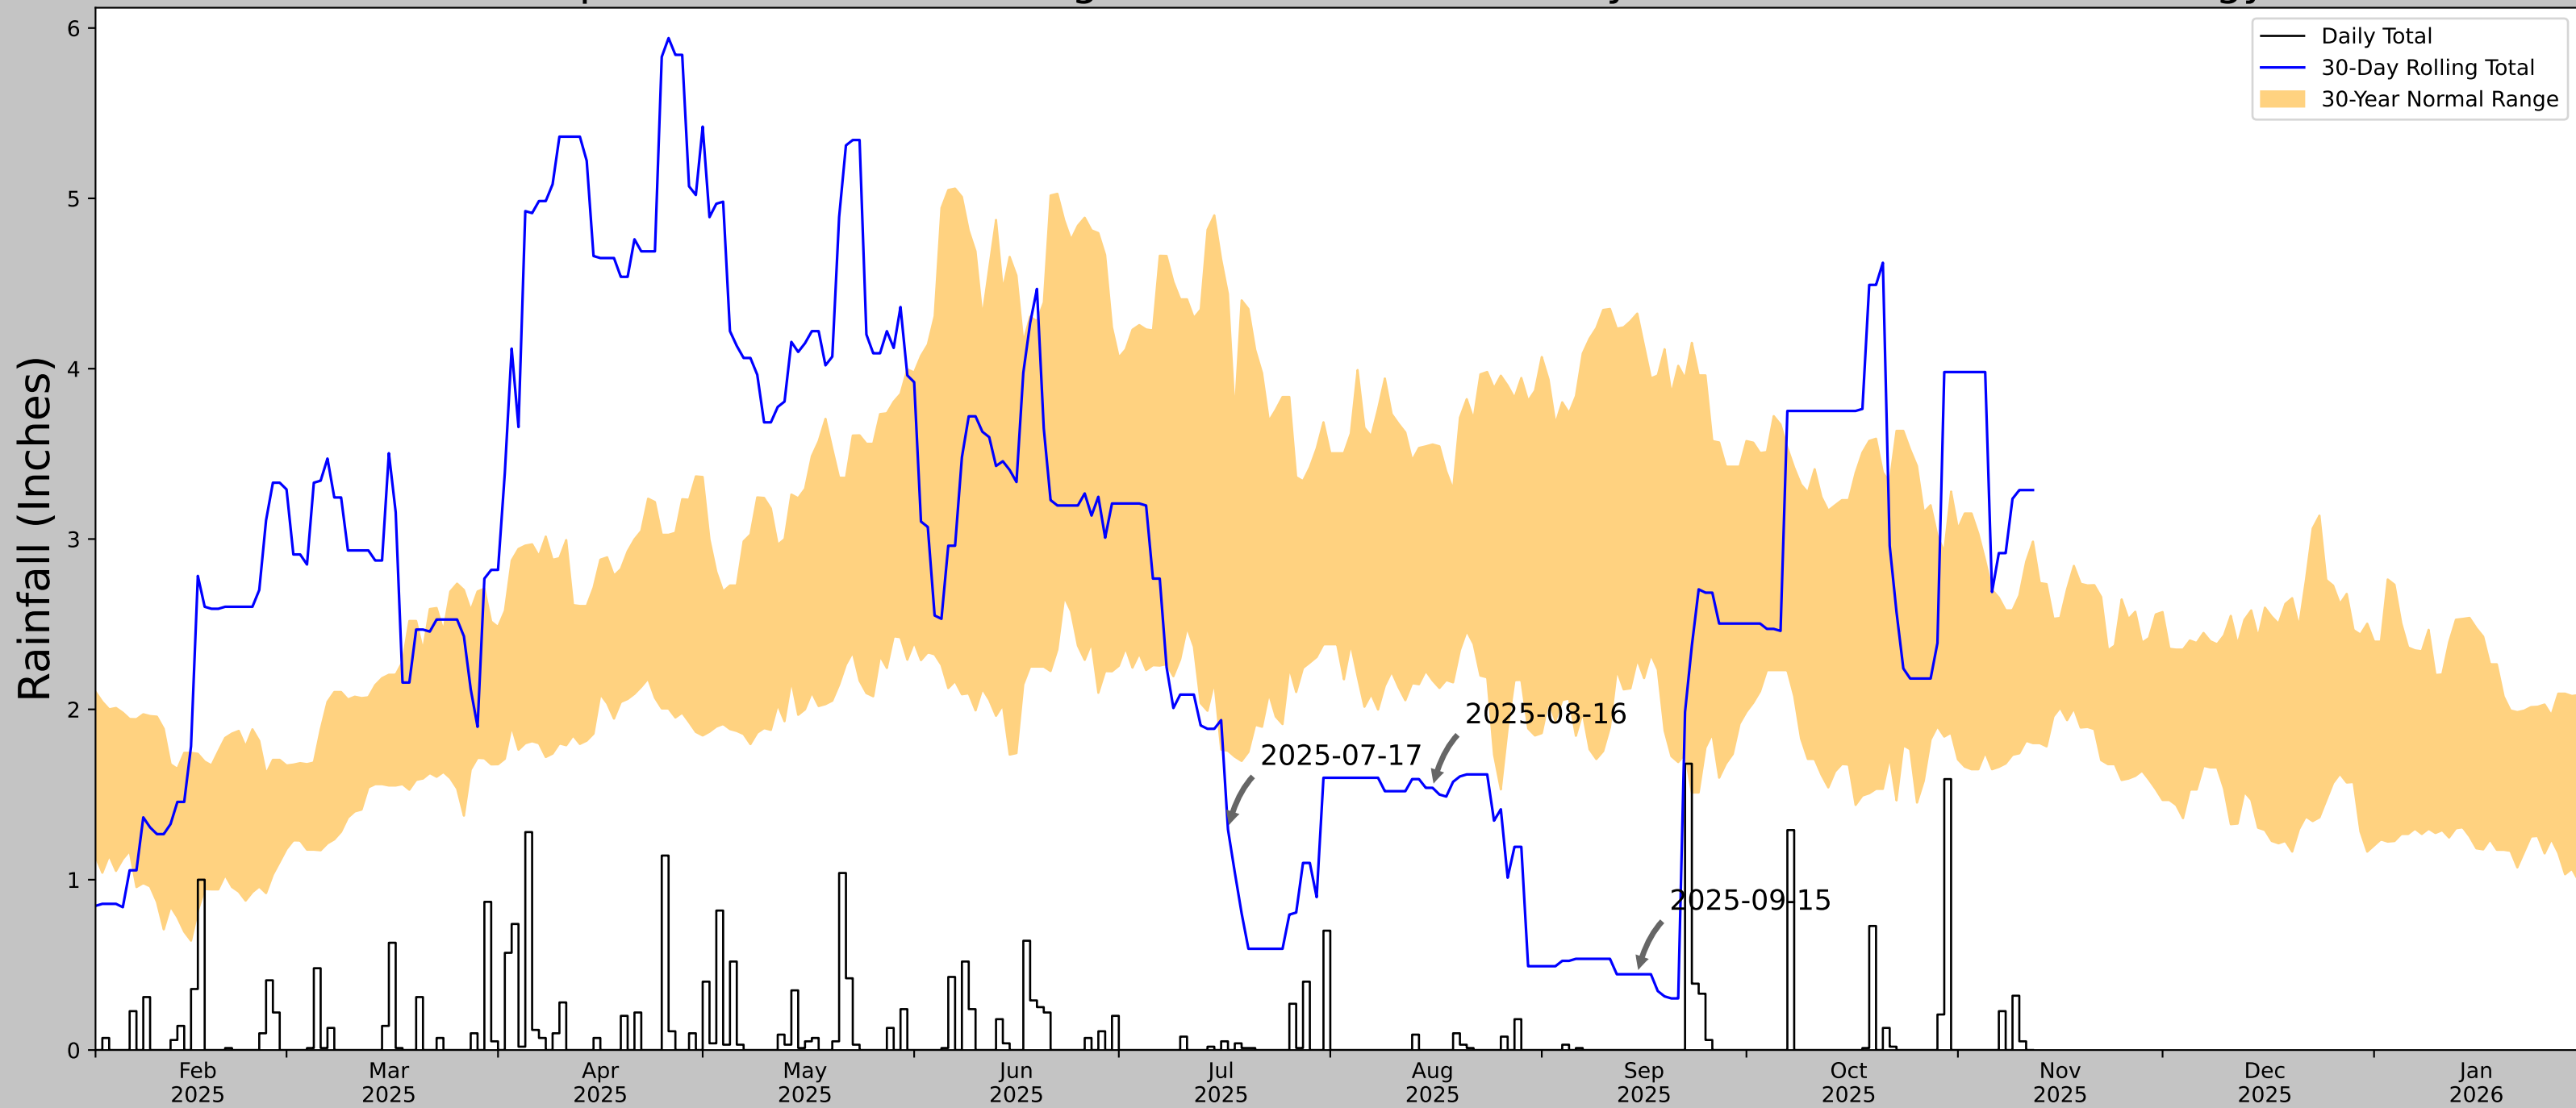
Coordinates	41.09709, -81.62727
Observation Date	2025-09-15
Elevation (ft)	1067.959
Drought Index (PDSI)	Mild drought (2025-08)
WebWIMP H ₂ O Balance	Dry Season

30 Days Ending	30 th %ile (in)	70 th %ile (in)	Observed (in)	Wetness Condition	Condition Value	Month Weight	Product
2025-09-15	2.293307	4.324016	0.444882	Dry	1	3	3
2025-08-16	2.169685	3.555512	1.53937	Dry	1	2	2
2025-07-17	1.756693	4.438583	1.295276	Dry	1	1	1
Result							Drier than Normal - 6

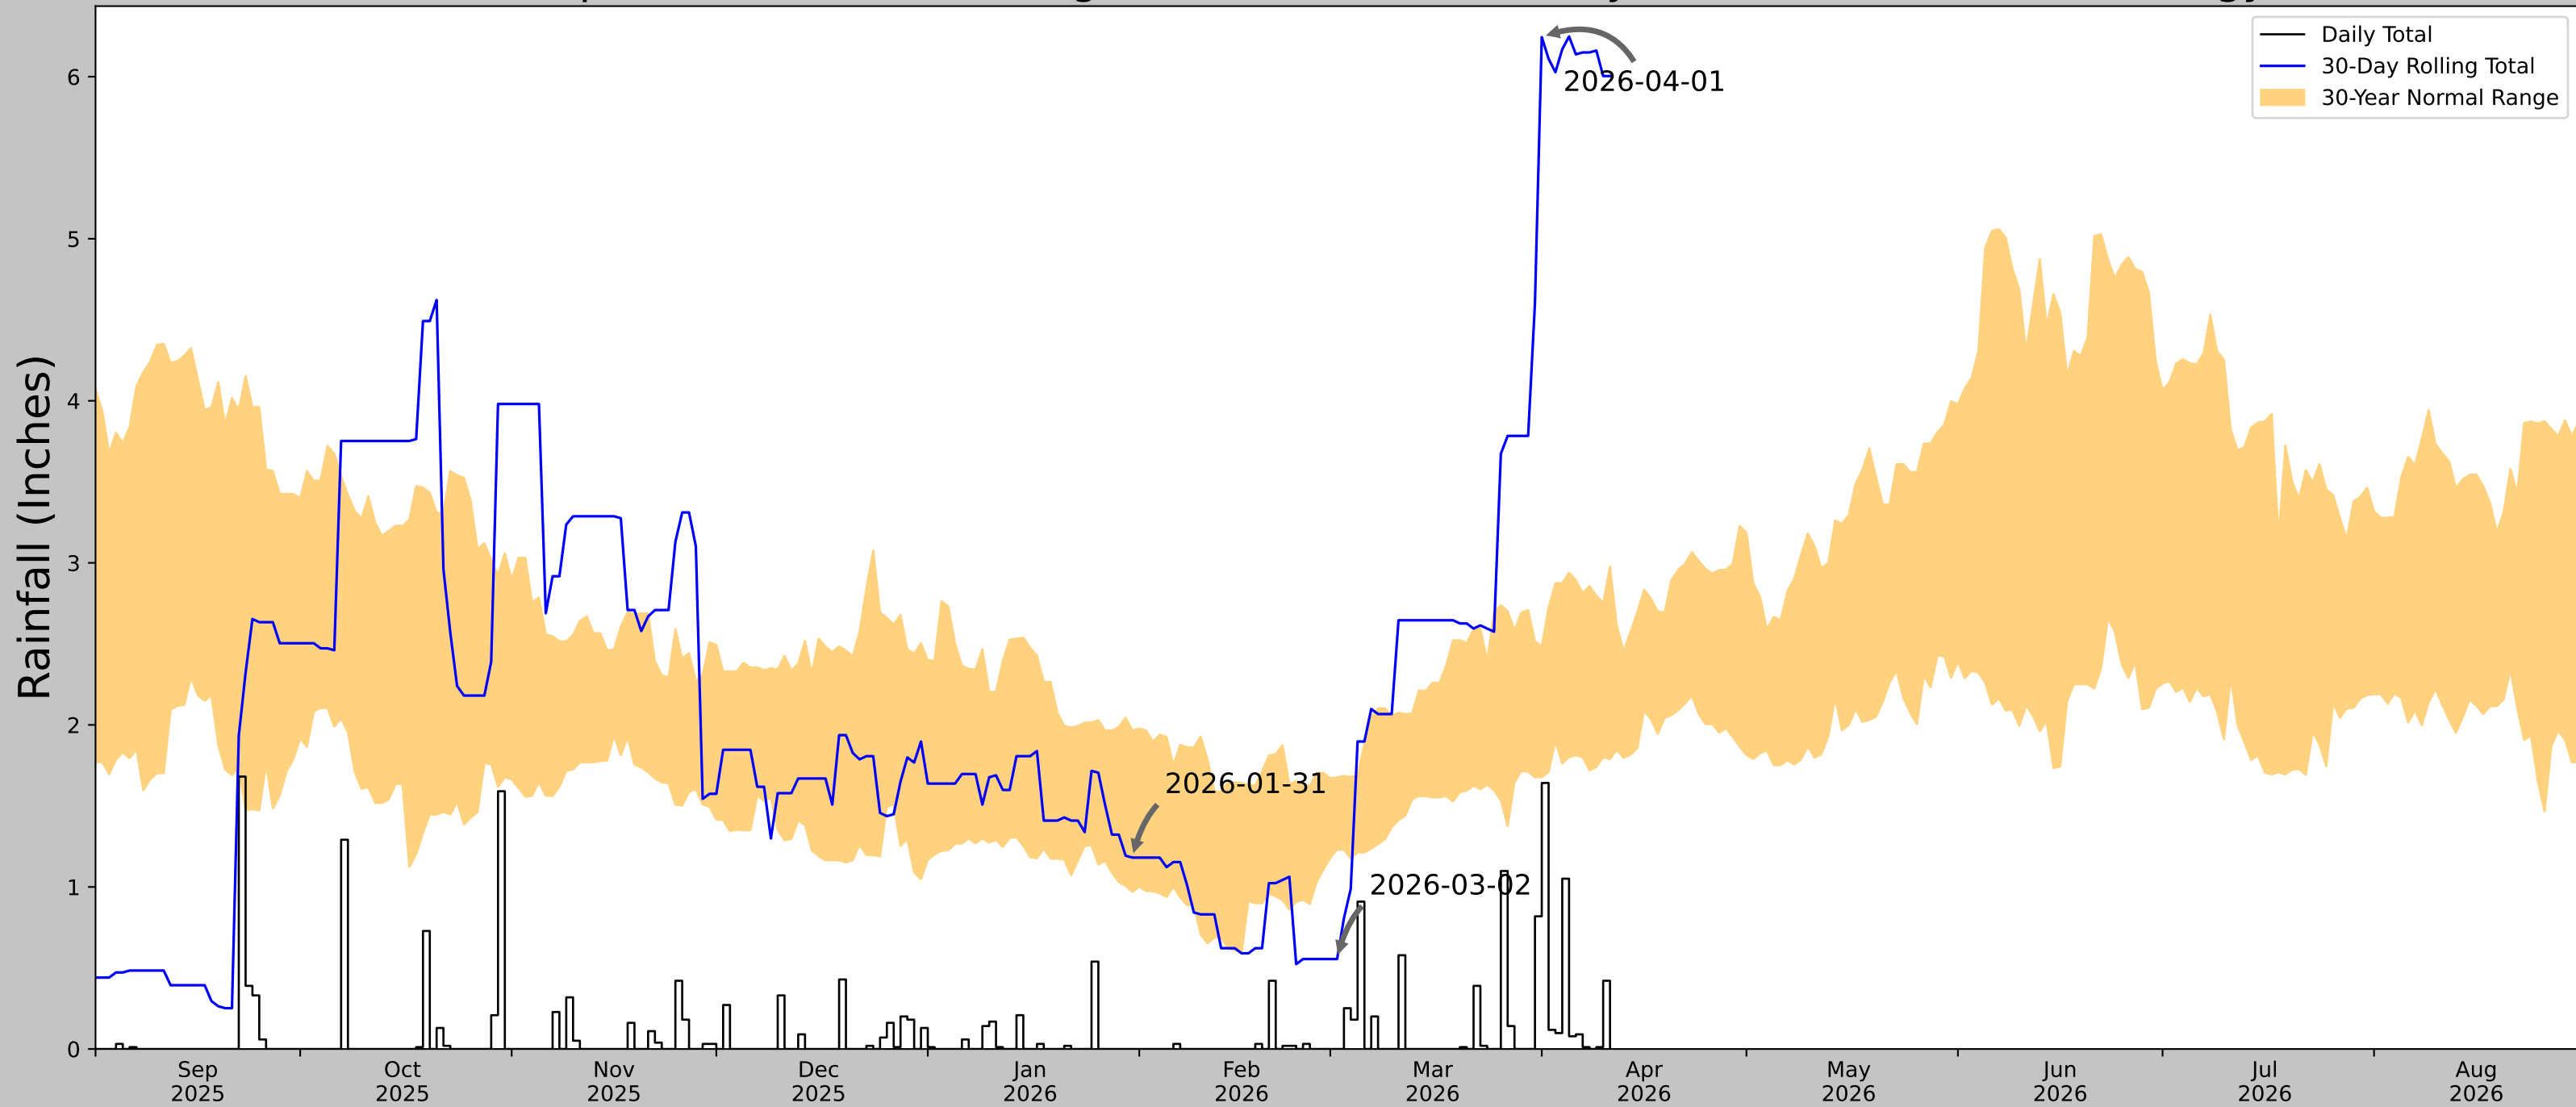
Coordinates	41.09715, -81.62875
Observation Date	2026-04-01
Elevation (ft)	1072.557
Drought Index (PDSI)	Mild drought (2026-03)
WebWIMP H ₂ O Balance	Wet Season

30 Days Ending	30 th %ile (in)	70 th %ile (in)	Observed (in)	Wetness Condition	Condition Value	Month Weight	Product
2026-04-01	1.677559	2.483858	6.244095	Wet	3	3	9
2026-03-02	1.230709	1.675984	0.555118	Dry	1	2	2
2026-01-31	0.969685	1.964567	1.181102	Normal	2	1	2
Result							Normal Conditions - 13
