**CONSTRUCTION NOTICE**

**SAMMIS-SOUTH CANTON  
345 kV TRANSMISSION LINE  
STRUCTURE REPLACEMENT PROJECT**

**OPSB Case No. 23-0951-EL-BNR**

**November 20, 2023**

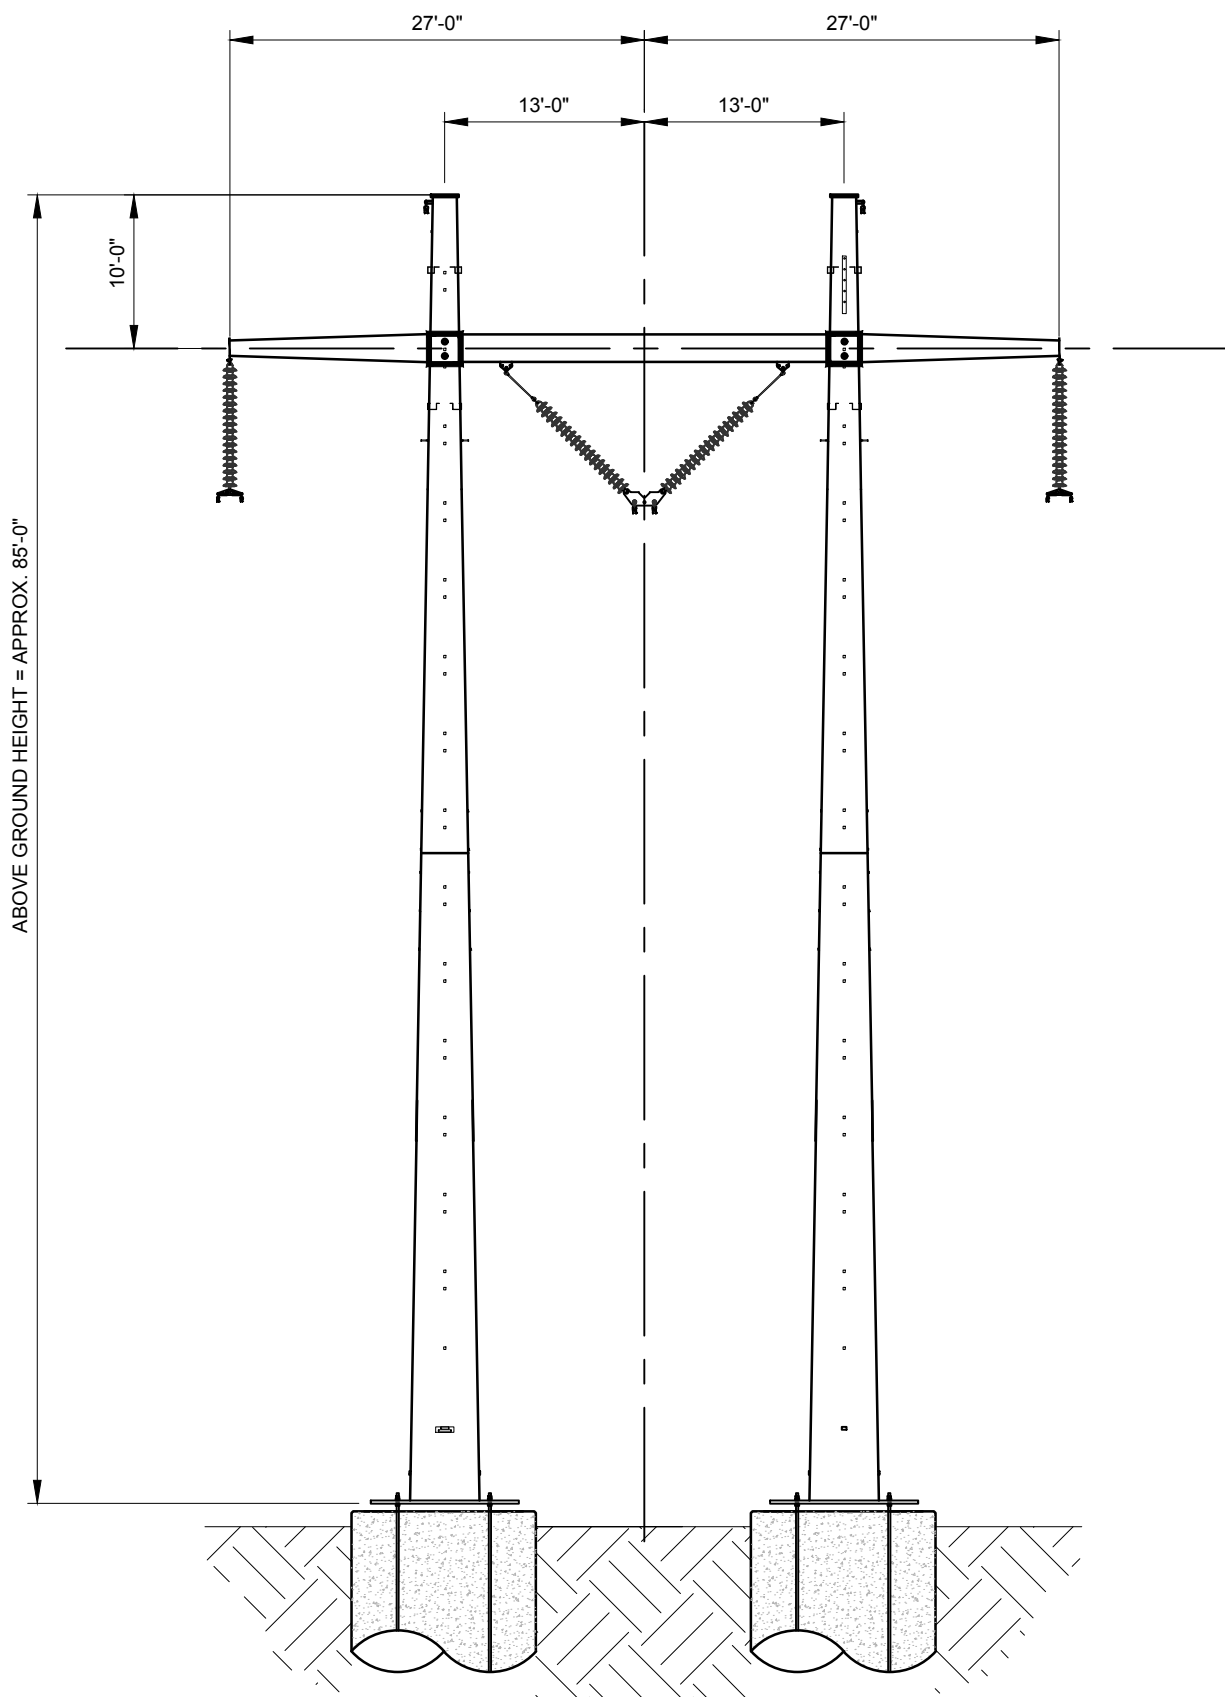
**EXHIBIT 4**

345KV SINGLE CIRCUIT 2-POLE TUBULAR STEEL  
SUSPENSION H-FRAME STRUCTURE  
STRUCTURE #40182B

The proposed solution is to replace Tower 40182 with 2 H-Frame steel pole structures, located one to the east and one to the west. They will be located outside of the flood plain. Structure 40182A will be designed as a dead-end structure capable of withstanding line loads from only one side and preventing cascading failure. This will improve the

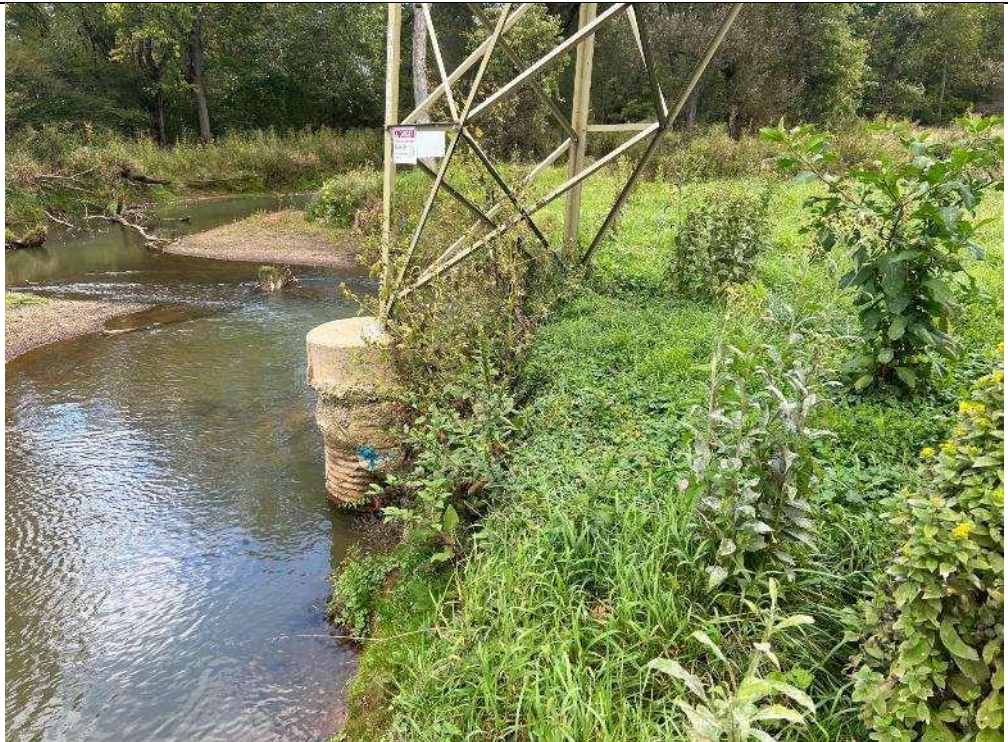
**Photo No. 11.**

Looking at the exposed foundation of Structure 40182 along the left descending bank of S-MRR-1, facing north.

Existing Tower 40182 is located within a flood plain of a meandering stream. The stream has severely eroded around the northwest tower foundation, almost completely exposing the foundation. The tower has been temporarily stabilized by restoring/stabilizing the stream bank and installing guy wires. However, due to the meandering nature of the stream, the integrity of the tower remains jeopardized. It is anticipated, that in the coming years, the stream will oxbow and place the tower directly in the path of the stream. A failure of one tower may cause cascading failure along the line since the towers on the Sammis-South Canton 345 kV Transmission Line are of a vintage design circa 1962 that have a very narrow footprint, providing little longitudinal support.

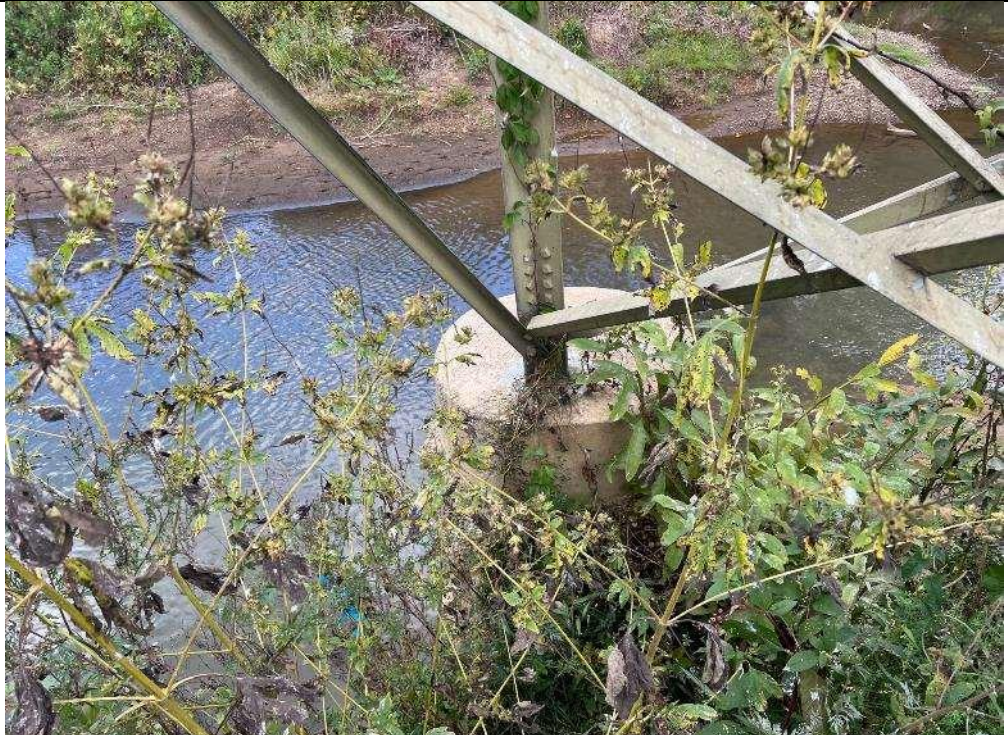
**Photo No. 12.**

Looking at the exposed foundation of Structure 40182 along the left descending bank of S-MRR-1, facing west.

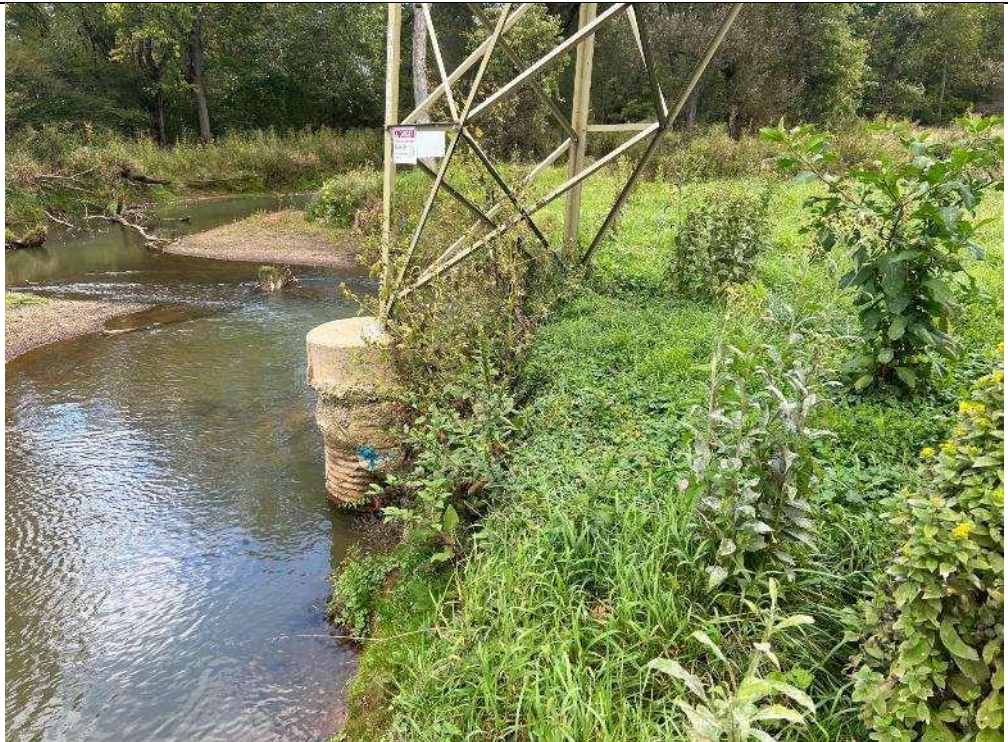
**Photo No. 11.**

Looking at the exposed foundation of Structure 40182 along the left descending bank of S-MRR-1, facing north.

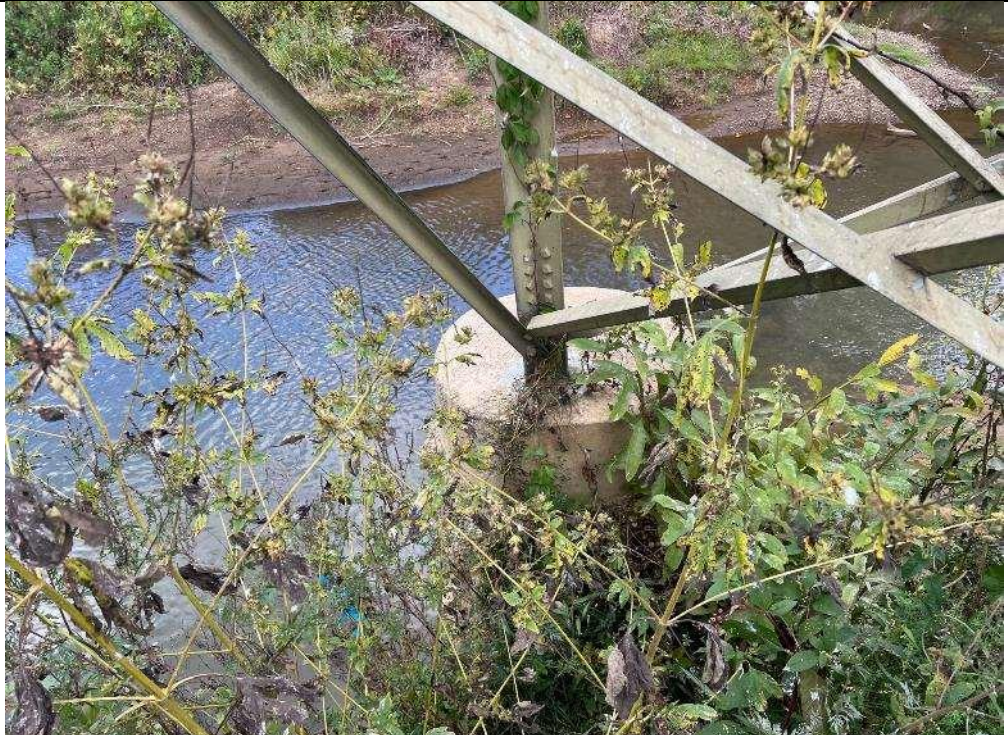
**Photo No. 12.**

Looking at the exposed foundation of Structure 40182 along the left descending bank of S-MRR-1, facing west.
