LETTER OF NOTIFICATION

**AYERSVILLE SUBSTATION EXPANSION AND
138 kV TRANSMISSION LINE PARTIAL REBUILD
PROJECT**

Case No.: 26-0122-EL-BLN

March 6, 2026

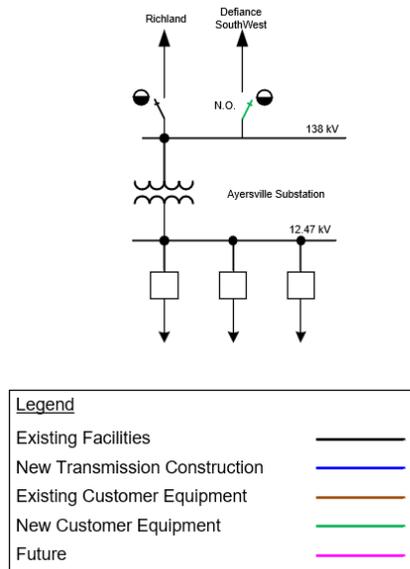
FIGURE 1

In addition to the customers served from the final networked Ayersville-Sand Ridge 69 kV Transmission Line, Ayersville Substation directly serves approximately 3,200 customers and 12 MW of load and is currently served radially from the Ayersville-Richland 138 kV Transmission Line. If there is a bus fault or a faulted breaker or a failure to open any one of the breakers for a fault connected to the bus at the existing Richland Substation or there is a fault on the Ayersville-Richland 138 kV Transmission Line, Ayersville Substation loses its only source, which would result in an interruption of service to these customers. The substation is currently configured as a tapped distribution substation with one 138-12.47 kV distribution transformer connected to the 138 kV bus as shown in Figure 1, *infra*, p. 7.

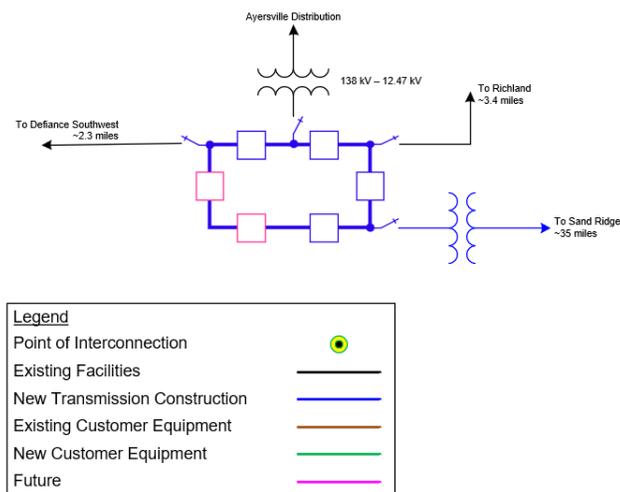
FIGURE 2

The ring bus configuration was ultimately selected as it will only require four breakers to adequately serve the two transmission lines and two transformers and provide the additional reliability and operational flexibility for this project. Upgrading the 138 kV substation to a robust ring-bus configuration will provide redundancy, improve operational flexibility and efficiency during outages, maintenance, and restoration efforts, and reduce the potential of local load loss due to the radial line configuration. Note that the proposed substation project is not needed to address a NERC, PJM, or FE Planning Criteria violation. The Project is a supplemental project driven by the FE Reliability Enhancement methodology, based on the existing system configuration and its impact on the reliability of electric service to the residents and businesses of the area.

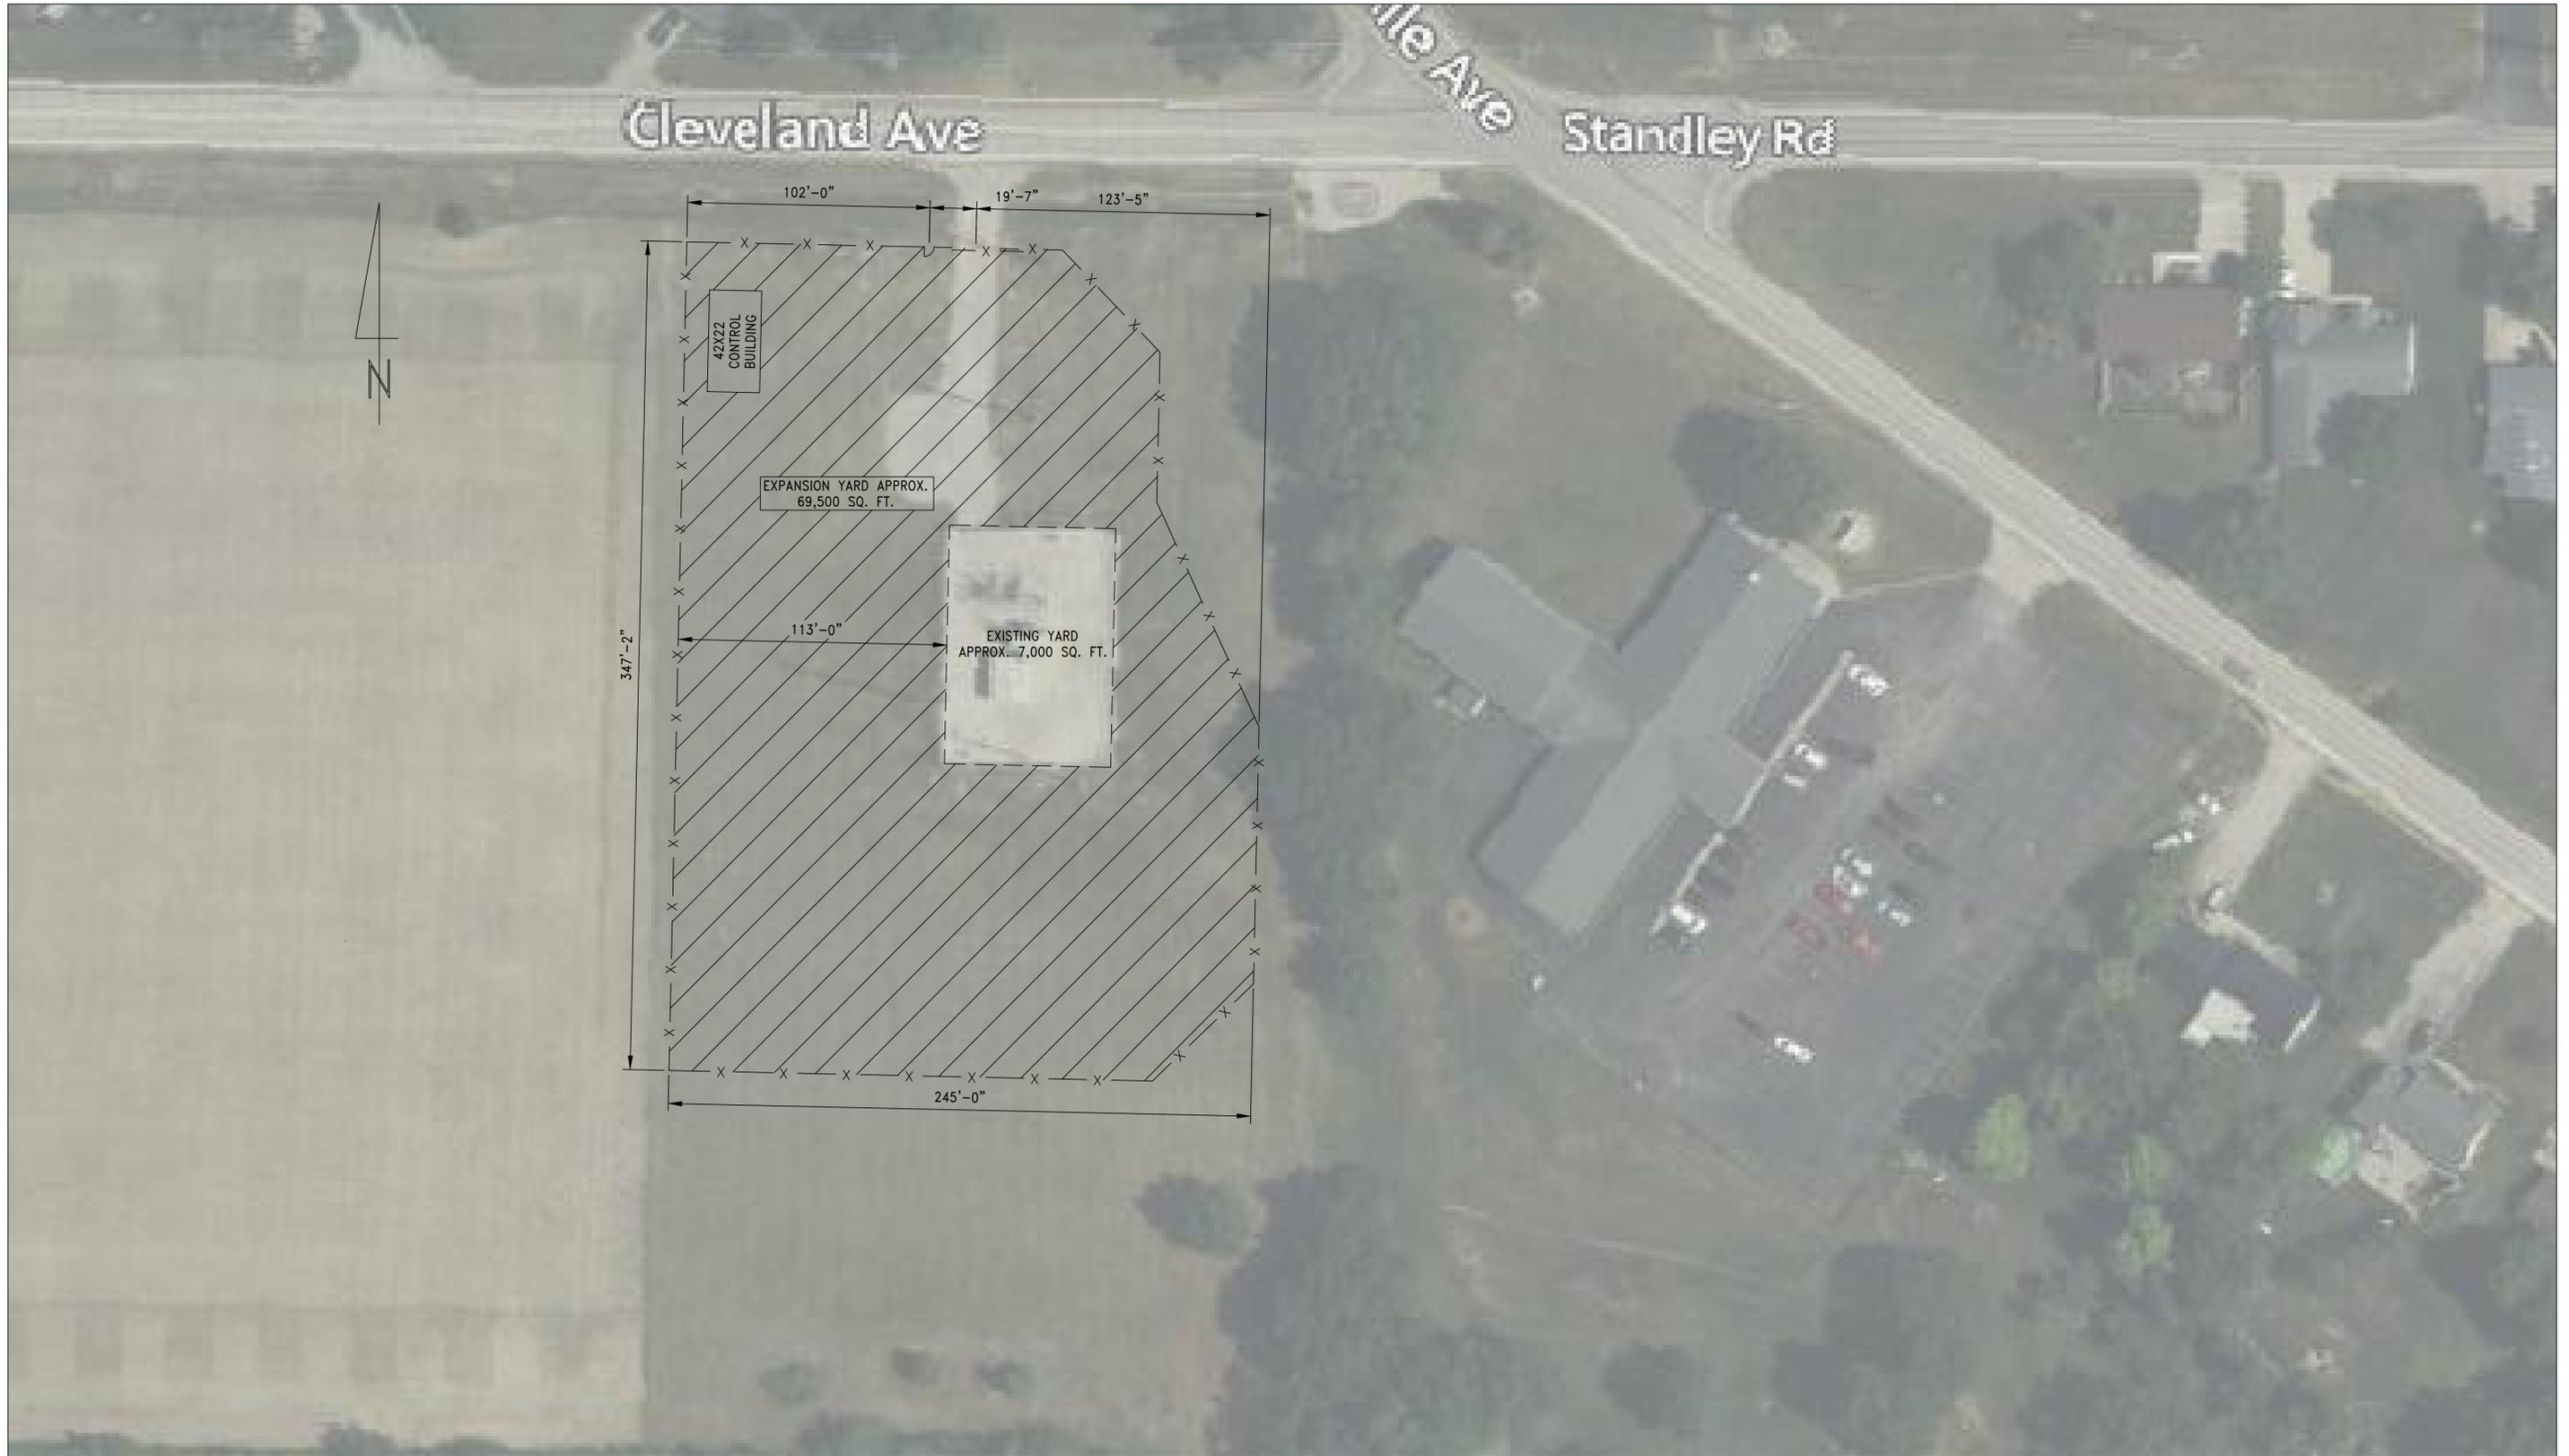
EXHIBIT 3 (SHEET 3 OF 3)

GENERAL LAYOUT

As shown on Exhibit 3, the existing Ayersville-Richland 138 kV Transmission Line will be reterminated into the reconfigured Ayersville Substation creating the Ayersville-Richland 138 kV No.1 and Ayersville-Richland 138 kV No.2 Transmission Lines. The existing Southwest Defiance-Richland 138 kV Transmission Line will be renamed to and become part of the Ayersville-Richland No.2 Transmission Line. The 0.5-mile rebuild of the Ayersville-Richland 138 kV No.1 Transmission Line and the Ayersville-Richland No.2 Transmission Line extension from Ayersville Substation to Structure No. 148 will use new 795 kcmil 26/7 Aluminum Conductor Steel Reinforced (“ACSR”) conductor, replacing the existing 636 kcmil 27 Strand All Aluminum Conductor (“AAC”).

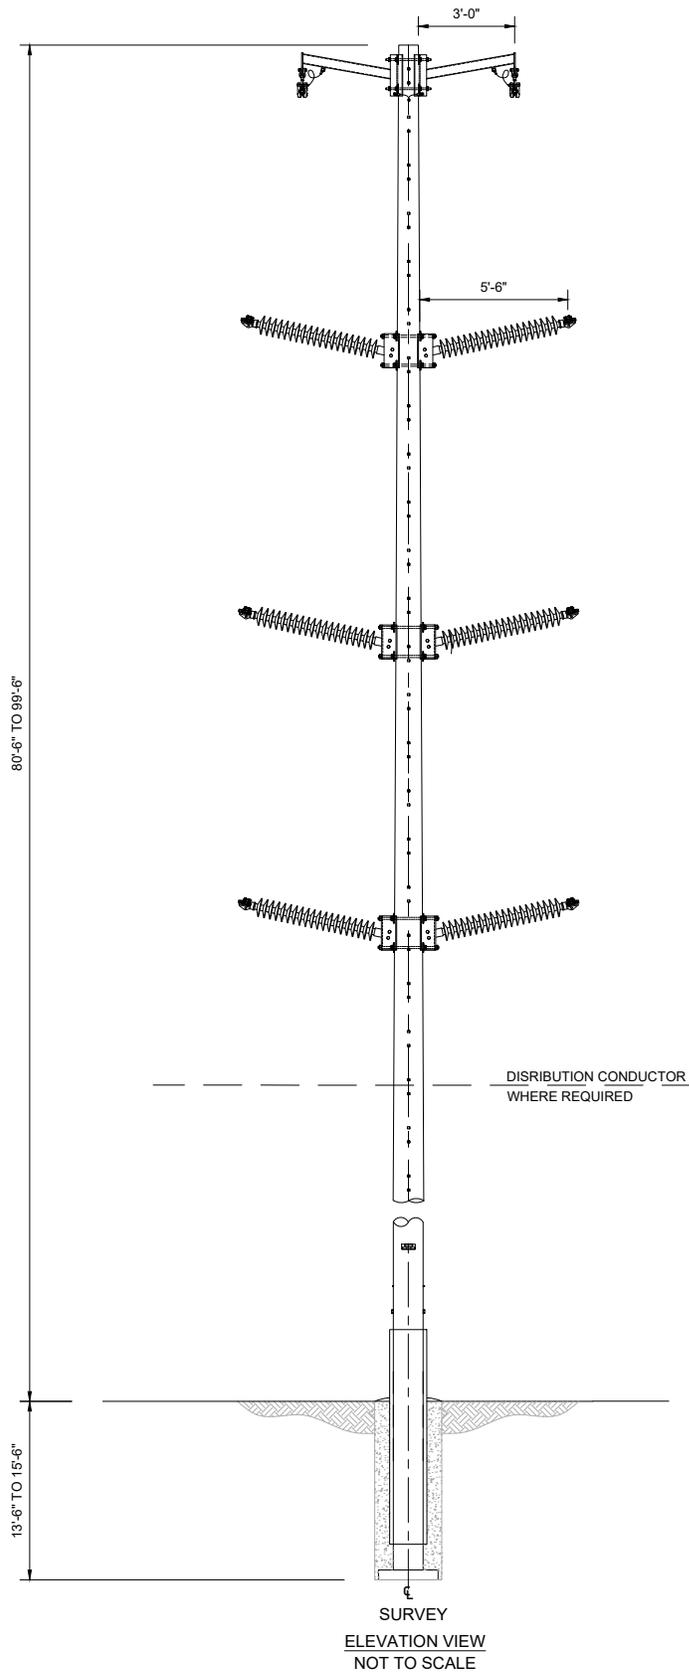
EXHIBIT 6

SURVEY
ELEVATION VIEW
NOT TO SCALE

69 kV/138 kV DOUBLE CIRCUIT
DIRECT EMBED STEEL TANGENT STRUCTURE

Voltage:	138 kV
Conductors:	795 kcmil 26/7 ACSR
Static Wire:	7#8 Alumoweld
Insulators:	Porcelain/Glass
ROW Width:	60'
Structure Types:	Exhibit 6: Double Circuit Direct Embed Steel Pole Tangent Structure (Qty. 11) Exhibit 7: Double Circuit Steel Pole DE Structure on Concrete Foundation (Qty. 3)

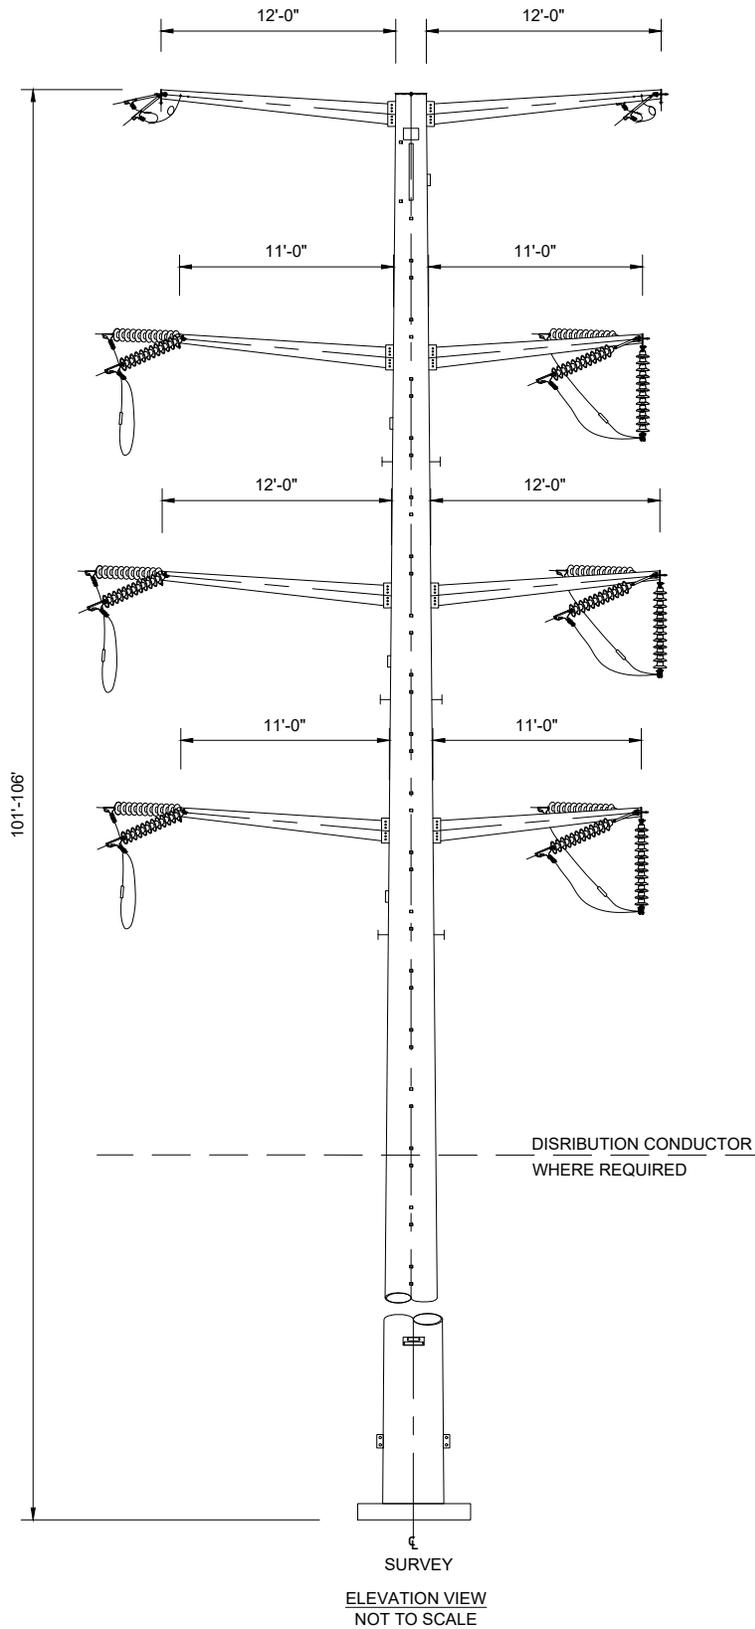
EXHIBIT 7

ELEVATION VIEW
NOT TO SCALE

69 kV/138 kV DOUBLE CIRCUIT STEEL POLE
DEADEND STRUCTURE ON CONCRETE FOUNDATION

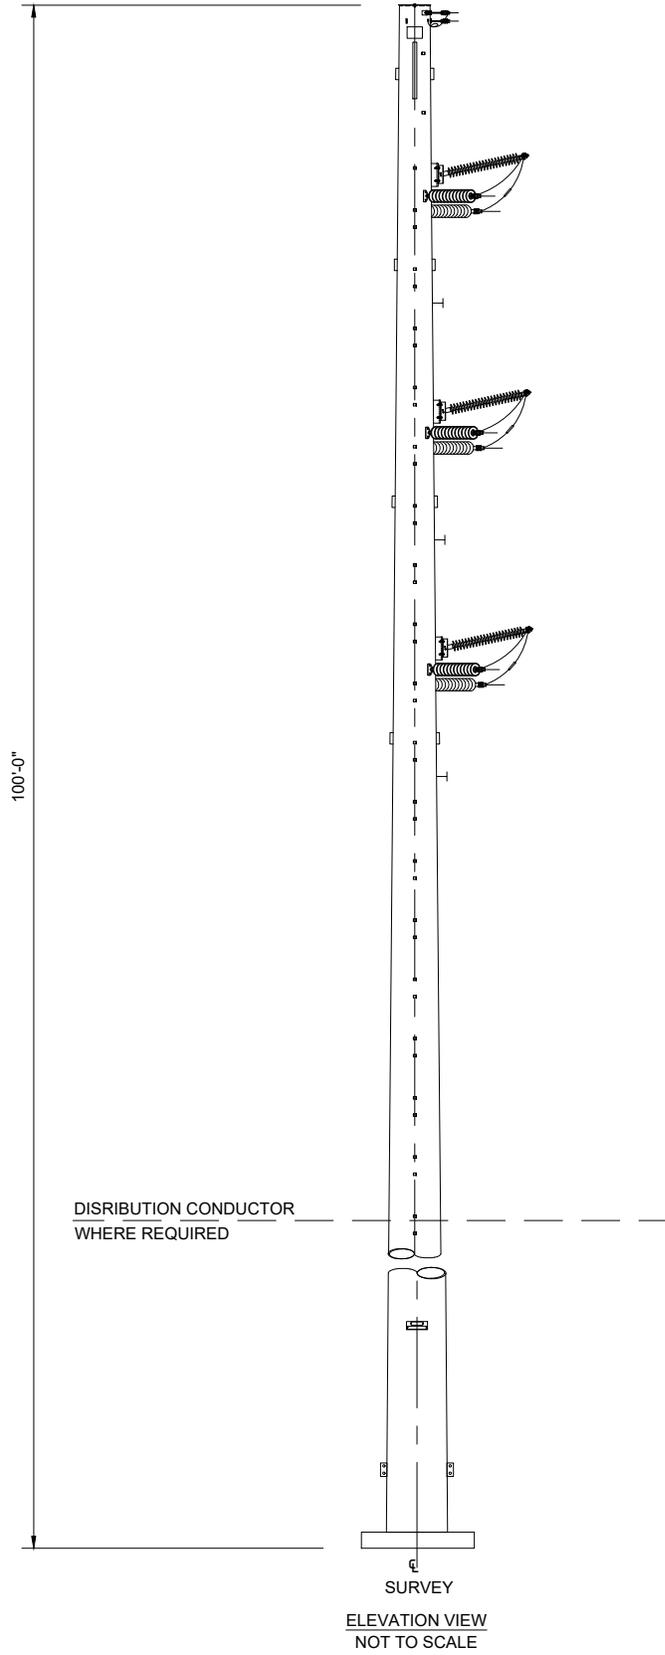
EXHIBIT 8

138 kV SINGLE CIRCUIT STEEL POLE STRUCTURE
ON CONCRETE FOUNDATION

Exhibit 8: Single Circuit Steel Pole Structure on Concrete Foundation (Qty. 1)

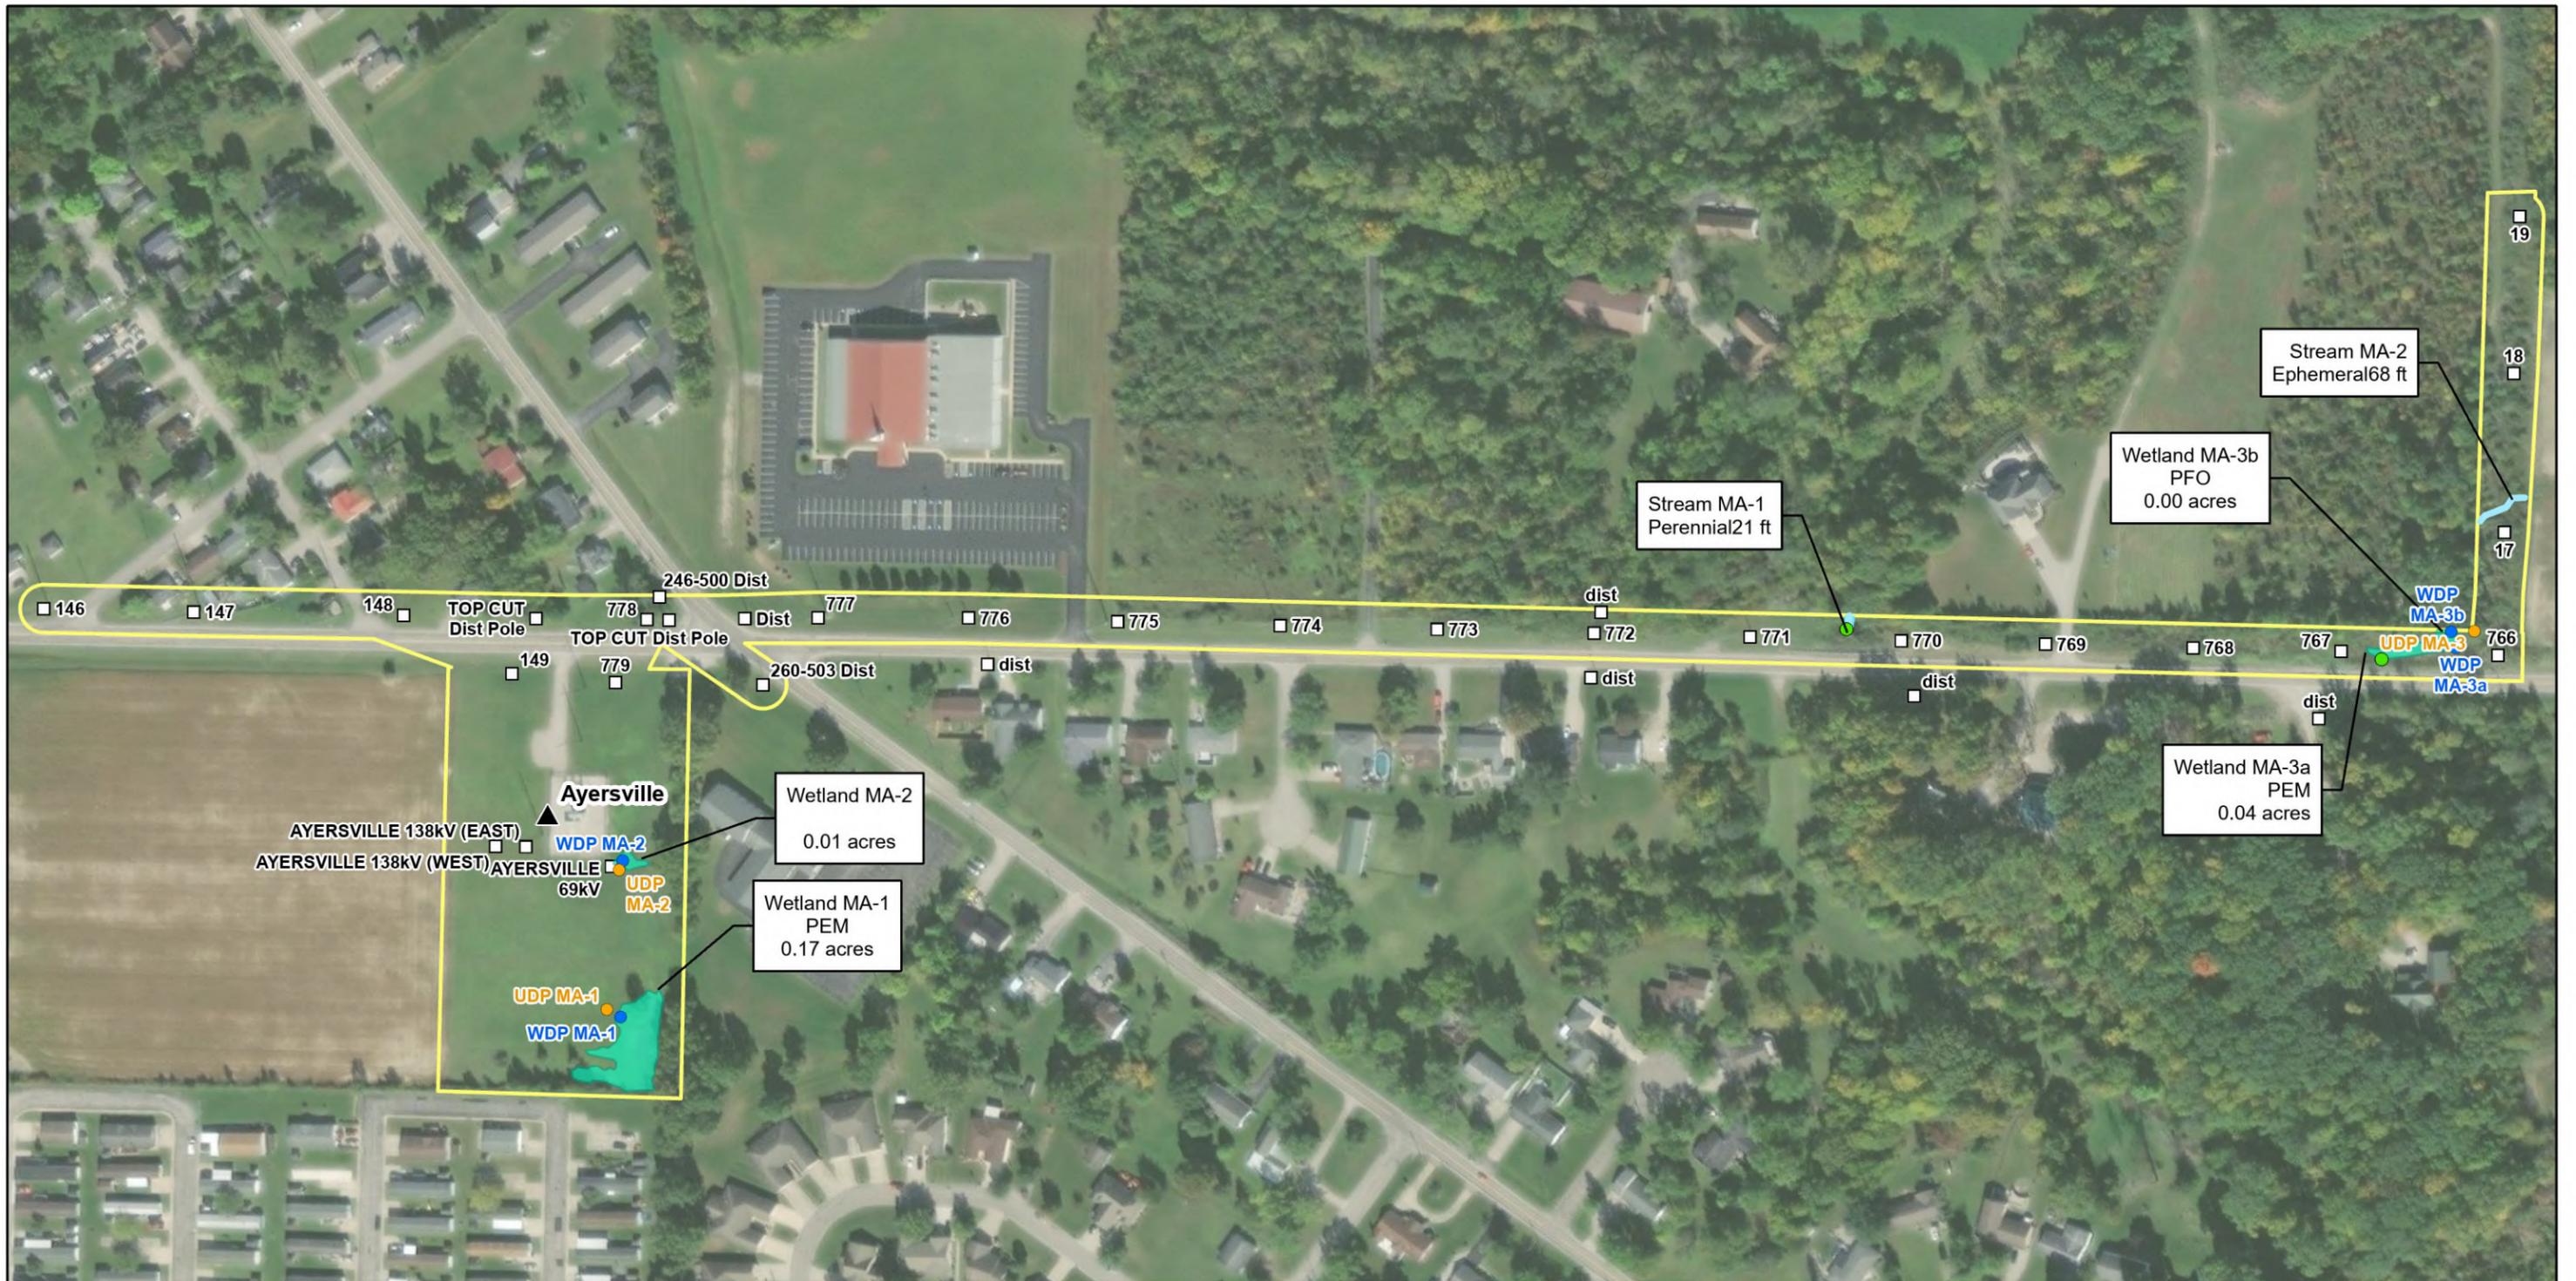
AYERSVILLE SUBSTATION EXPANSION
& 138KV TRANSMISSION LINE REBUILD
Figure 3: Delineated Features

- Proposed Structure
- Culvert
- ▭ Environmental Survey Corridor
- Wetland Data Point
- Delineated Stream
- Upland Data Point
- Delineated Wetland

WSP ecologists surveyed the ESC on April 10, 2025 and June 4, 2025 by walking the ESC and evaluating for wetlands, streams, and other potential Waters of the U.S. (WOTUS) or waters of the state. The WSP ecologists delineated three wetlands and two streams within the ESC. No open-water features were observed within the ESC. The results of the desktop review are provided in Figure 2 (Appendix A). The location and extents of delineated features are provided in Figure 3 (Appendix A).
