**AMERICAN TRANSMISSION SYSTEMS,
INCORPORATED
A FIRSTENERGY COMPANY**

CONSTRUCTION NOTICE

**BAYSHORE-JEEP NO.2 STICKNEY 138 KV
TRANSMISSION LINE STRUCTURE
RELOCATION AND REPLACEMENT PROJECT
OPSB CASE NO.: 25-0558-EL-BNR**

OPSB CASE No. 25-0558-EL-BNR: CONSTRUCTION NOTICE
BAYSHORE-JEEP NO. 2 STICKNEY 138 KV TRANSMISSION LINE
STRUCTURE RELOCATION AND REPLACEMENT PROJECT

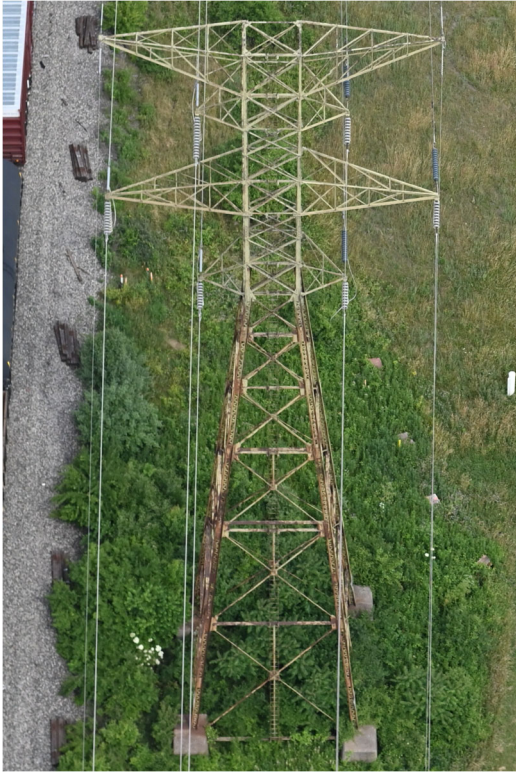
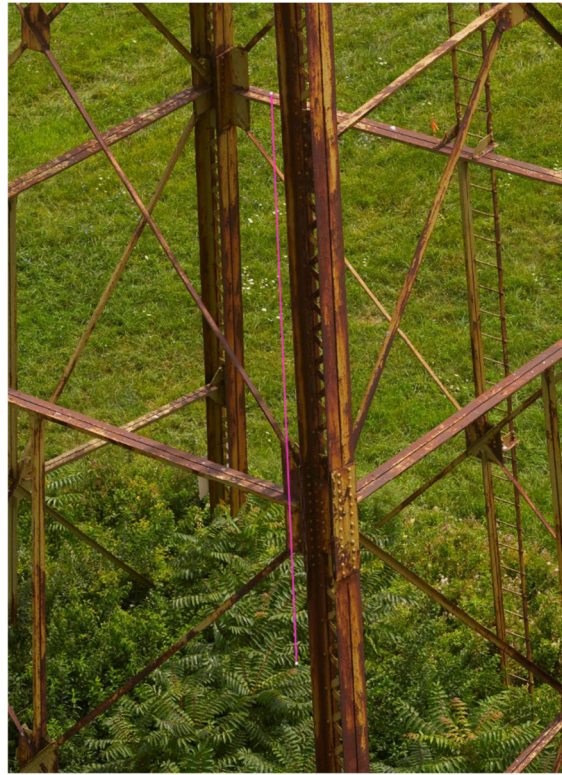
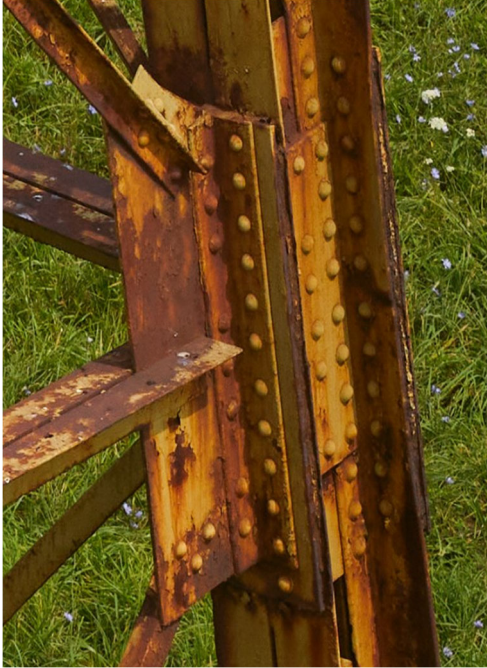
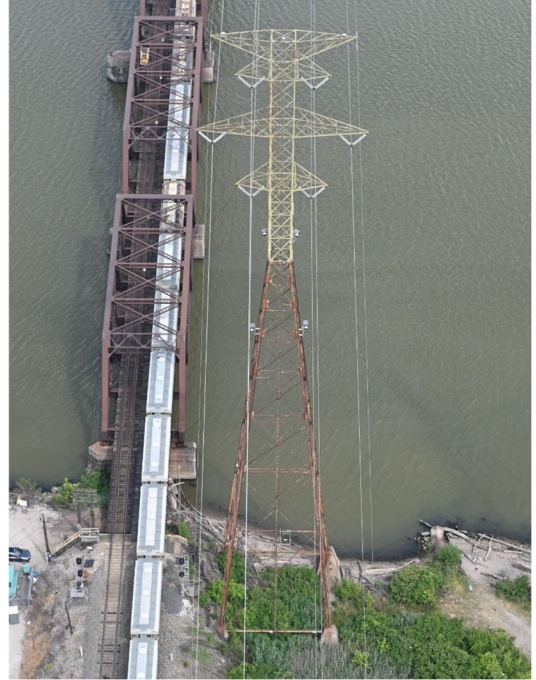
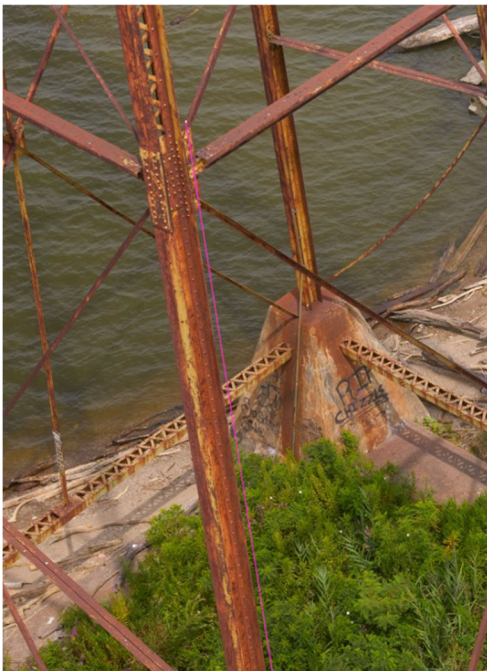
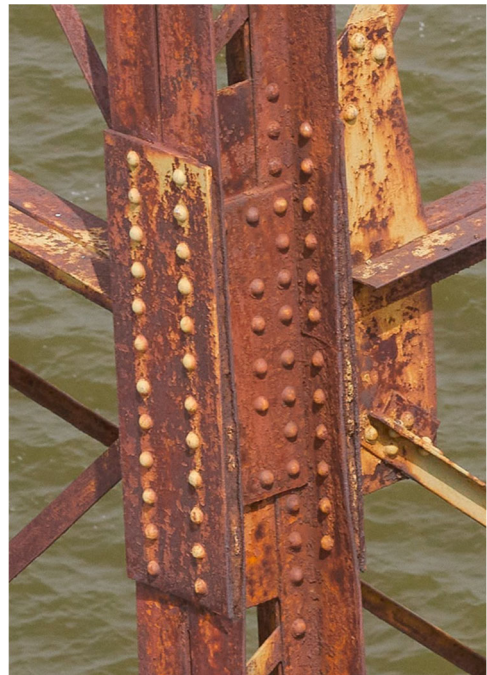
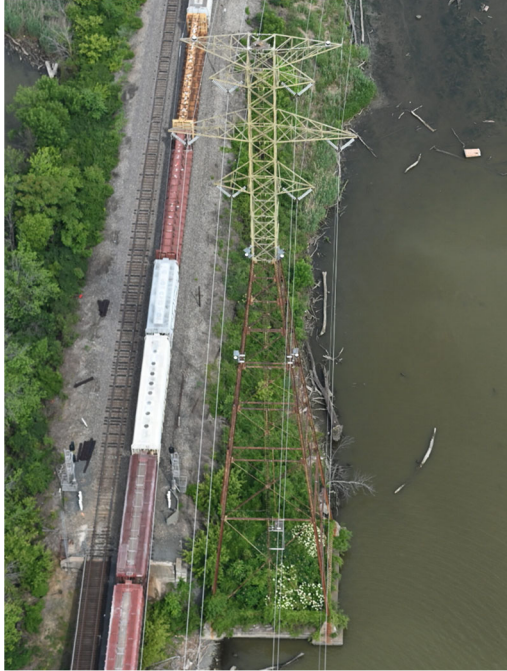
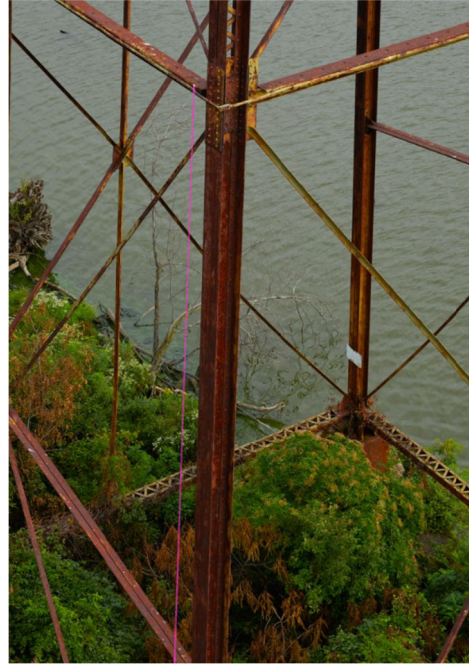
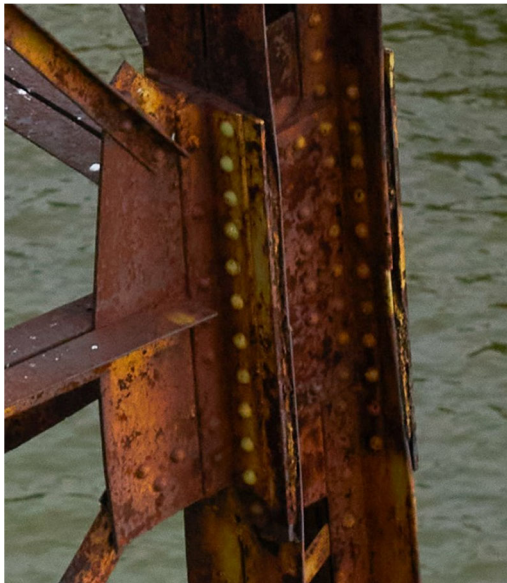
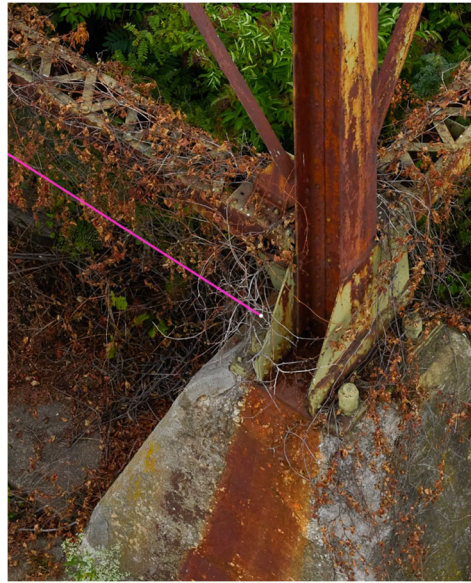
The need to replace towers Structure Nos. 51, 52 and 53 on the Bayshore-Jeep No. 2 Stickney 138 kV/Ironville-Lapier 69 kV double circuit transmission line is due to the current condition of the towers. The base sections of all three towers show significant rust and deterioration, as most members have very little coating left. Many of the bolted tower connections are showing signs of pack rust or packout, that will continue to accelerate as these towers age. At least one of the towers (Structure No. 53) has significant holes in a horizontal member caused by extreme rust. The top sections of the towers were replaced in the 1970s. No other members were replaced at that time. The degradation of the structures is shown in the following photographs.

A 2024 iHawk Steelworks drone inspection was completed to confirm the severity of the deterioration on all three towers. Using the National Grid grading system, iHawk ranked all steel members on a scale from 1-6. See Table 1 for grading information. See Table 2 for the tower results. A majority of the members (58%) were graded as 4, confirming that most members are significantly corroded and/or pitted. Around 1% of members were

graded as 5 or 6, suggesting that they may offer lower strength capacity. ATSI did a review of drone photos of these members and determined that emergency action was not required, but that this inspection added further justification for replacement of these towers.

In addition to the drone inspection, an Osmose foundation inspection was also completed in 2024. This resulted in the need to do some temporary repairs on all three tower foundations to ensure safe operation until replacement. Four legs on tower 51 and three legs on tower 52 were temporarily strengthened in March 2025 using supplemental steel members to ensure the proper load is transferred to the concrete piers. For tower 53, supplemental steel members were bolted or welded to the areas of heavy corrosion to ensure strength is not lost. This repair was completed in June 2025. Any non-load bearing horizontals that have been disconnected from the concrete piers have been reconnected.

Only crucial repairs near ground level were done on these towers. These areas had the most corrosion with pitting and visual holes in multiple members. By temporarily repairing these members, the structural strength will last until replacement.

Possible alternatives considered were steel member replacement and re-coating/repainting the structures. Given the severity of the corrosion, replacing specific steel members on each tower is not a viable solution. This would include replacing over 1000 members on 57-year-old towers with restricted access near the Maumee River. Additionally, to replace some of the key members, temporary supports would be needed, and to install the temporary structures, it is almost impossible given that two of the towers are adjacent to the water. Additionally, painting or re-coating these structures would be insufficient as rust and deterioration has consumed most members. All rust would need to be removed prior to coating, thus making it a non-viable solution, given the amount of rust on each tower.

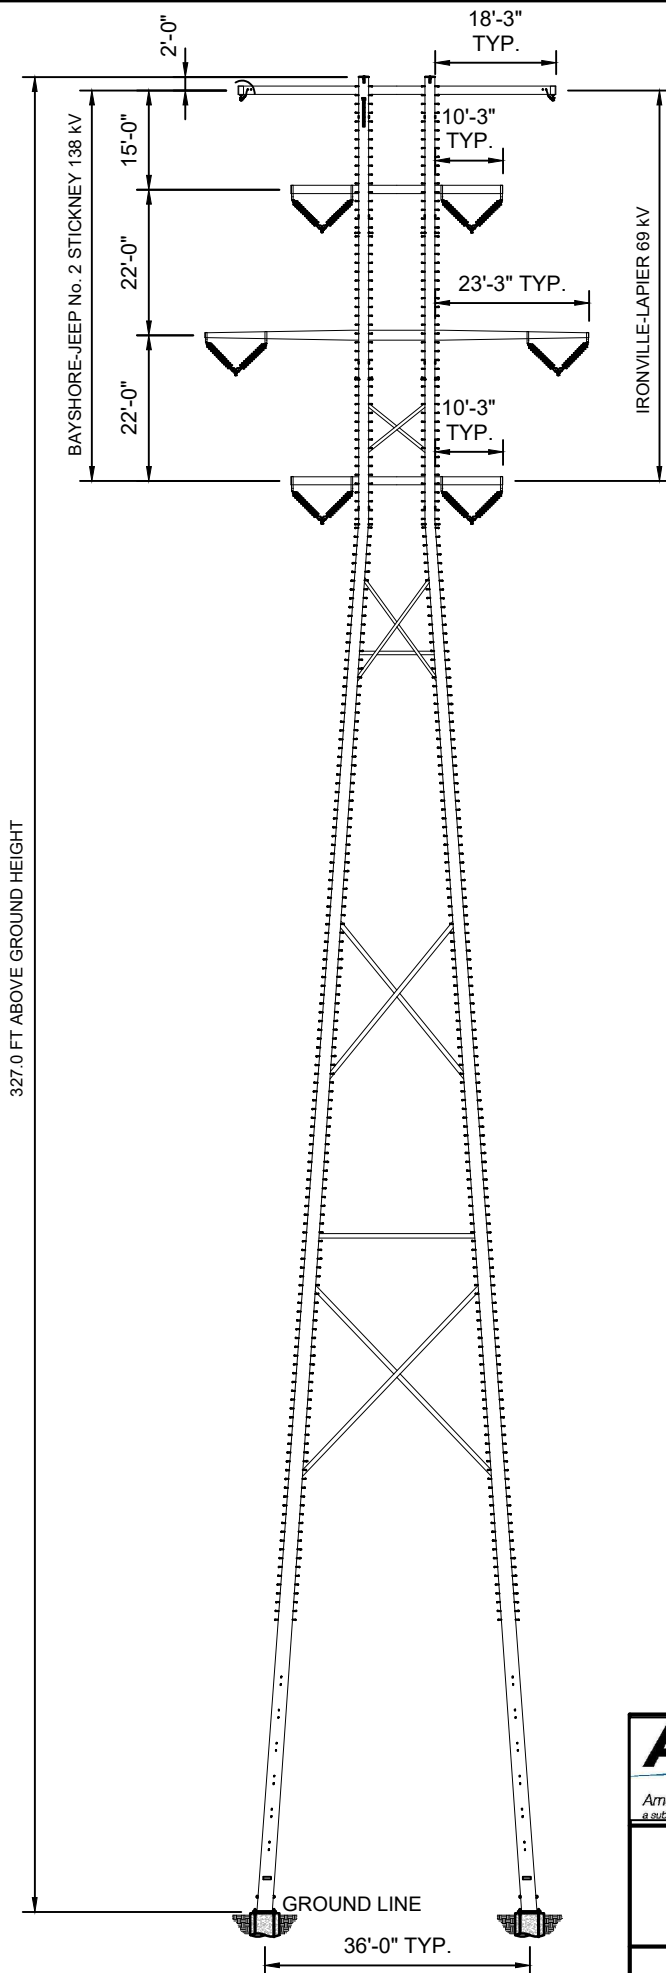
EXHIBIT 5

69 kV/138 kV DOUBLE CIRCUIT VALMONT PYRAMAX
 SUSPENSION TOWER STRUCTURE (No. 52)

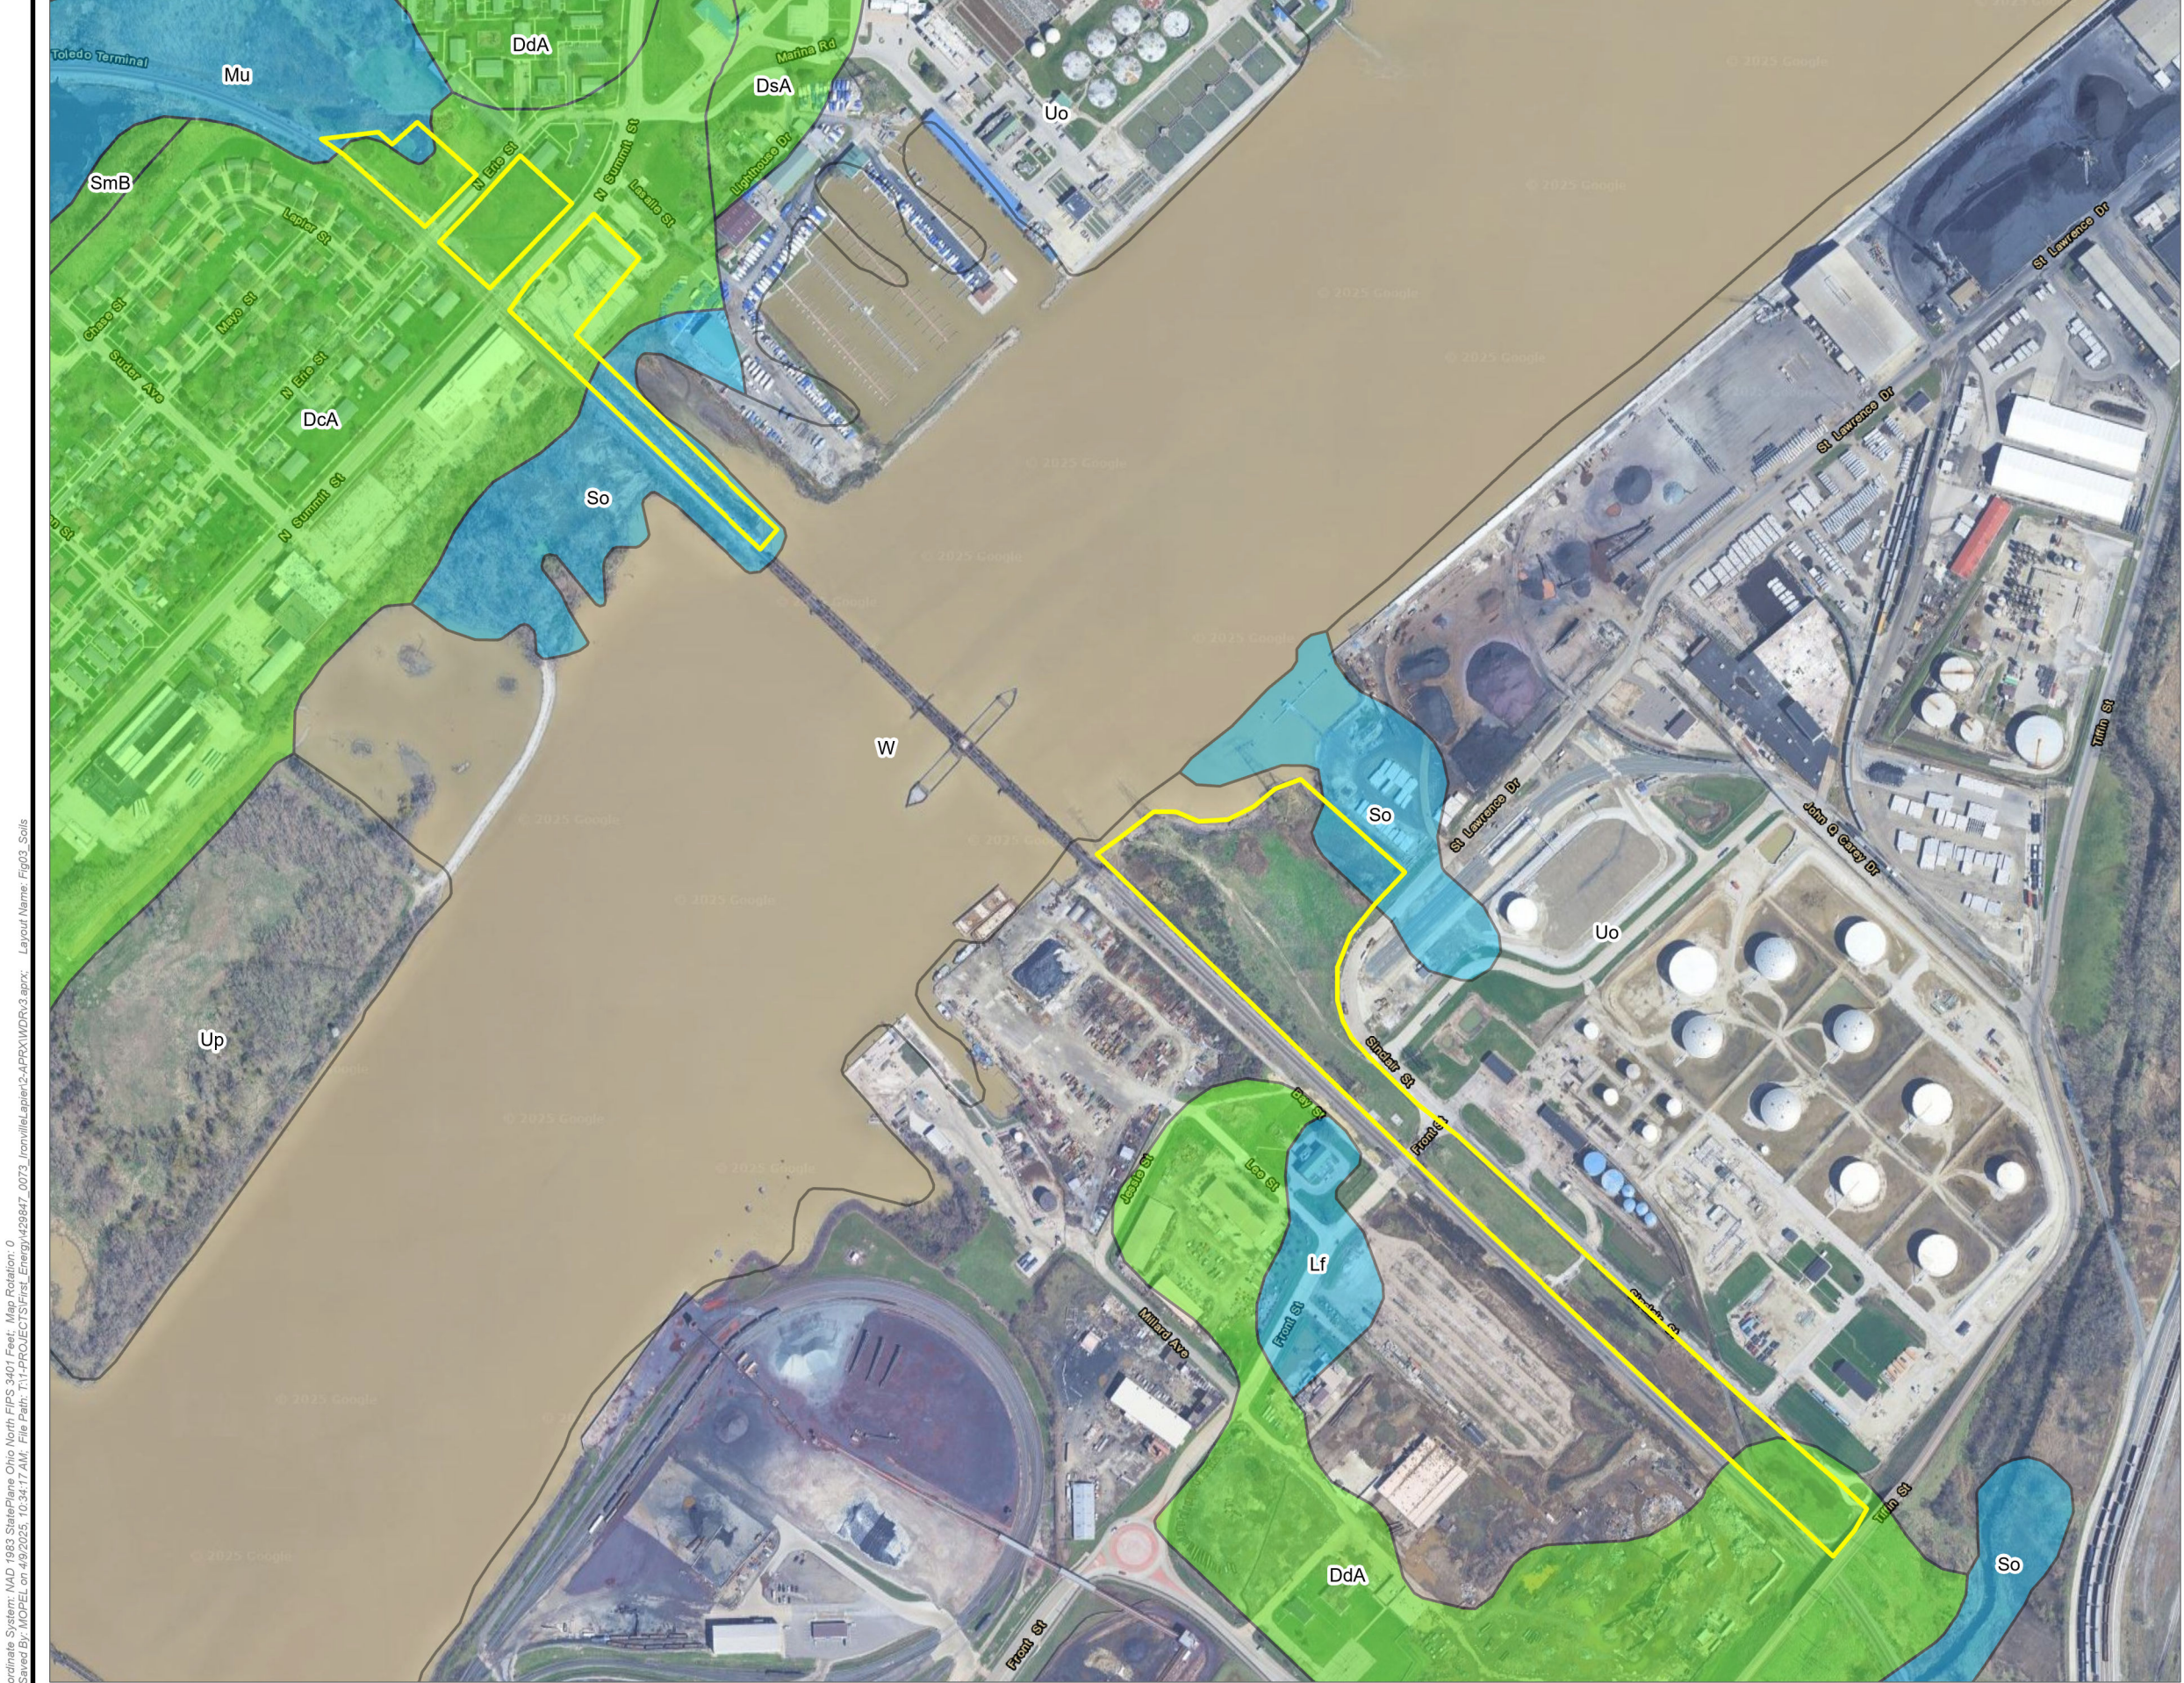
- PROJECT STUDY AREA
- HYDRIC SOIL
- NON-HYDRIC W/ HYDRIC INCLUSIONS SOIL
- NON-HYDRIC SOIL

PROJECT: FIRSTENERGY - IRONVILLE-LAPIER 69KV TOWER STRUCTURE REPLACEMENT PROJECT LUCAS COUNTY, OH	
TITLE: SOILS MAP	
DRAWN BY: M. OPEL	PROJ. NO.: 429847.0073
CHECKED BY: M. MOLNAR	FIGURE 3
APPROVED BY: B. FALKINBURG	
DATE: APRIL 2025

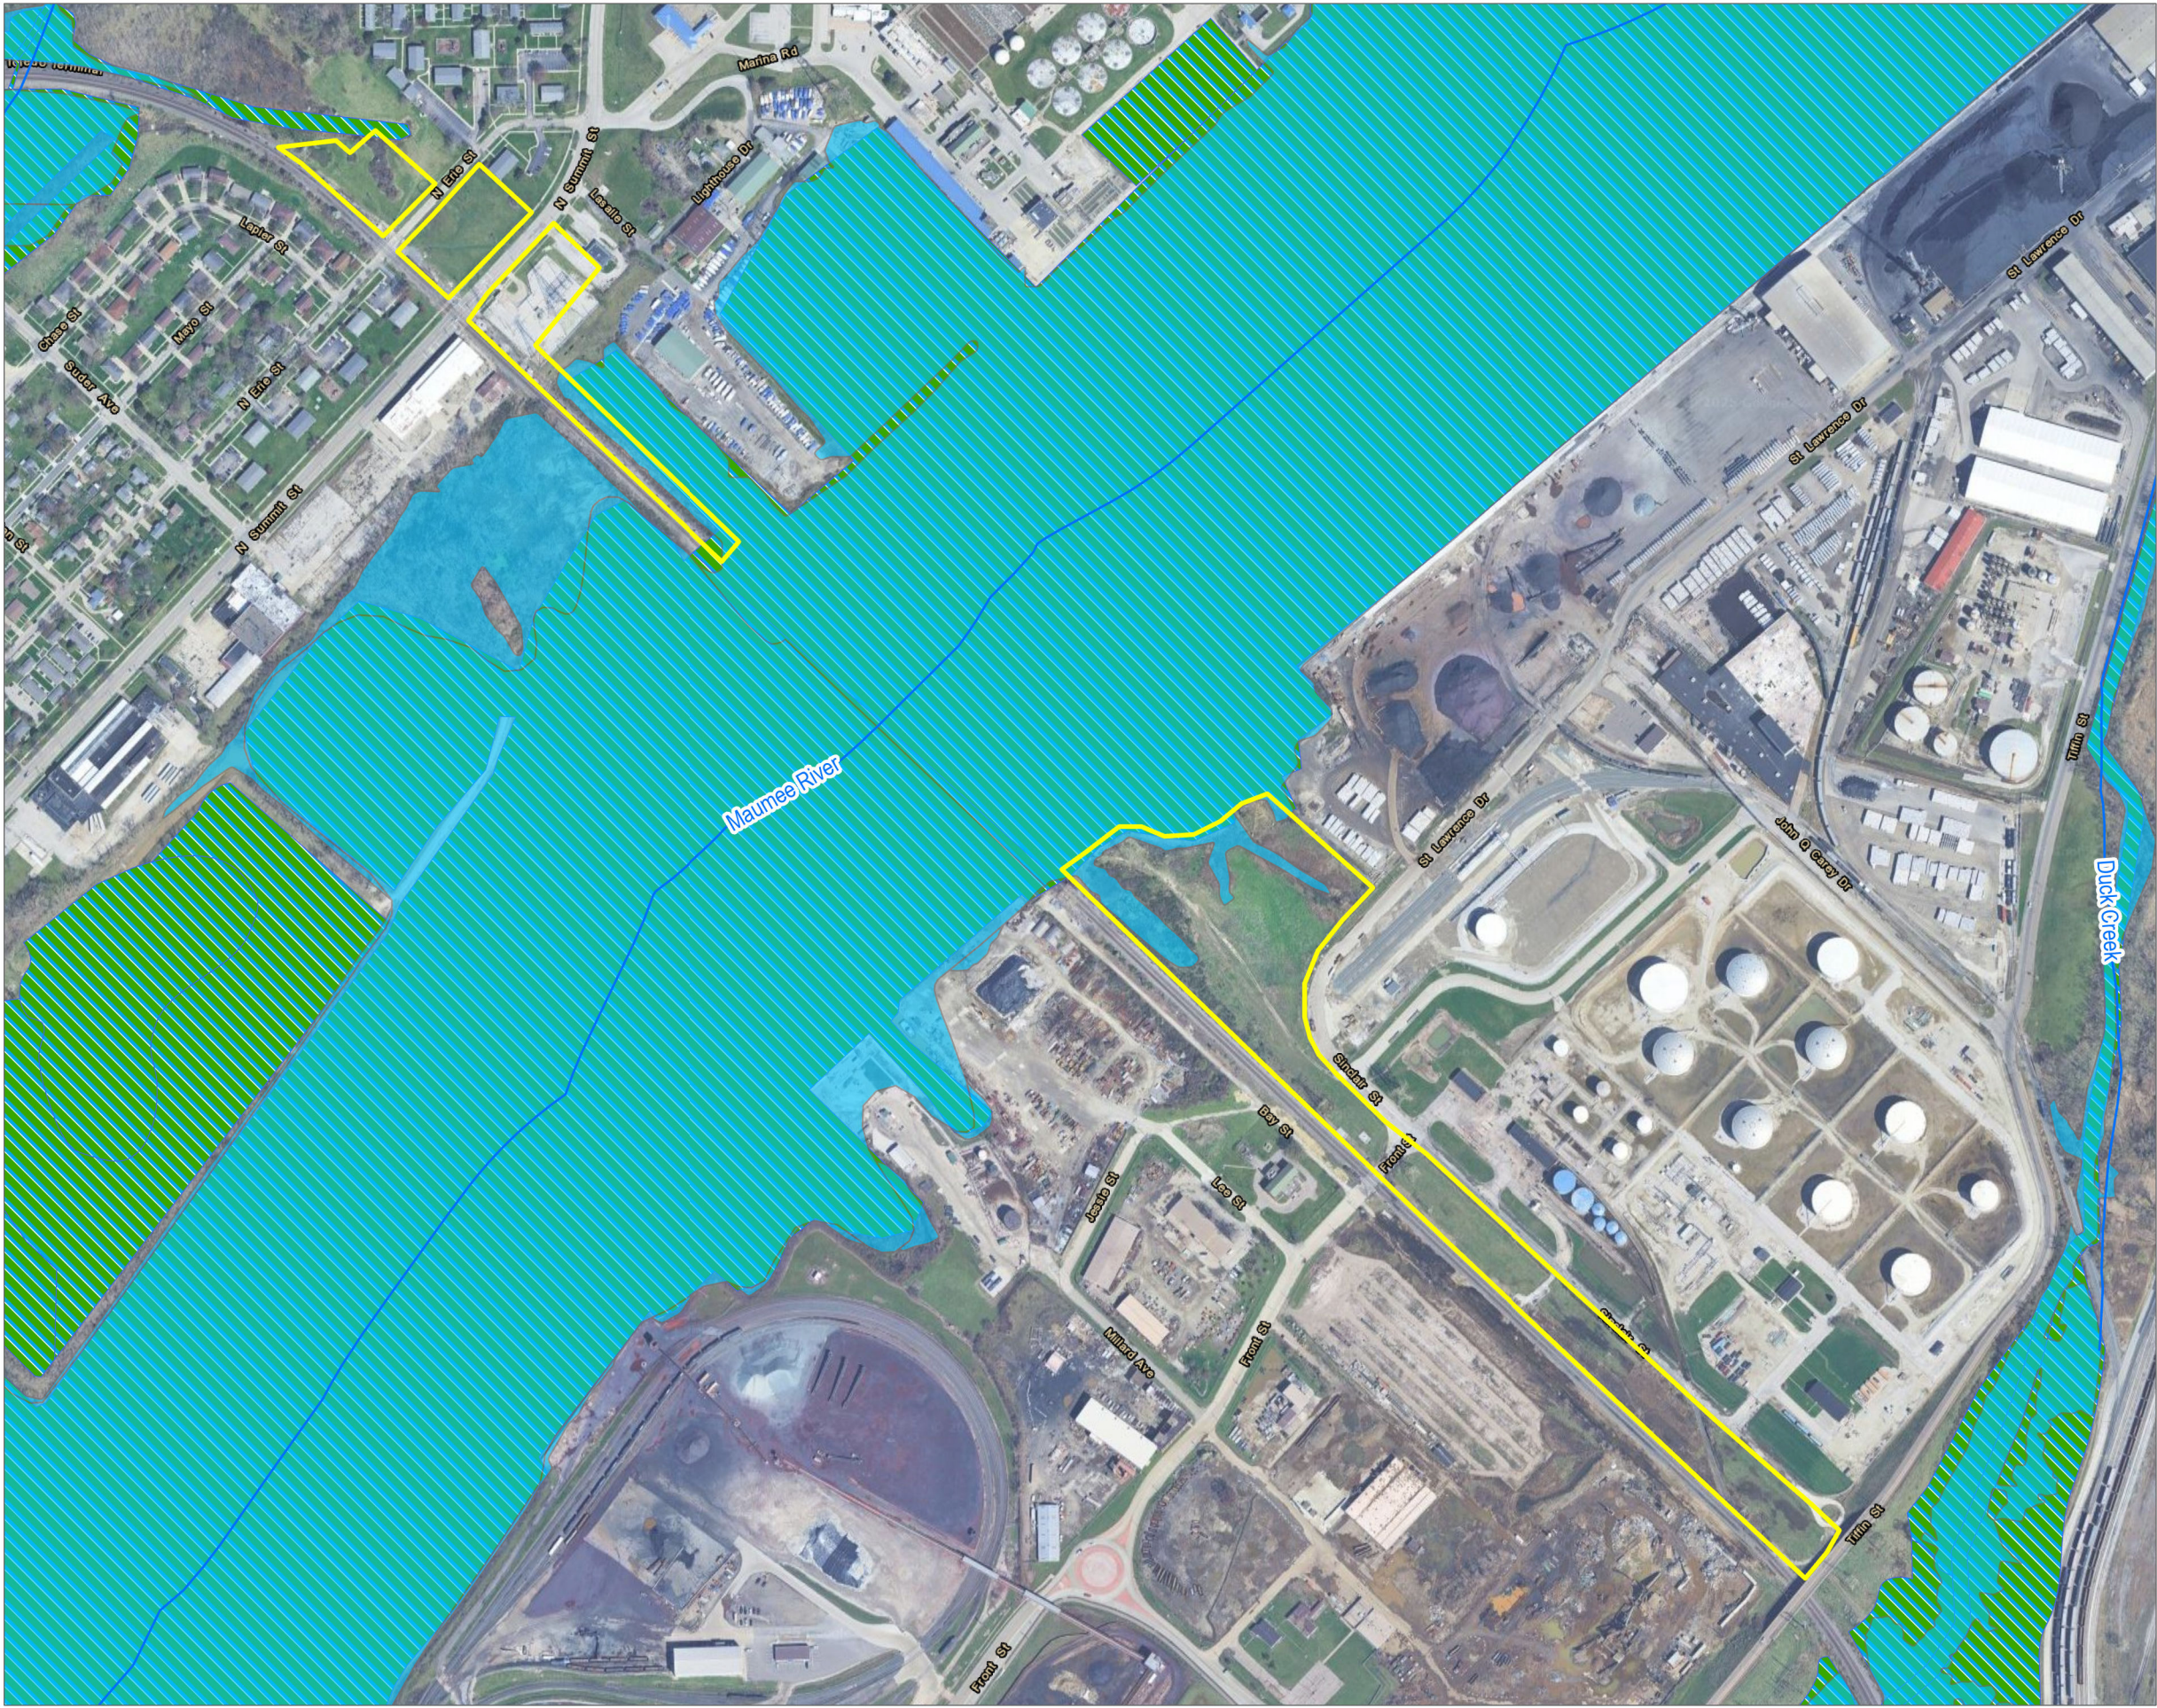
- PROJECT STUDY AREA
- NATIONAL HYDROGRAPHY DATASET (NHD) STREAM
- NATIONAL WETLANDS INVENTORY (NWI) FEATURE
- 100-YEAR FLOOD ZONE

PROJECT: FIRSTENERGY - IRONVILLE-LAPIER 69KV TOWER STRUCTURE REPLACEMENT PROJECT LUCAS COUNTY, OH		
TITLE: NHD, NWI AND FEMA FLOODPLAIN MAP		
DRAWN BY: M. OPEL	PROJ. NO.: 429847.0073	FIGURE 4
CHECKED BY: M. MOLNAR		
APPROVED BY: B. FALKINBURG		
DATE: APRIL 2025

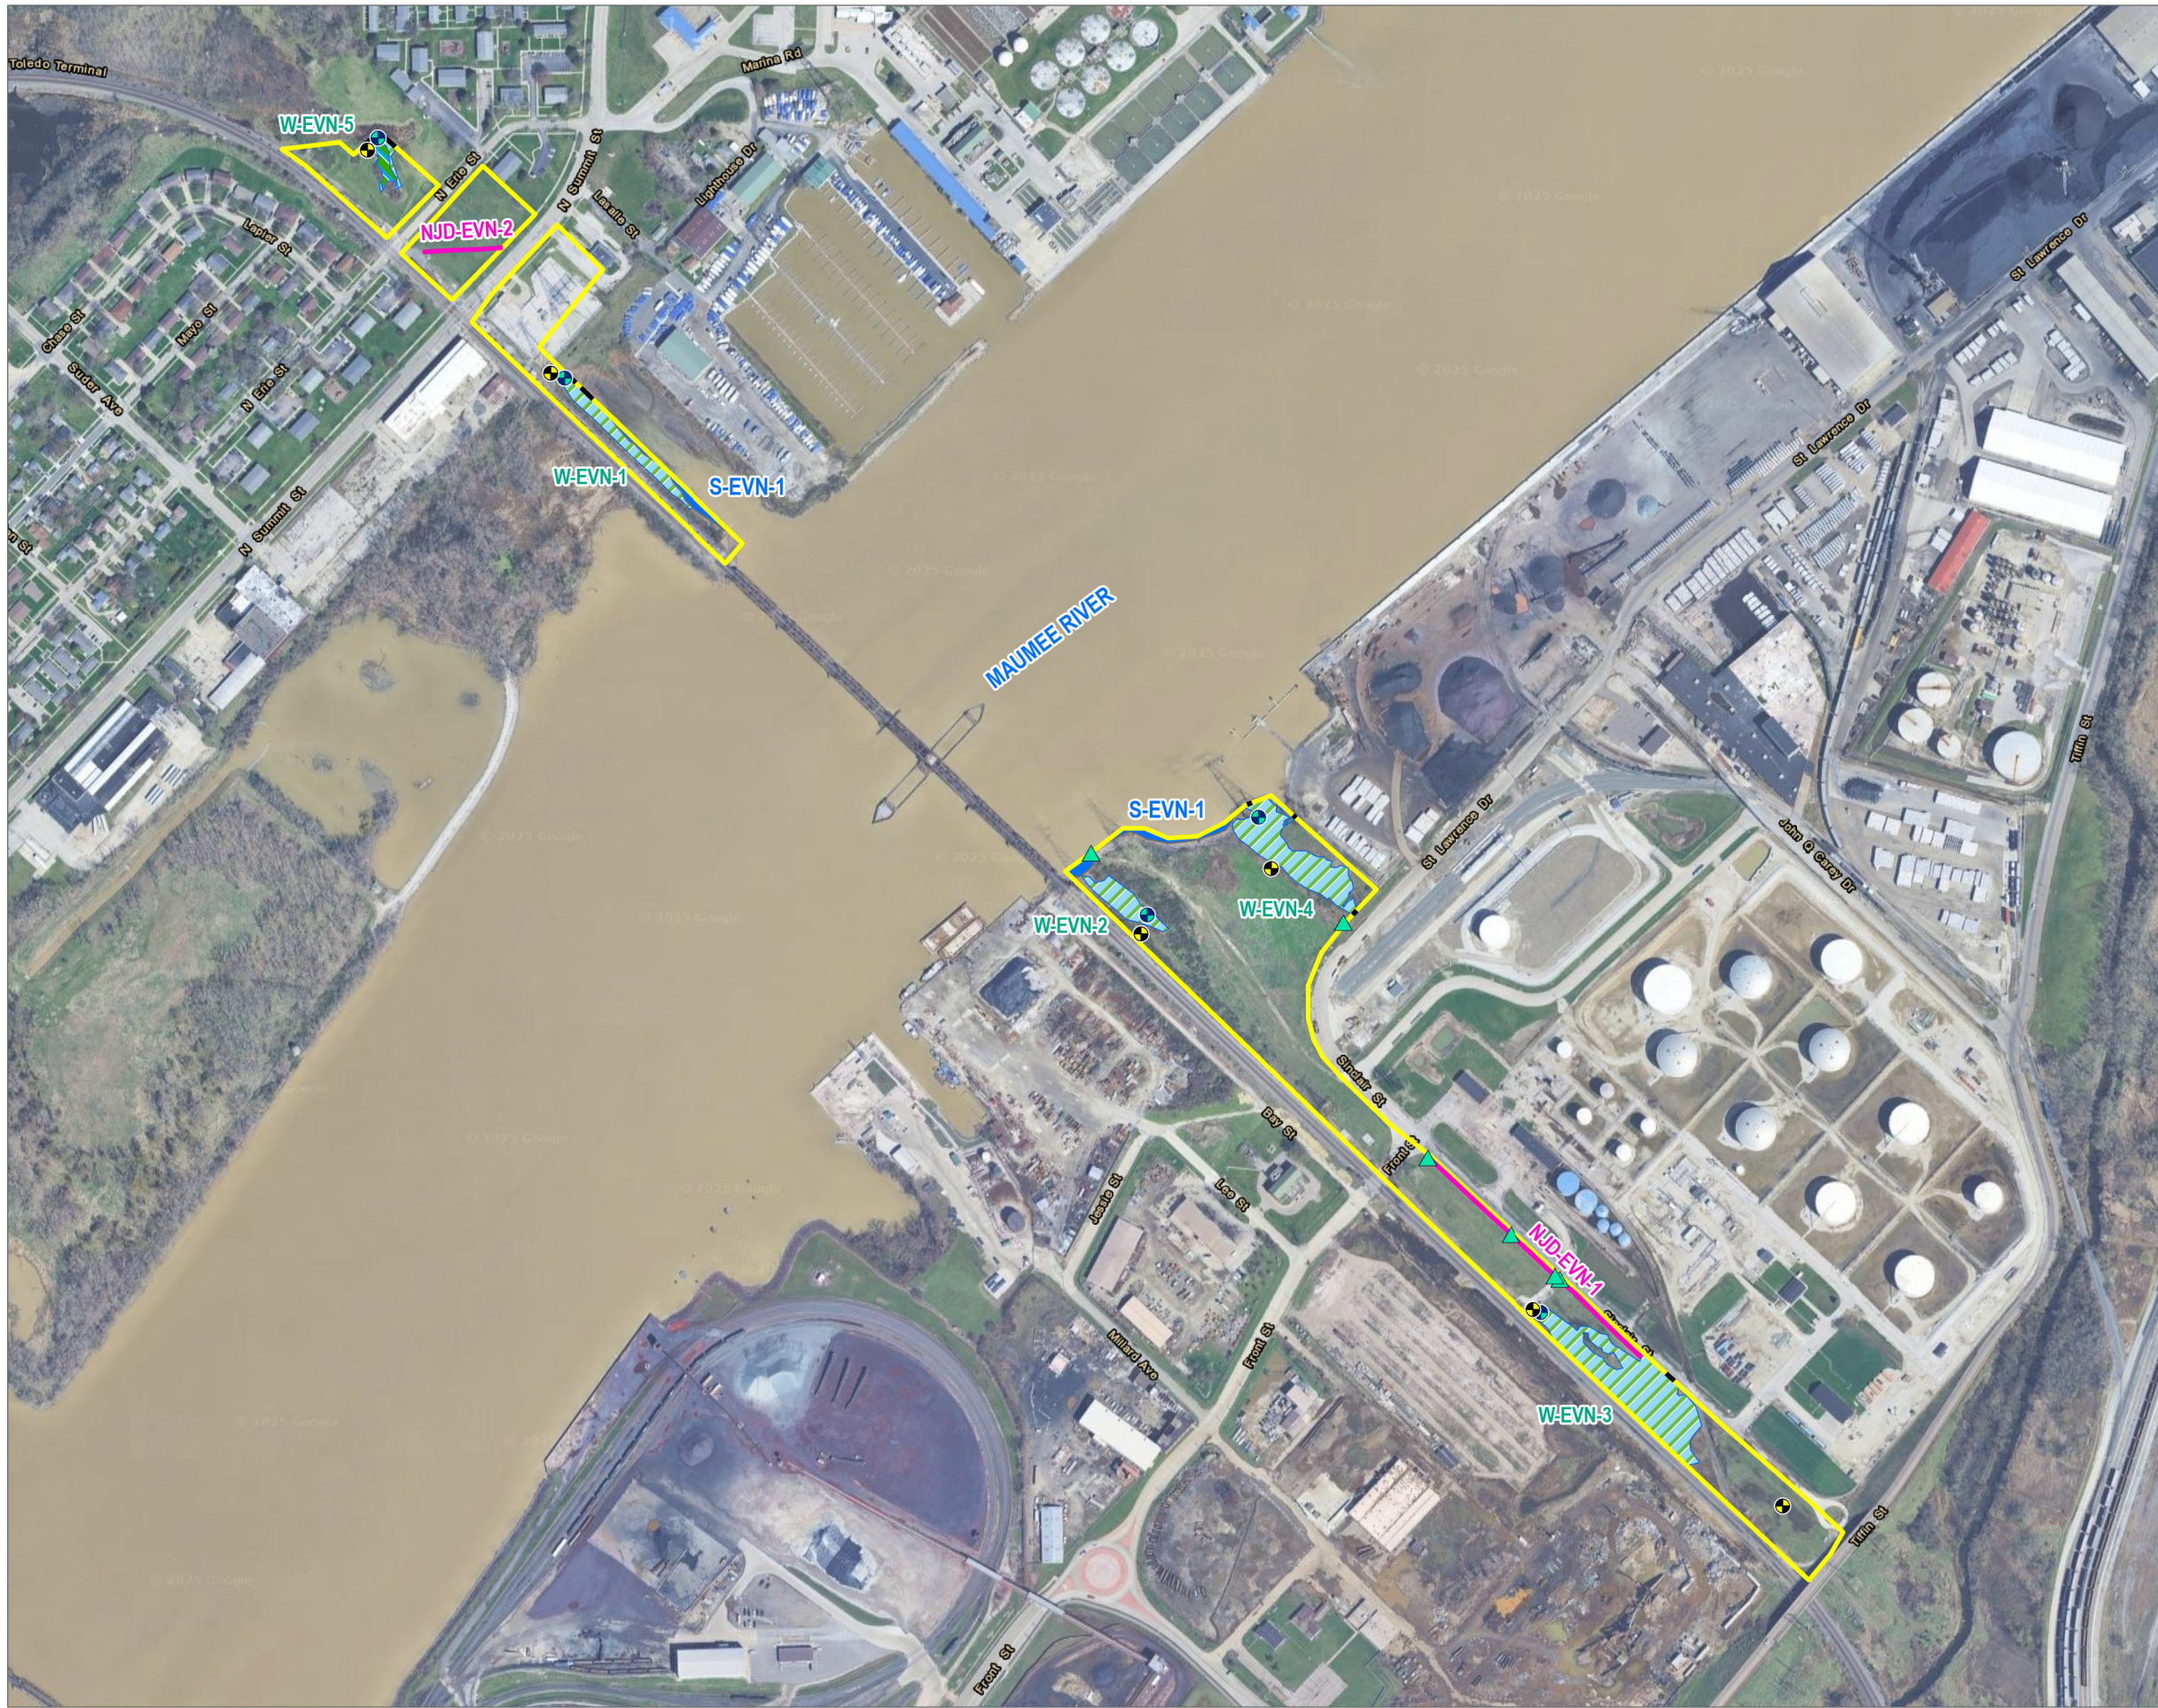
- PROJECT STUDY AREA
- CULVERT
- NON-JURISDICTIONAL DRAINAGE
- PERENNIAL STREAM
- PEM WETLAND
- PFO WETLAND
- WETLAND CONTINUES
- WETLAND DATA POINT
- UPLAND DATA POINT

PROJECT: FIRSTENERGY - IRONVILLE-LAPIER 69KV TOWER STRUCTURE REPLACEMENT PROJECT LUCAS COUNTY, OH			
TITLE: DELINEATED RESOURCES MAP			
DRAWN BY: M. OPEL		PROJ. NO.: 429847.0073	
CHECKED BY: M. MOLNAR		FIGURE 5	
APPROVED BY: B. FALKINBURG			
DATE: APRIL 2025

During the field investigation, one (1) Section 10 Navigable Water (S-EVN-1, Maumee River) was delineated within the Project Study Area. A detailed summary of the waterbody resource identified is provided in **Table 3** and **Appendix A, Figure 5**. Data points were recorded to provide a characterization of the delineated waterbody resource located within the Project Study Area. Representative photographs of the described waterbody identified within the Project Study Area can be found in **Appendix B**.
