**AMERICAN TRANSMISSION SYSTEMS,
INCORPORATED
A FIRSTENERGY COMPANY**

CONSTRUCTION NOTICE

**CHAMBERLAIN-WEST AKRON 138 KV TRANSMISSION
LINE SWITCH REPLACEMENT PROJECT**

OPSB Case No. 24-0079-EL-BNR

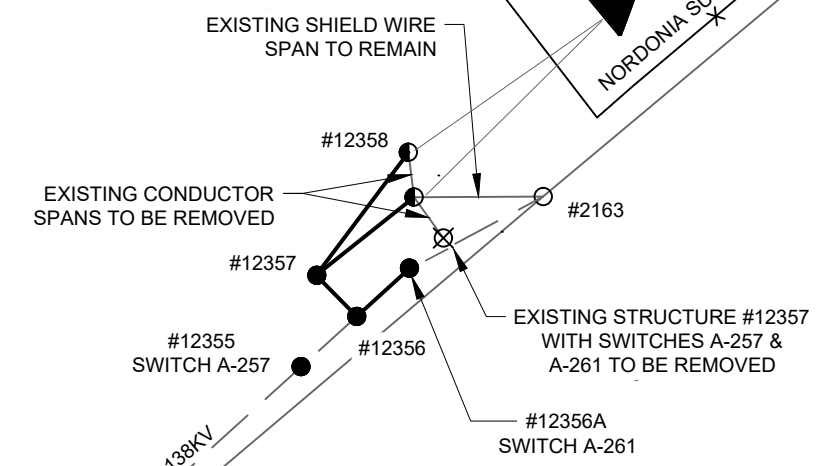
EXHIBIT 3

CHAMBERLIN-WEST AKRON 138KV, 138KV-REPLACE-LINE-SWITCHES A-261 AND A-257, EX. 3

The location of the Project relative to existing or proposed lines is shown in the ATSI Transmission Network Map, included as part of the confidential portion of the FirstEnergy Corp. 2023 Long-Term Forecast Report. This map was submitted to the Public Utilities Commission of Ohio (“PUCO”) in Case No. 23-0504-EL-FOR under Rule 4901:5-5:04 (C)(2)(b) of the Ohio Administrative Code. This map is incorporated by reference only. This Project is not included in the 2023 Long-Term forecast Report because the Project does not entail any topology or rating change. The general location of the Project area is shown in Exhibits 1 and 2. The general layout of the Project is shown in Exhibit 3.

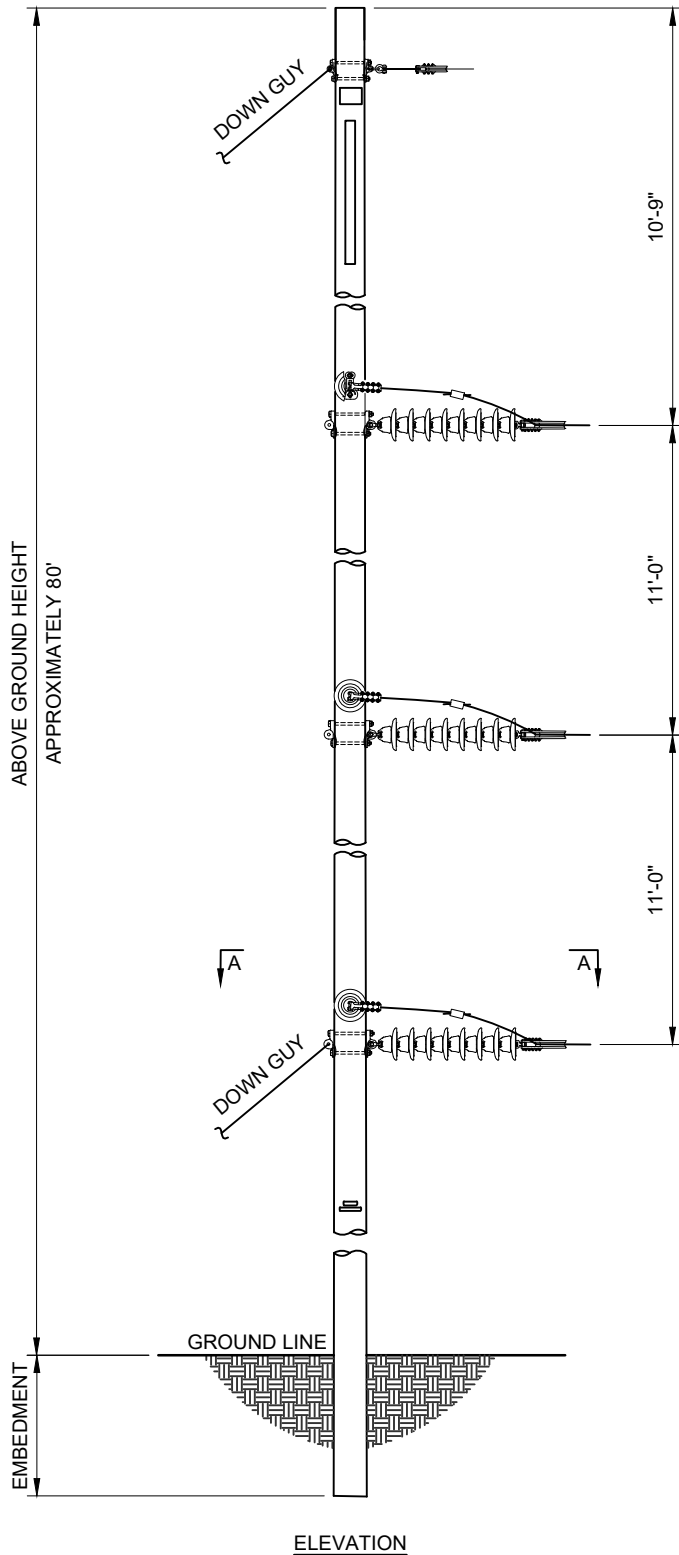
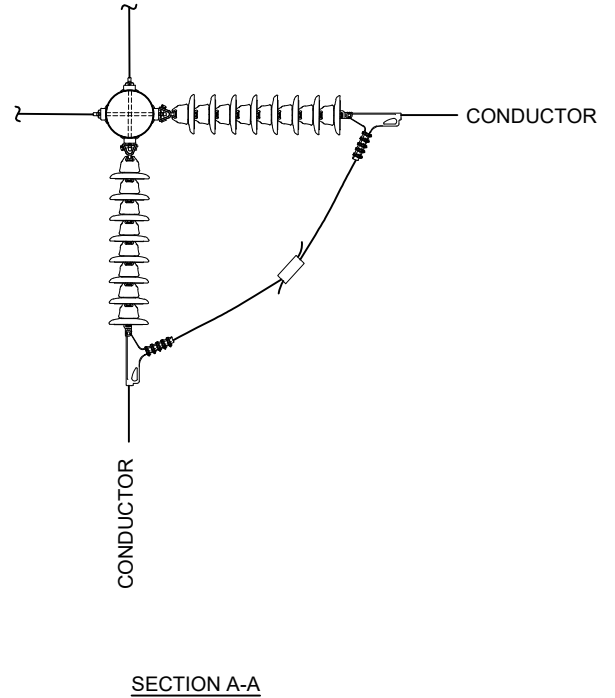
EXHIBIT 4

138 KV SINGLE CIRCUIT WOOD POLE STRUCTURE DEADEND
VERTICAL SINGLE POLE ANGLES 60° TO 120°
STRUCTURE 12357

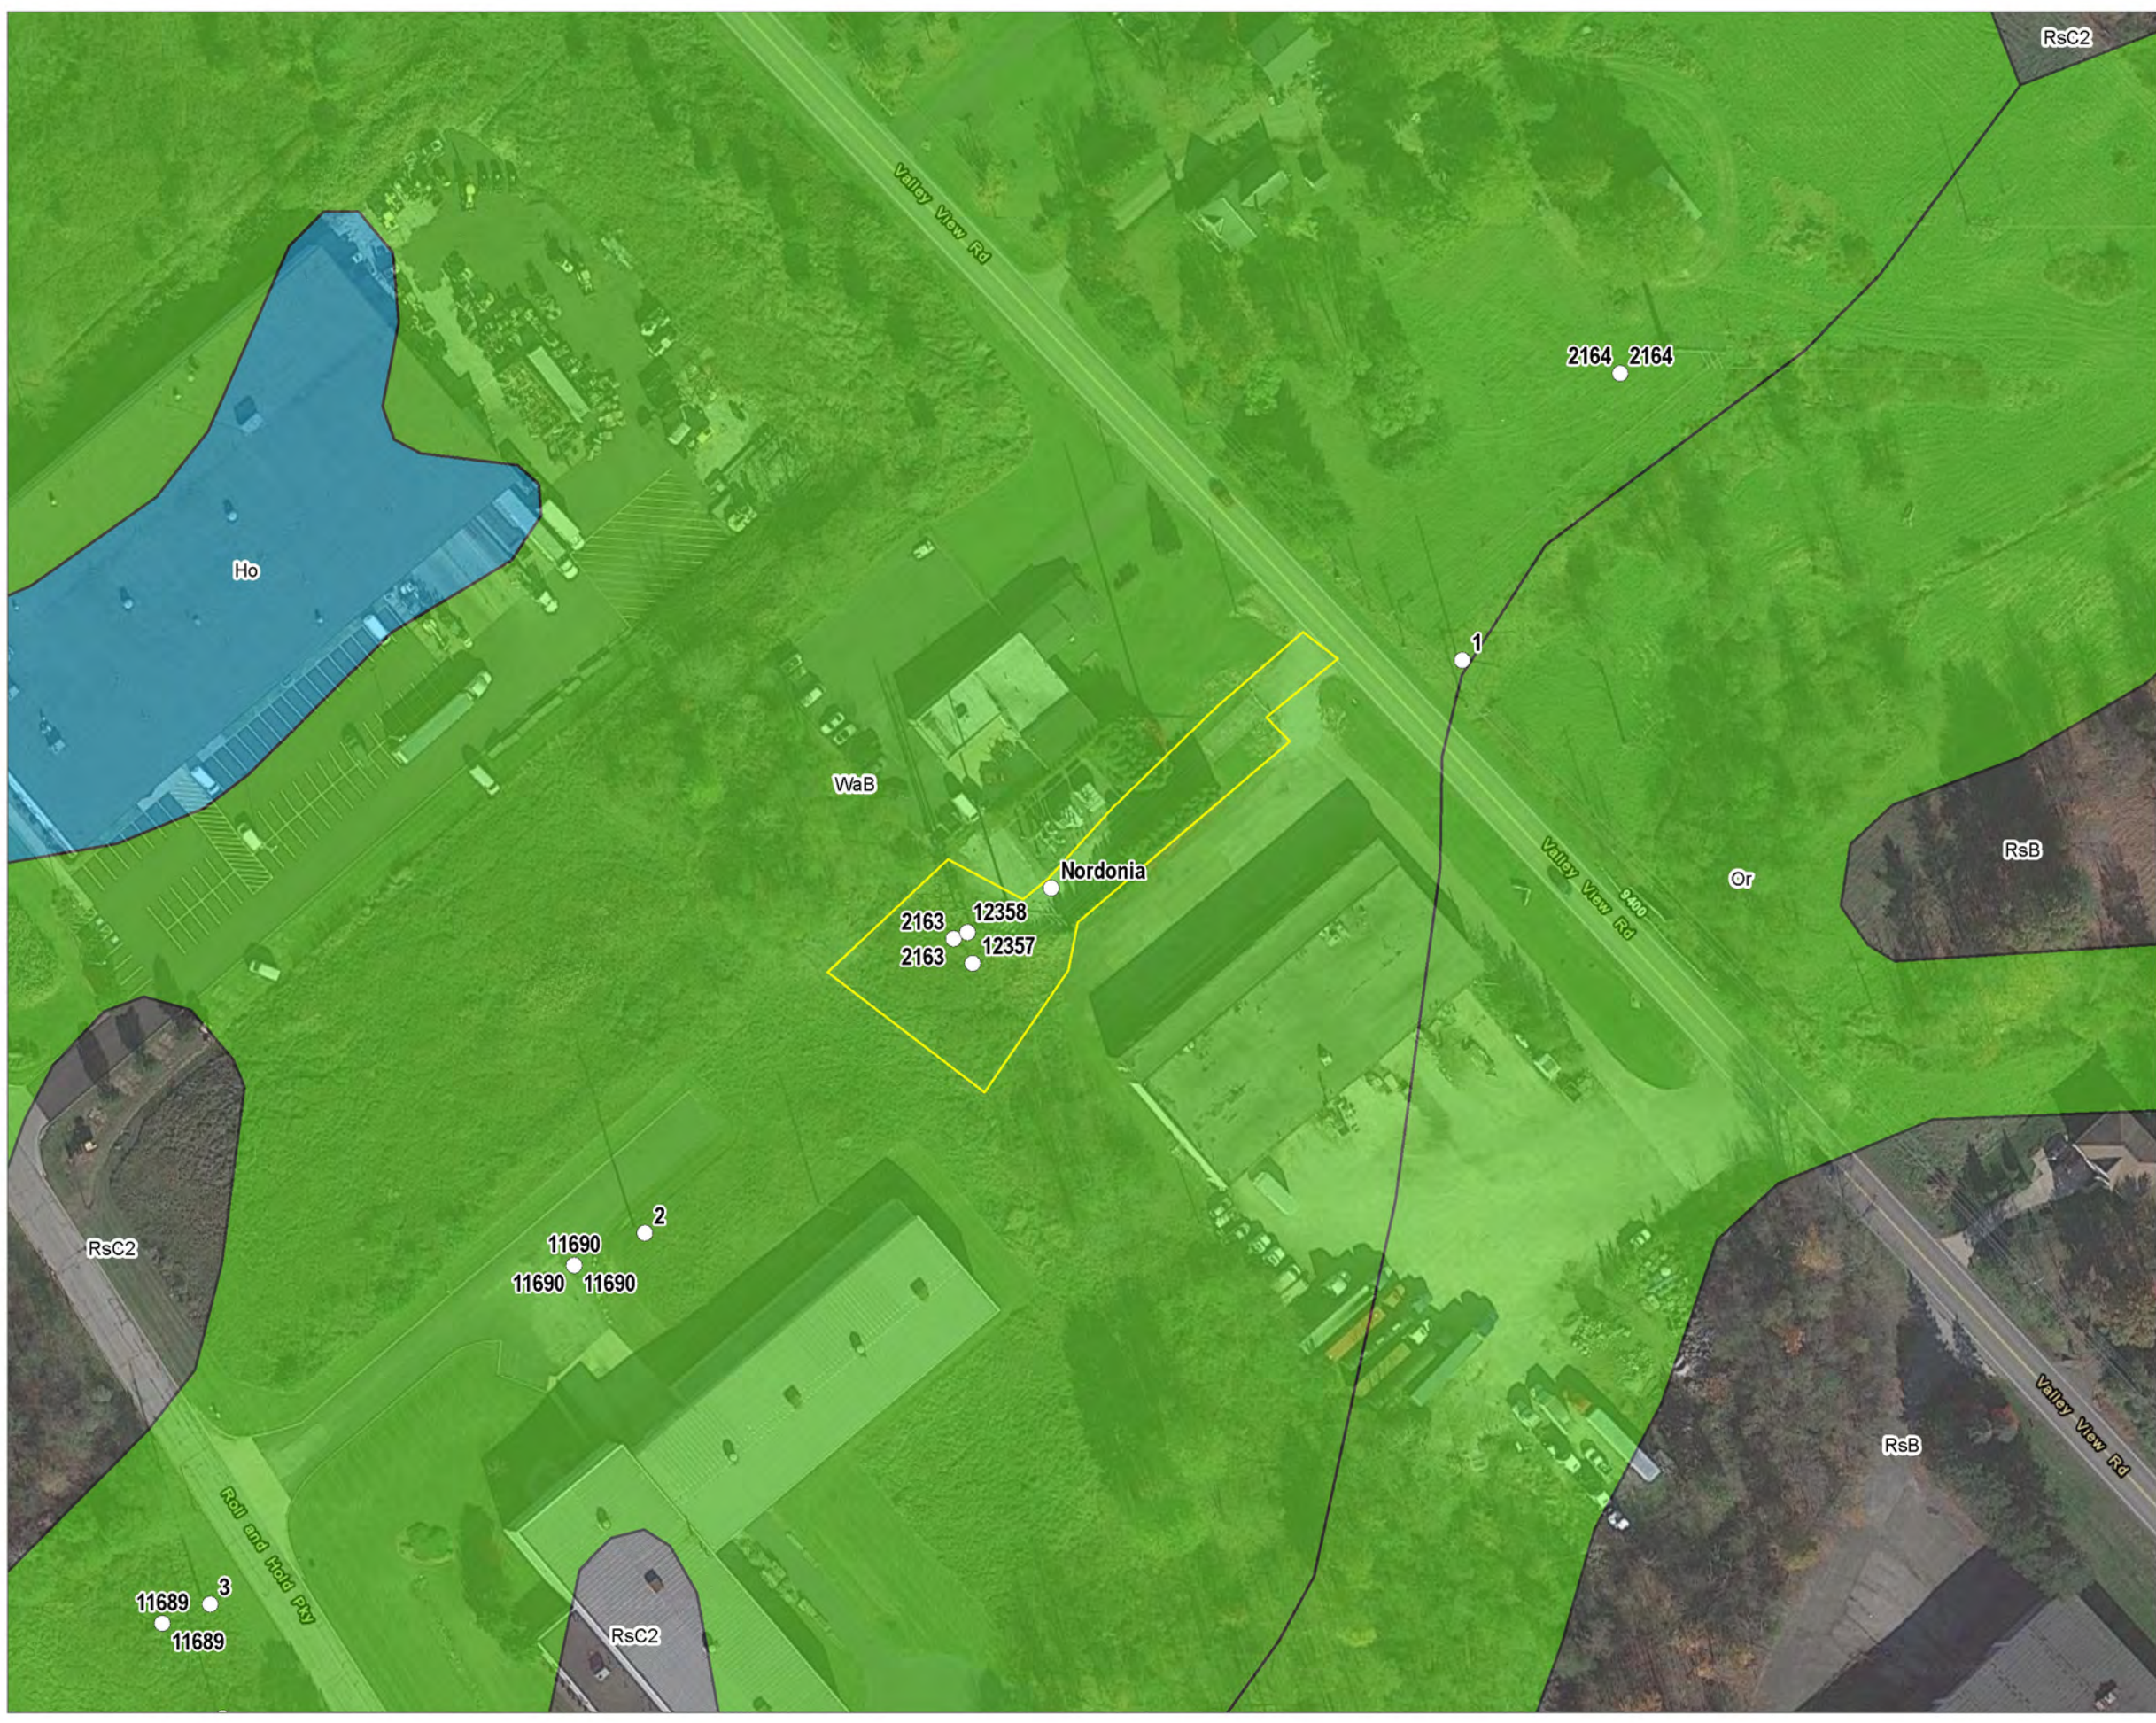
- PROJECT STUDY AREA
- EXISTING STRUCTURE
- HYDRIC SOIL
- NON-HYDRIC W/ HYDRIC INCLUSIONS SOIL
- NON-HYDRIC SOIL

BASE MAP: GOOGLE MAPS
 DATA SOURCES: SOILS DATA ACQUIRED FROM USDA/NRCS SSURGO DATABASE

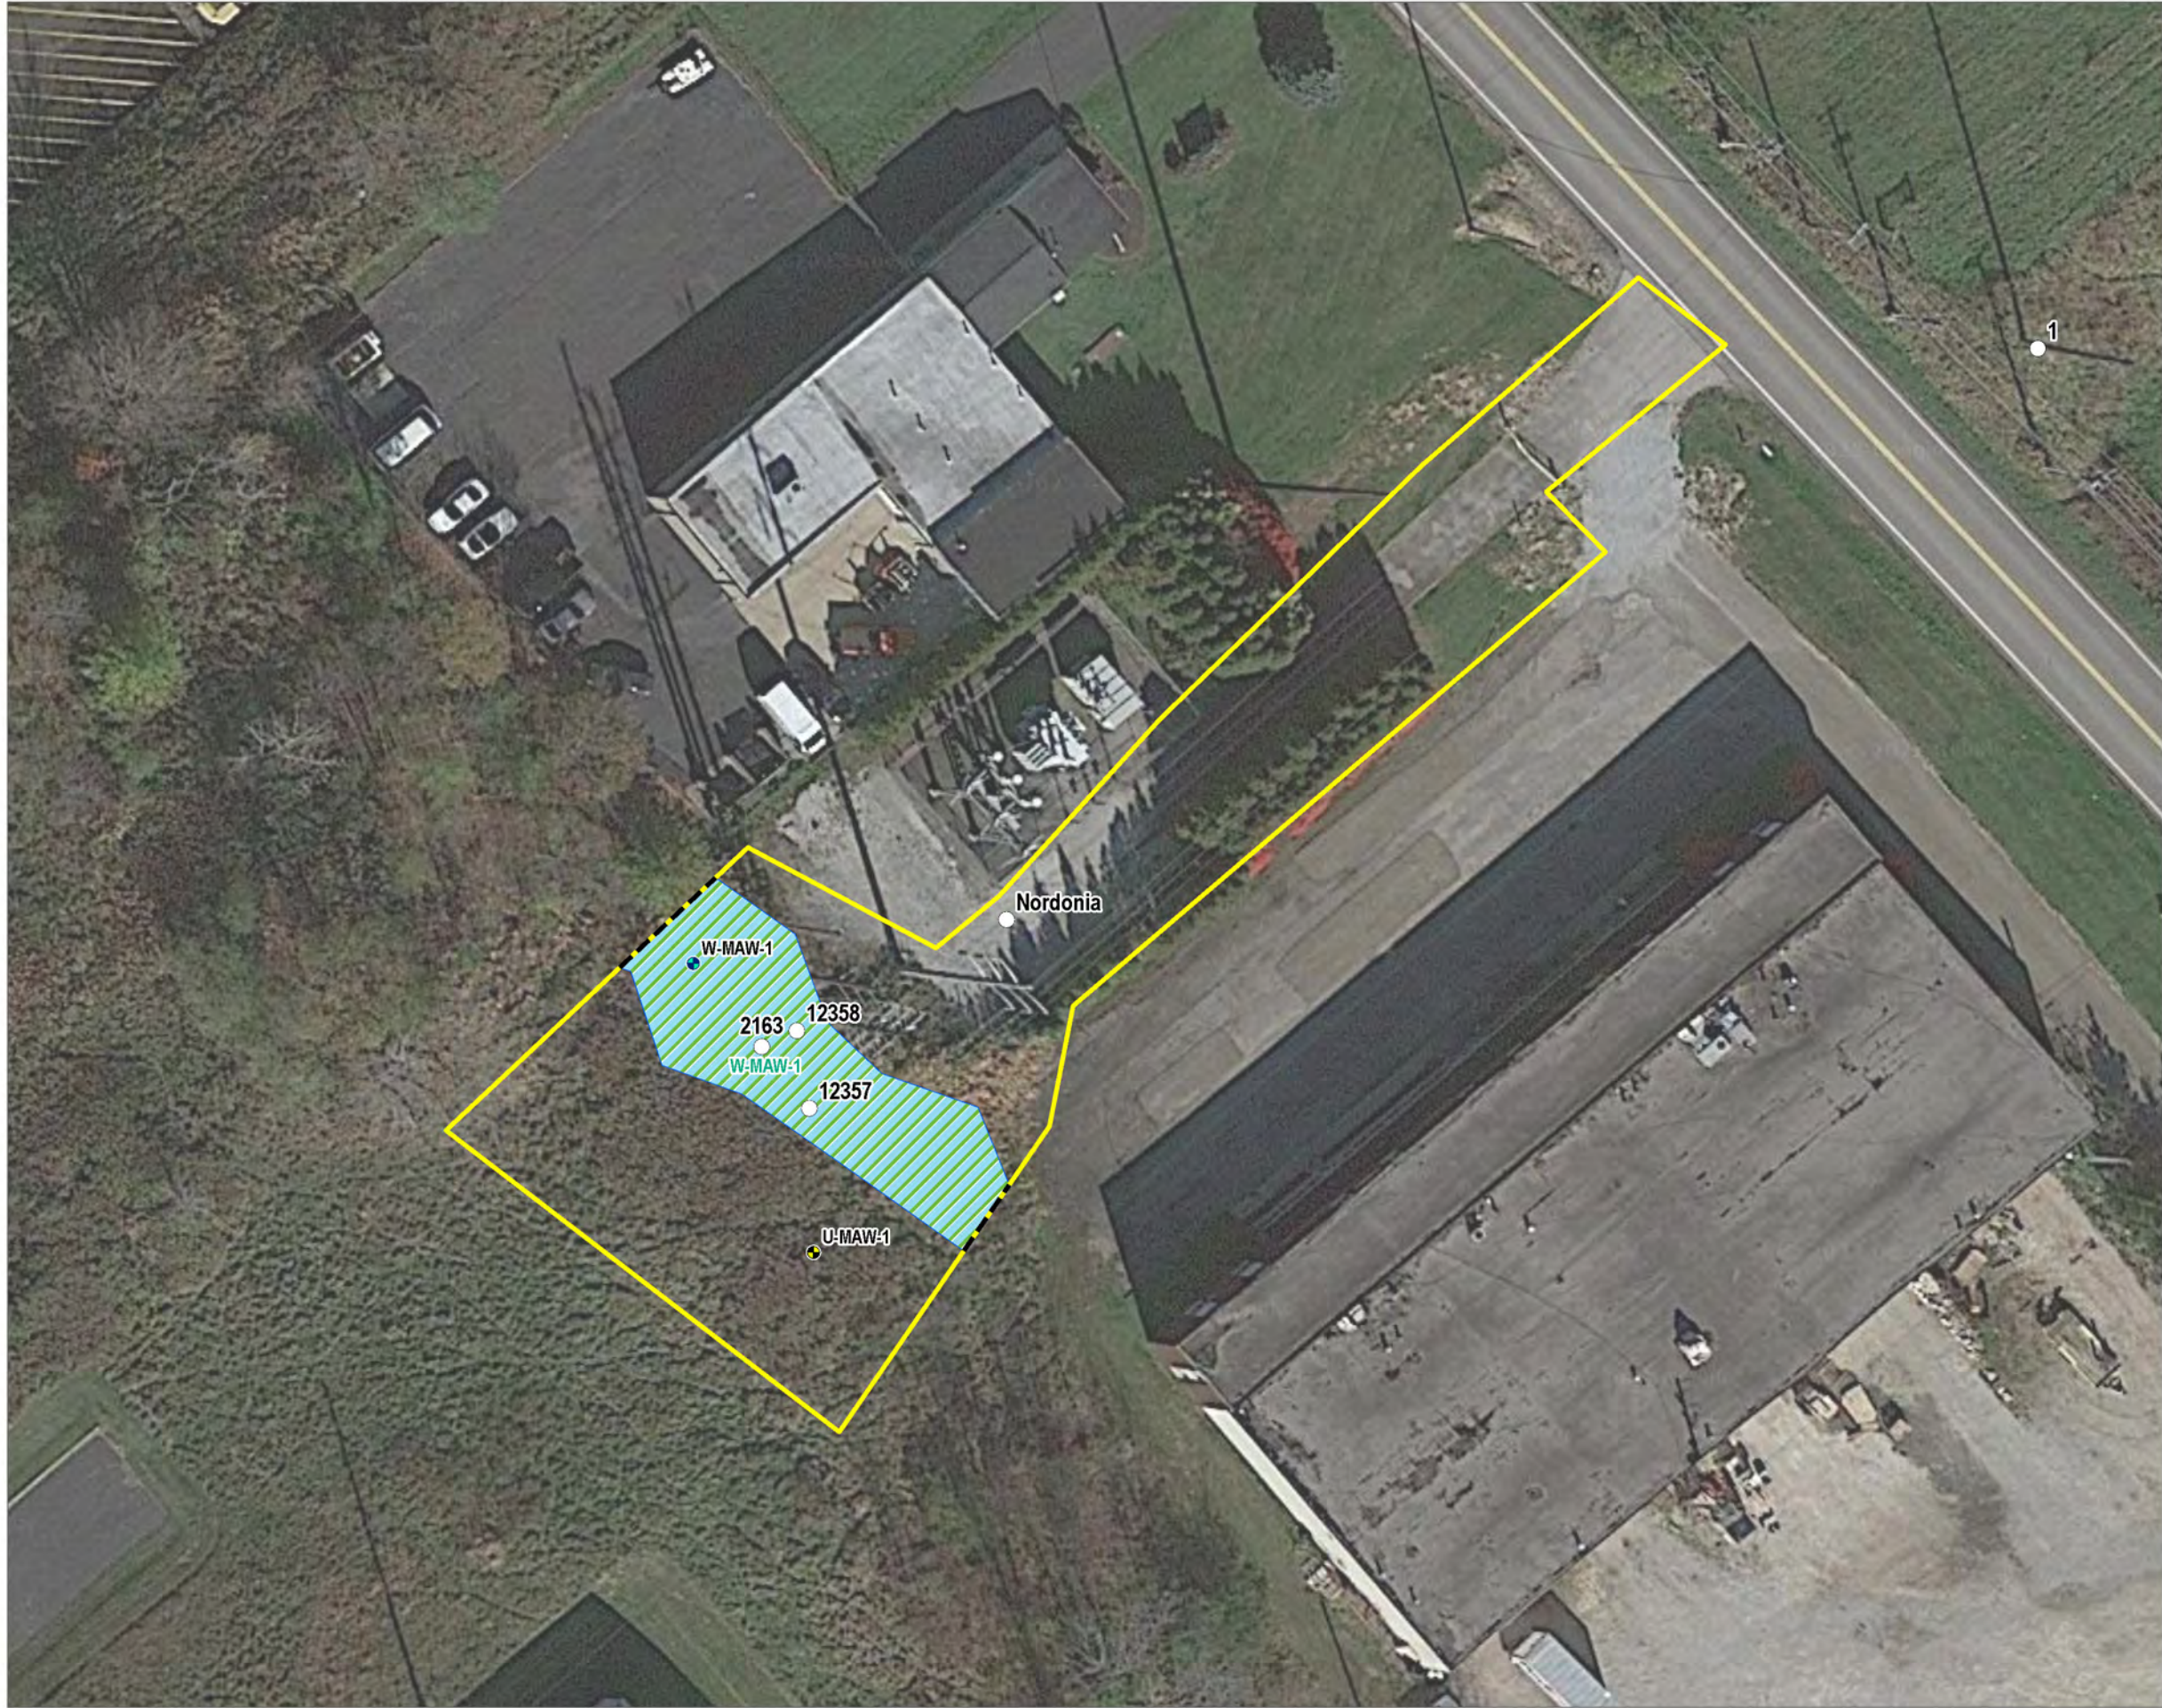
- PROJECT STUDY AREA
- EXISTING STRUCTURE
- PEM WETLAND
- WETLAND CONTINUES
- WETLAND DATA POINT
- UPLAND DATA POINT

BASE MAP: GOOGLE MAPS.
 DATA SOURCES: TRC WETLAND DELINEATION COMPLETED JULY 21, 2023.

The ODNR and USFWS comments did not identify any areas of ecological concern. On July 21, 2023, TRC biologists conducted a wetland and waterways delineation for the Chamberlin-West Akron 138kV Switch Replacement Project. The Project Study Area is approximately 0.43-acre, located in the City of Macedonia, Summit County, Ohio. One (1) palustrine emergent wetland feature (Wetland W-MAW-1), totaling 0.07-acre in size, was identified and delineated within the Project Study Area. Wetland W-MAW-1 was evaluated utilizing OEPA's Ohio Rapid Assessment Method and scored as a Category 1 wetland with a score of 21. Wetland W-MAW-1 is of very low quality and was found to be dominated by non-native/invasive species (*Phragmites australis*).

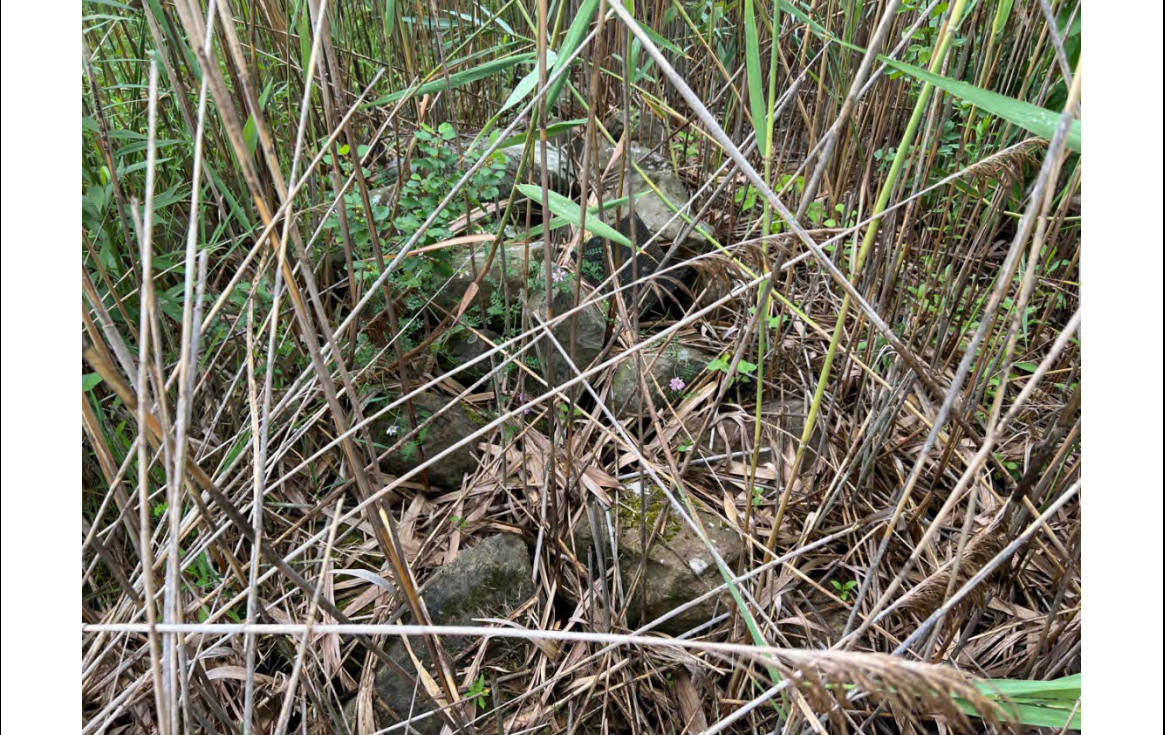
Photo No. 9.

Description:
Large rock fill located within Wetland W-MAW-1.

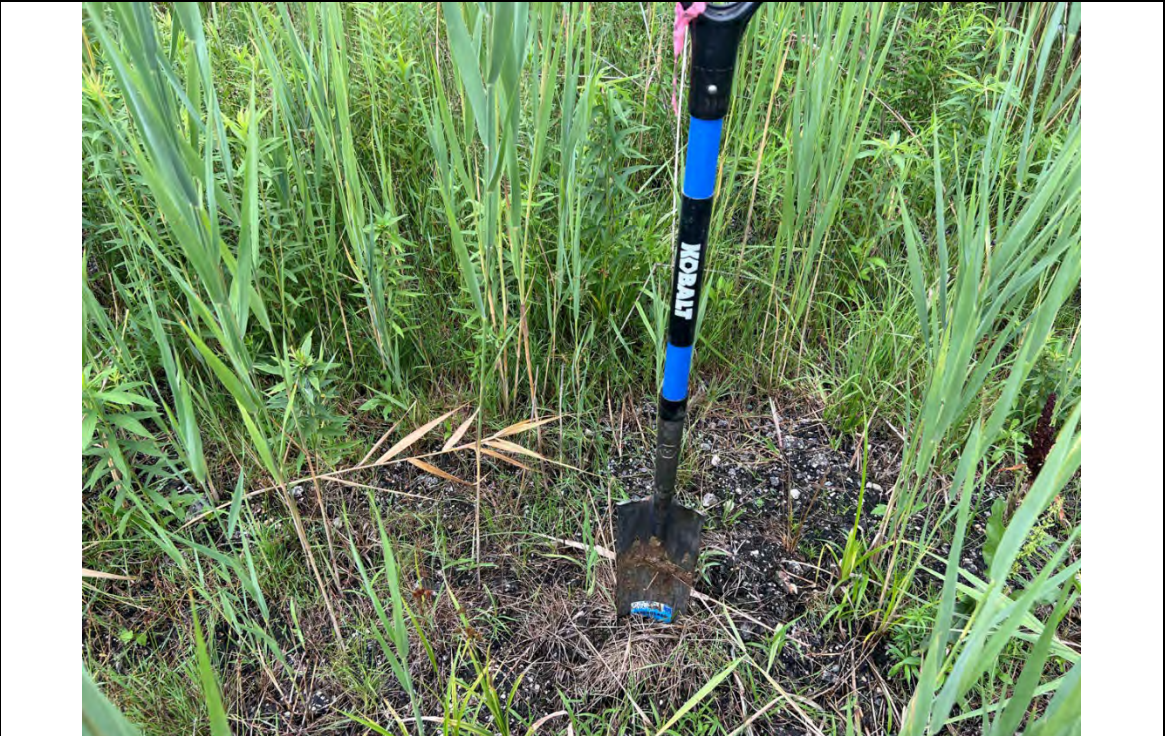
Photo No. 10.

Description:
Asphalt fill located within the southern extent of Wetland W-MAW-1.
