**AMERICAN TRANSMISSION SYSTEMS, INCORPORATED
A FIRSTENERGY COMPANY**

CONSTRUCTION NOTICE

**DOBBINS-TORONTO 138kV-TRANSMISSION LINE
TOWER REPLACEMENT PROJECT**

OPSB Case No.: 26-0141-EL-BNR

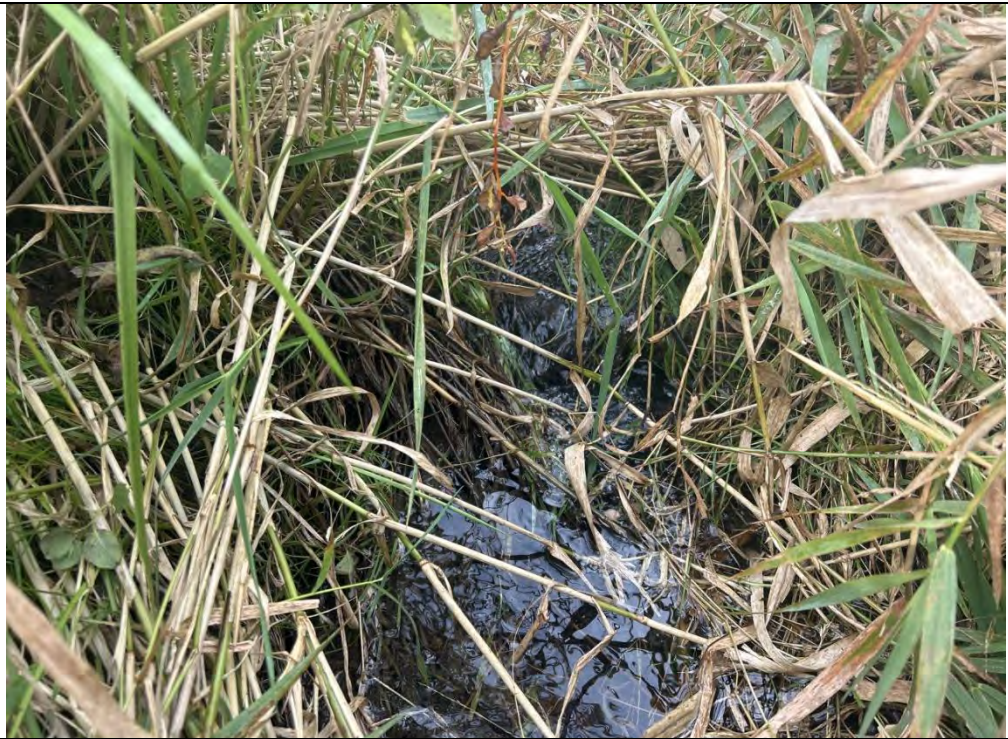
Photo No. 1.
Photo Date: 10/19/2023
Description: Stream S-EKG-1 (intermittent), looking upstream, facing west.

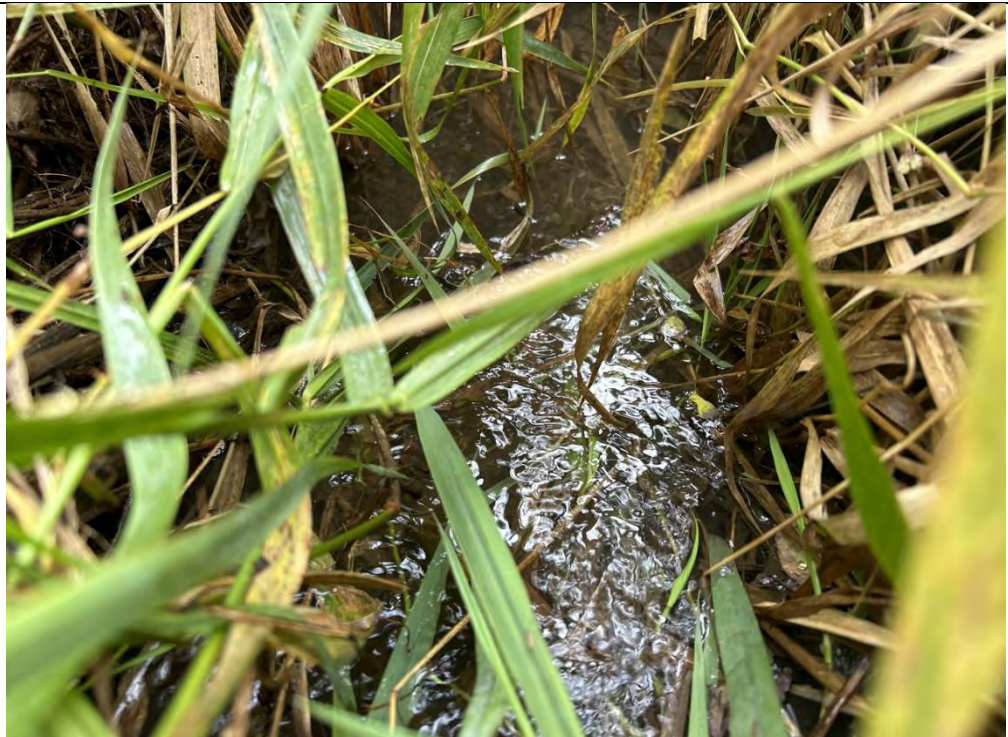
Photo No. 2.
Photo Date: 10/19/2023
Description: Stream S-EKG-1 (intermittent), looking downstream, facing east.

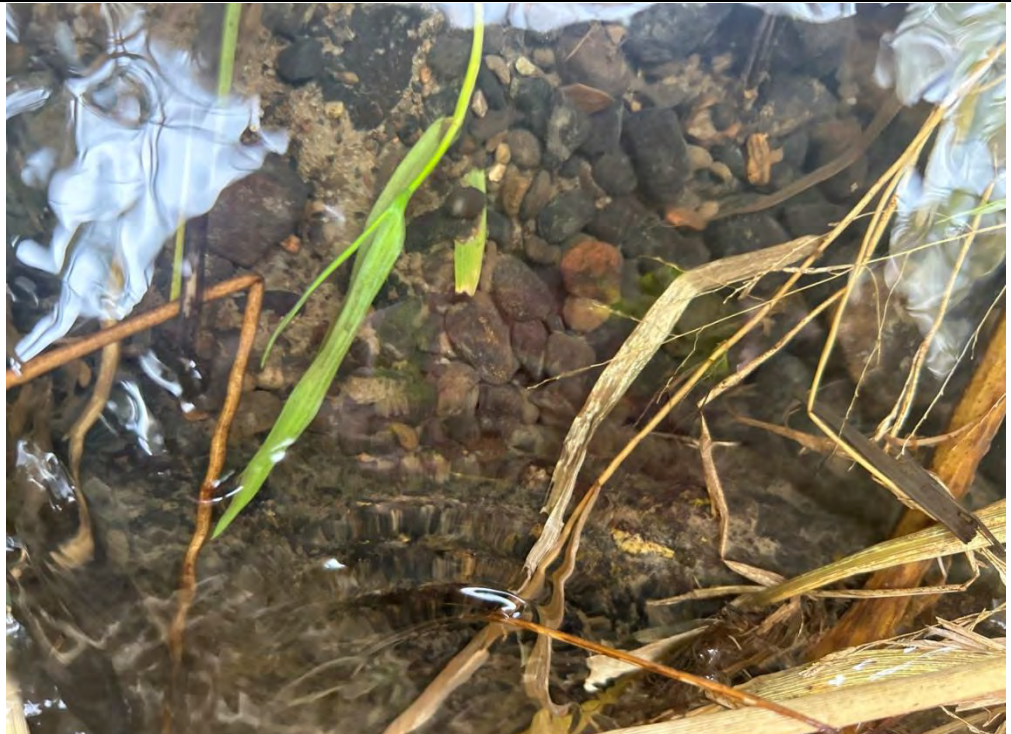
Description:Stream S-EKG-1
(intermittent), looking
down at substrate.

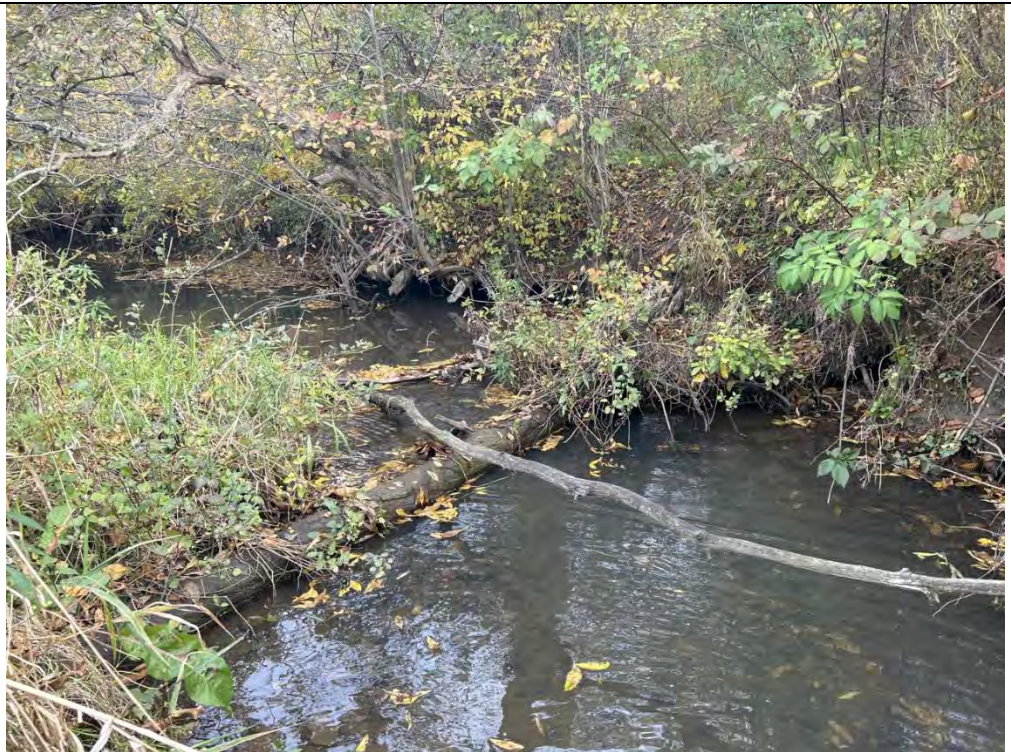
**Photo No. 4.****Photo Date:**

Description:Stream S-EKG-2
(Little Bull Creek)
looking upstream,
facing northwest.

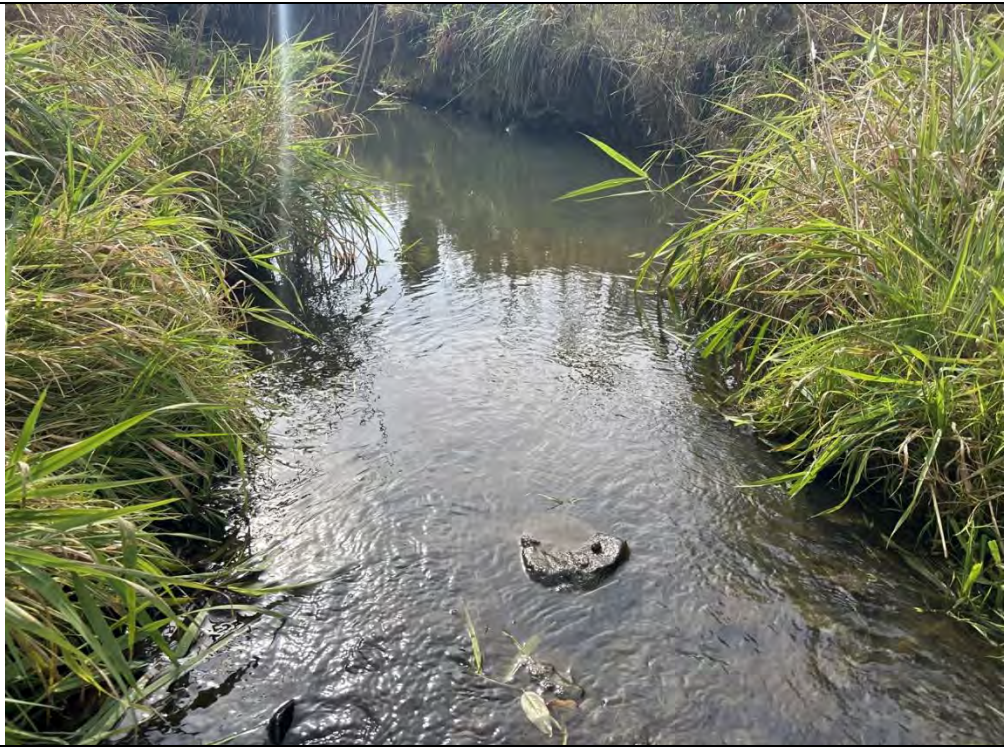
Photo No. 5.

Description:
Stream S-EKG-2 (Little Bull Creek) looking downstream, facing southeast.

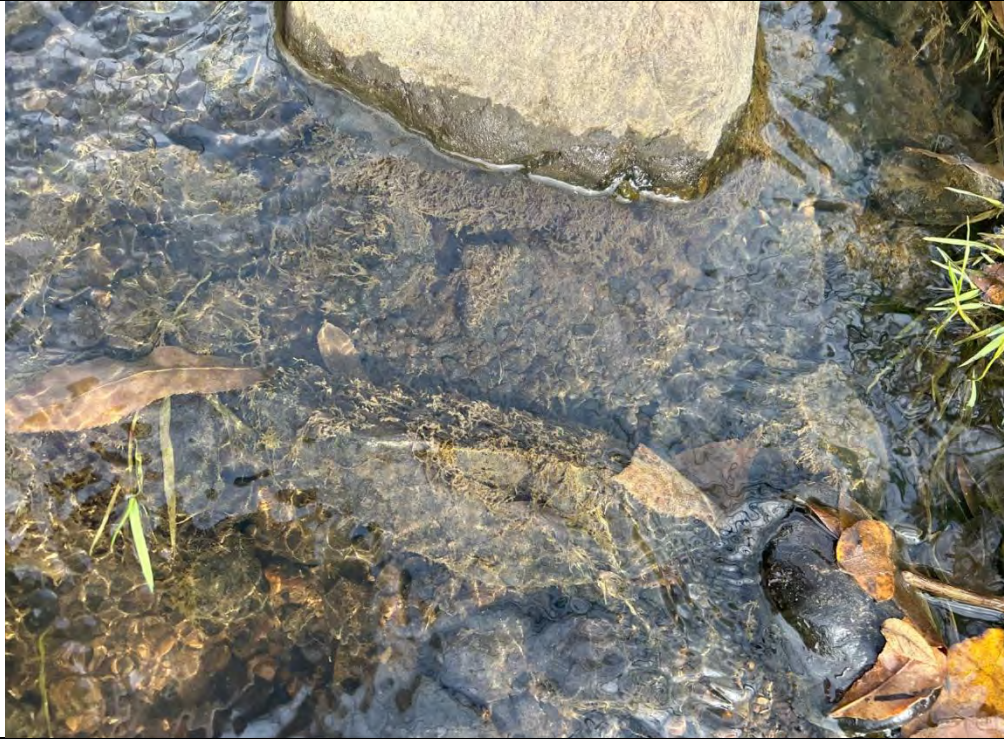
Photo No. 6.

Description:
Stream S-EKG-2 (Little Bull Creek) looking down at substrate.
