**LETTER OF NOTIFICATION**

**LONDON-TANGY 138 kV TRANSMISSION LINE TAP TO  
MITCHELL DELIVERY POINT SUBSTATION PROJECT**

**OPSB CASE NO.: 22-0007-EL-BLN**

**January 21, 2022**

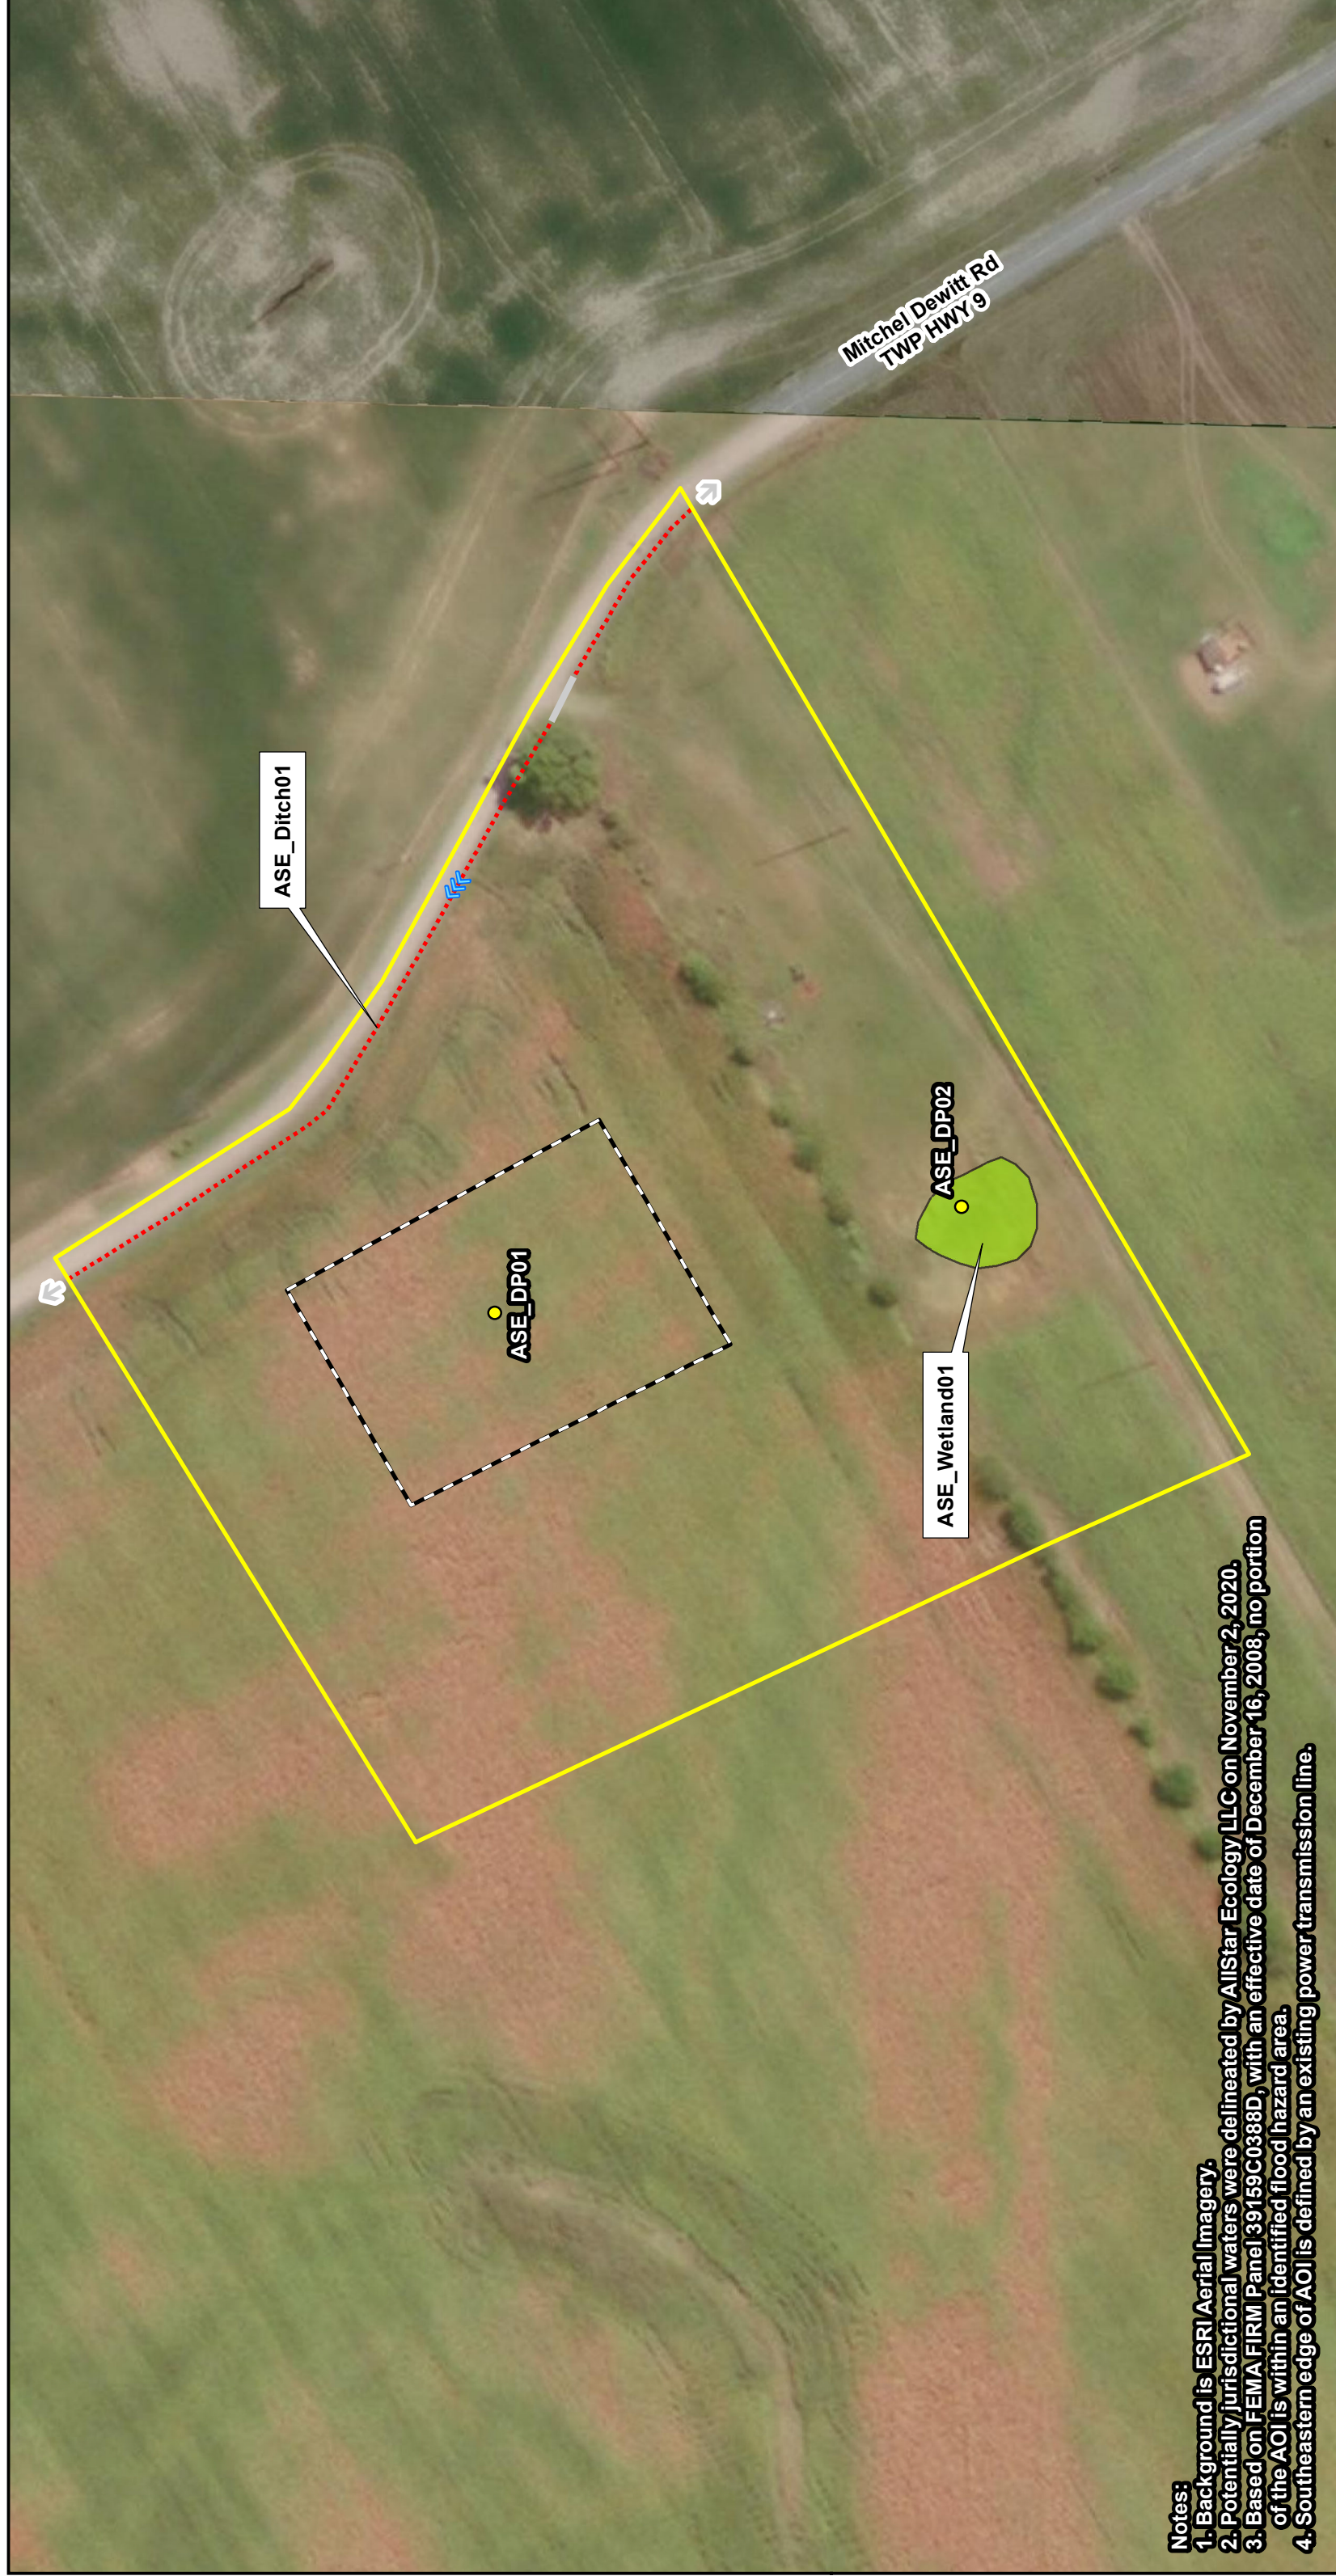
Figure 2  
Union Rural Electric  
Mitchell Substation  
Potentially Jurisdictional Waters

- Notes:**
1. Background is ESRI Aerial Imagery.
  2. Potentially jurisdictional waters were delineated by AllStar Ecology LLC on November 2, 2020.
  3. Based on FEMA FIRM Panel 39159C0388D, with an effective date of December 16, 2008, no portion of the AOI is within an identified flood hazard area.
  4. Southeastern edge of AOI is defined by an existing power transmission line.

The stream and wetland delineation of the Mitchell Substation found one potentially jurisdictional feature, one palustrine emergent (PEM) wetland.

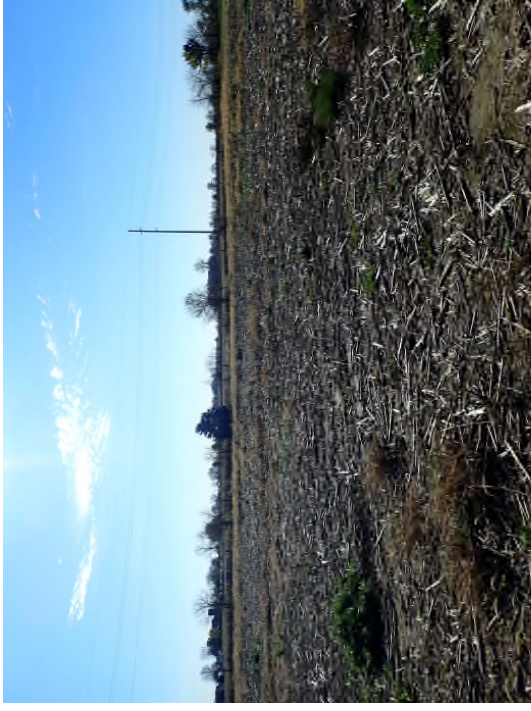
Photo 2. A view to the south of ASE\_DP01 (Upland).

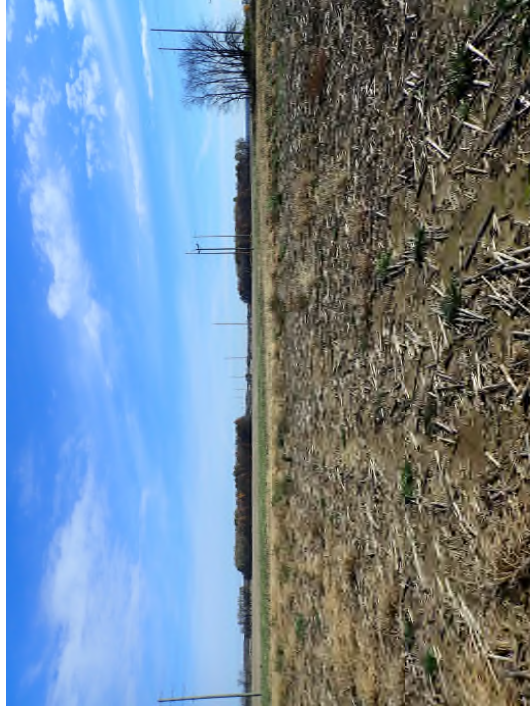
Photo 3. A view to the east of ASE\_DP01 (Upland).

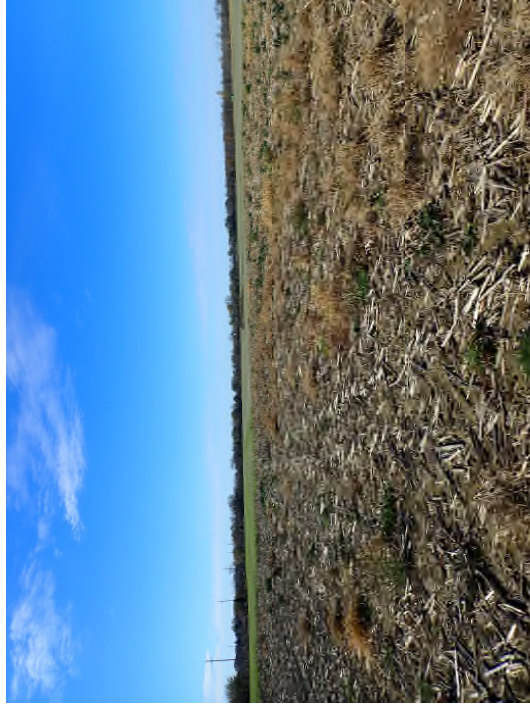
Photo 4. A view to the west of ASE\_DP01 (Upland).

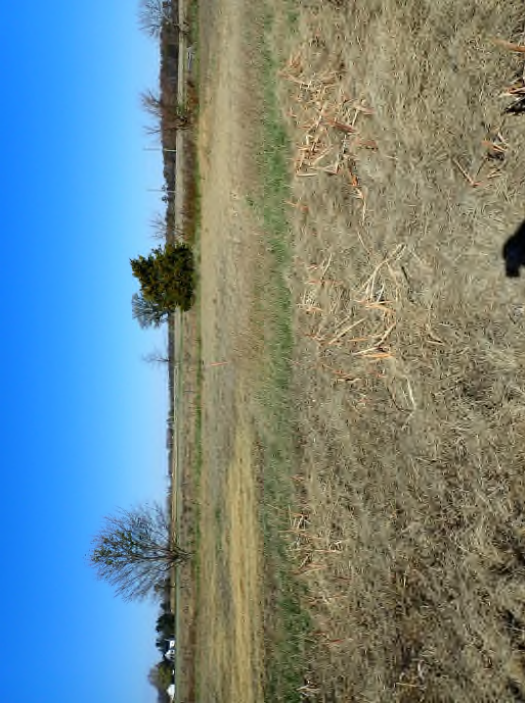
Photo 5. A view to the north of ASE\_DP02 (ASE\_Wetland01)(PEM).

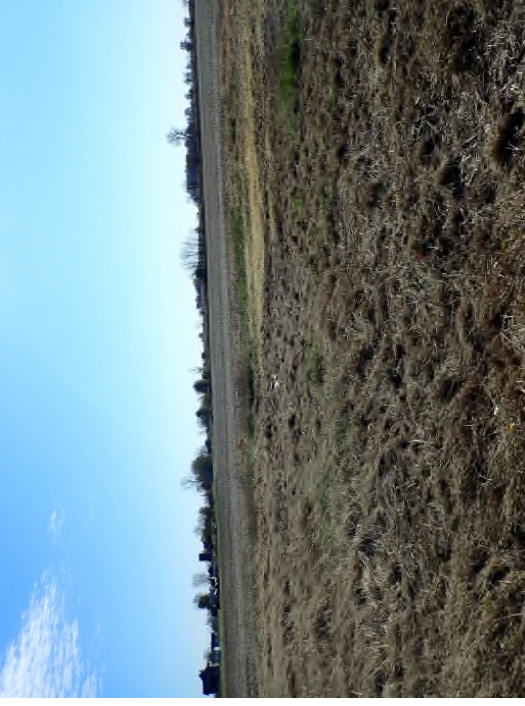
Photo 6. A view to the south of ASE\_DP02 (ASE\_Wetland01)(PEM).

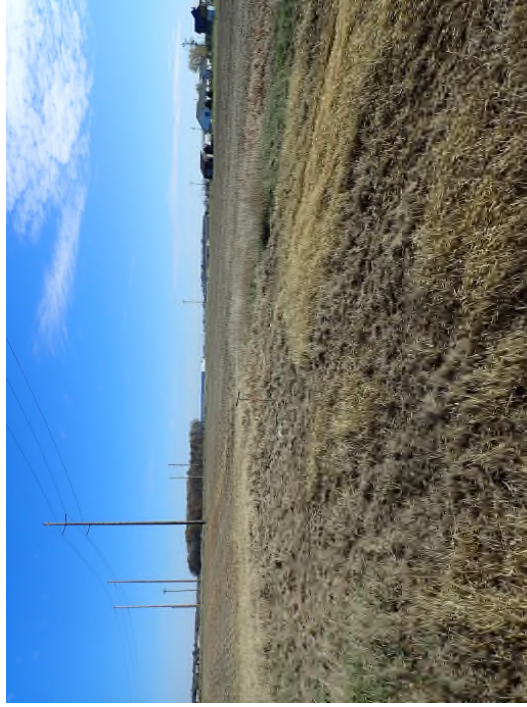
Photo 7. A view to the east of ASE\_DP02 (ASE\_Wetland01)(PEM).
