**AMERICAN TRANSMISSION SYSTEMS, INCORPORATED
A FIRSTENERGY COMPANY**

LETTER OF NOTIFICATION

TALMADGE SUBSTATION EXPANSION PROJECT

Case No.: 24-0037-EL-BLN

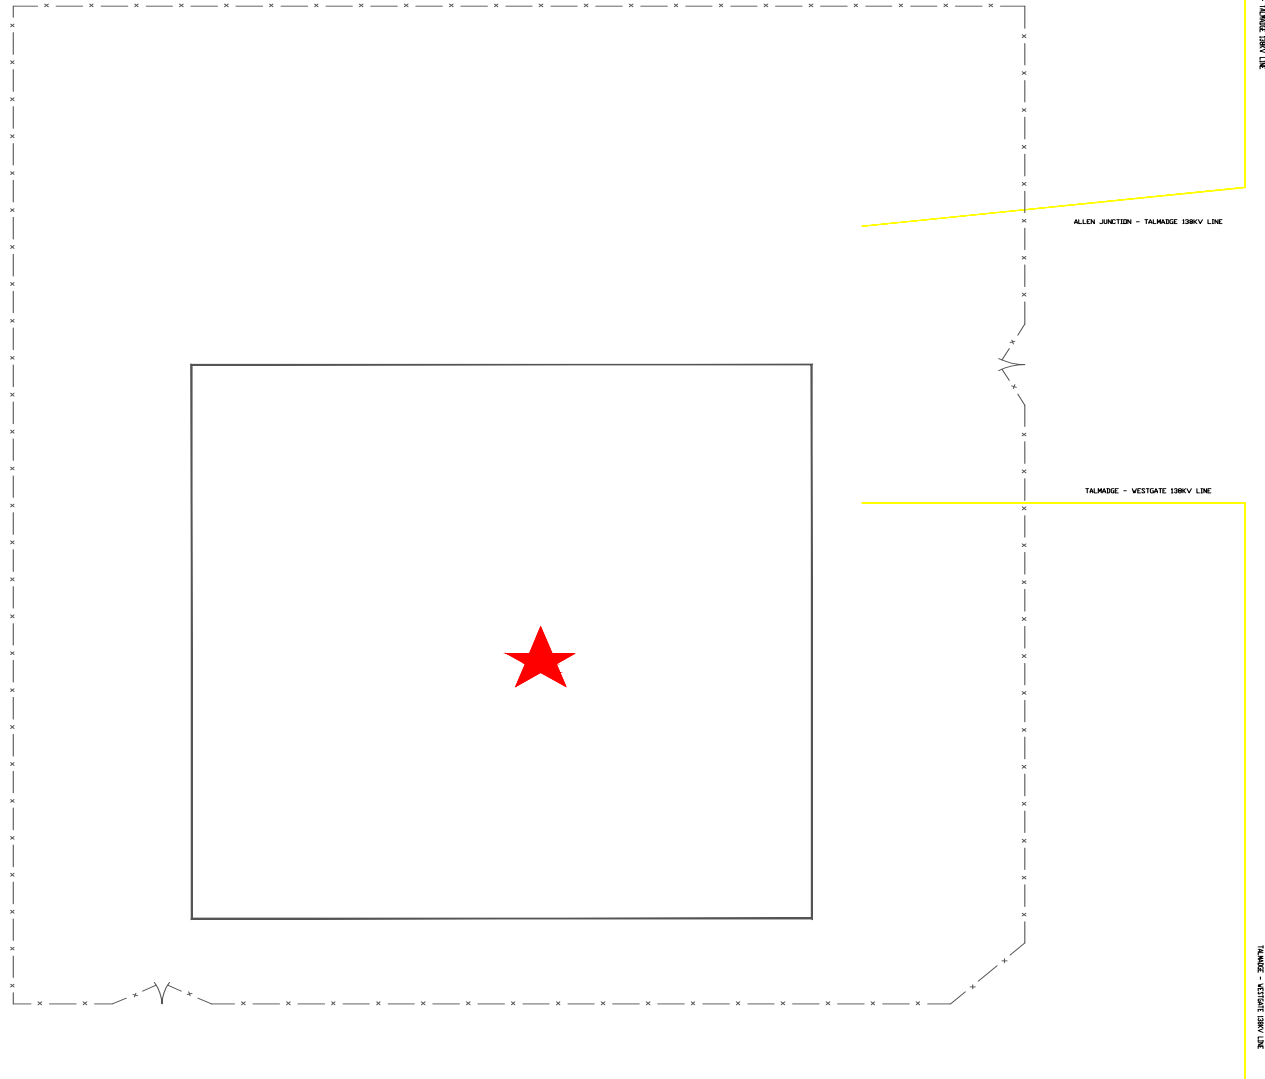
EXHIBIT 3

GENERAL LAYOUT

American Transmission Systems, Incorporated, (“ATSI”), a FirstEnergy company, is proposing to expand the existing Talmadge 138 kV Substation to convert the existing substation straight bus configuration into a four (4) breaker ring bus configuration. To facilitate this, the substation will expand from its existing square footage of approximately 17,000 square feet to approximately 49,900 square feet. This will result in an approximate 193 percent increase in square footage. In addition to the substation expansion, this project will also involve the installation of two (2) new structures outside of the Talmadge Substation. These new structures are needed to support the reconfigured line exits out of the Talmadge Substation. These components will be collectively referred to as the “Project”.

1. Expand and reconfigure the Talmadge Substation from a straight bus configuration into a four (4) 138 kV breaker ring bus with connections to three (3) 138 – 12.47 kV

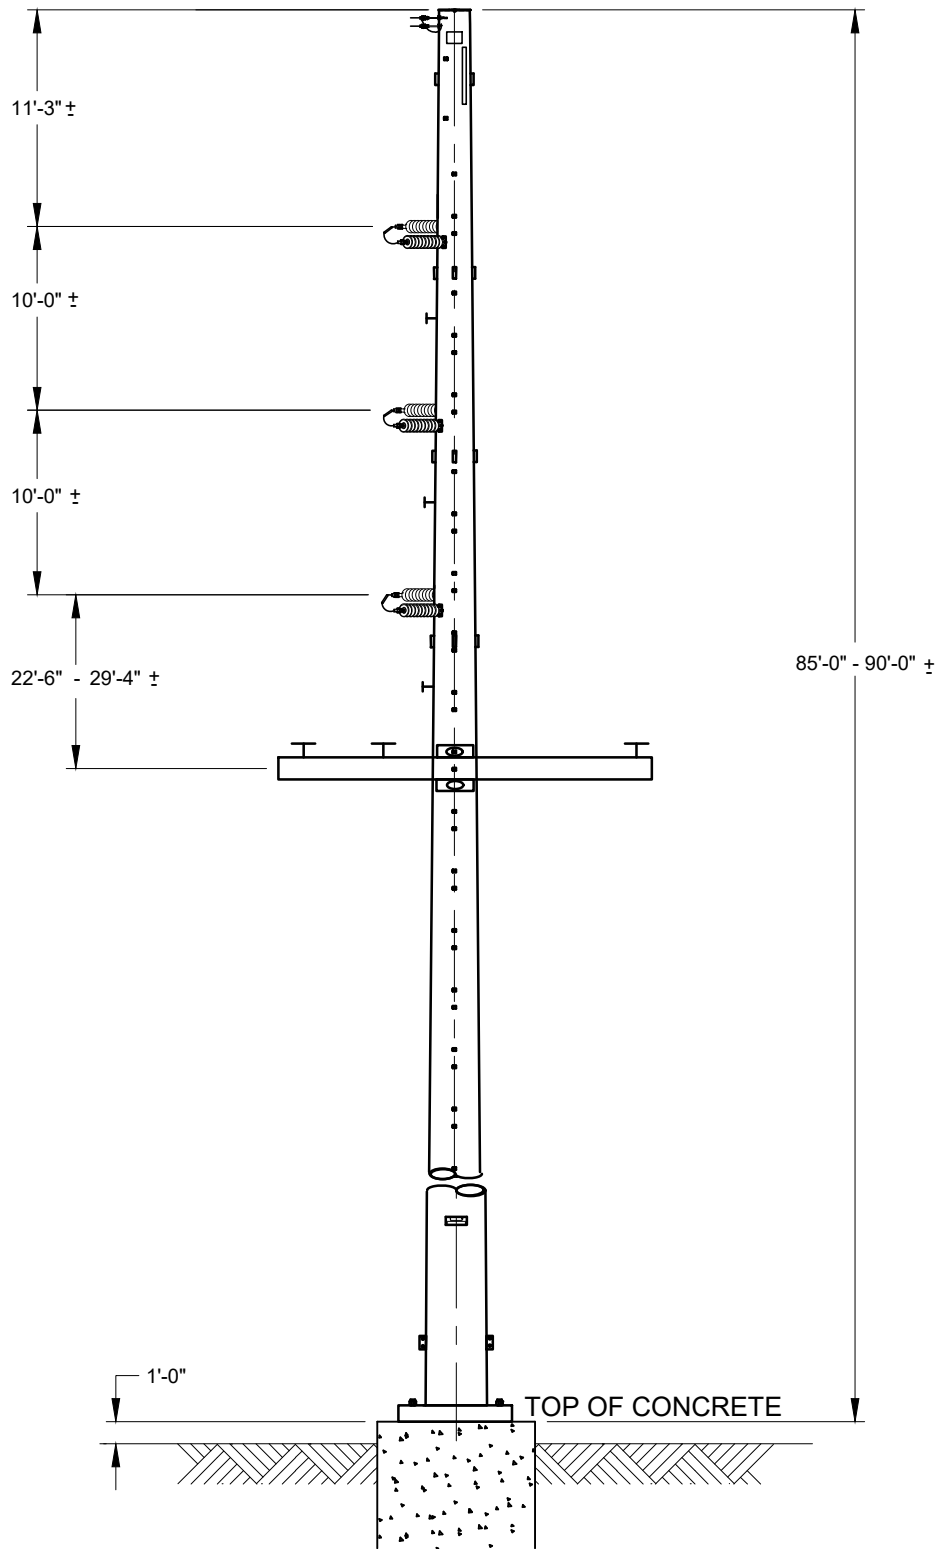
EXHIBIT 5

ELEVATION VIEW

CUSTOM SINGLE CIRCUIT DEADEND SINGLE POLE

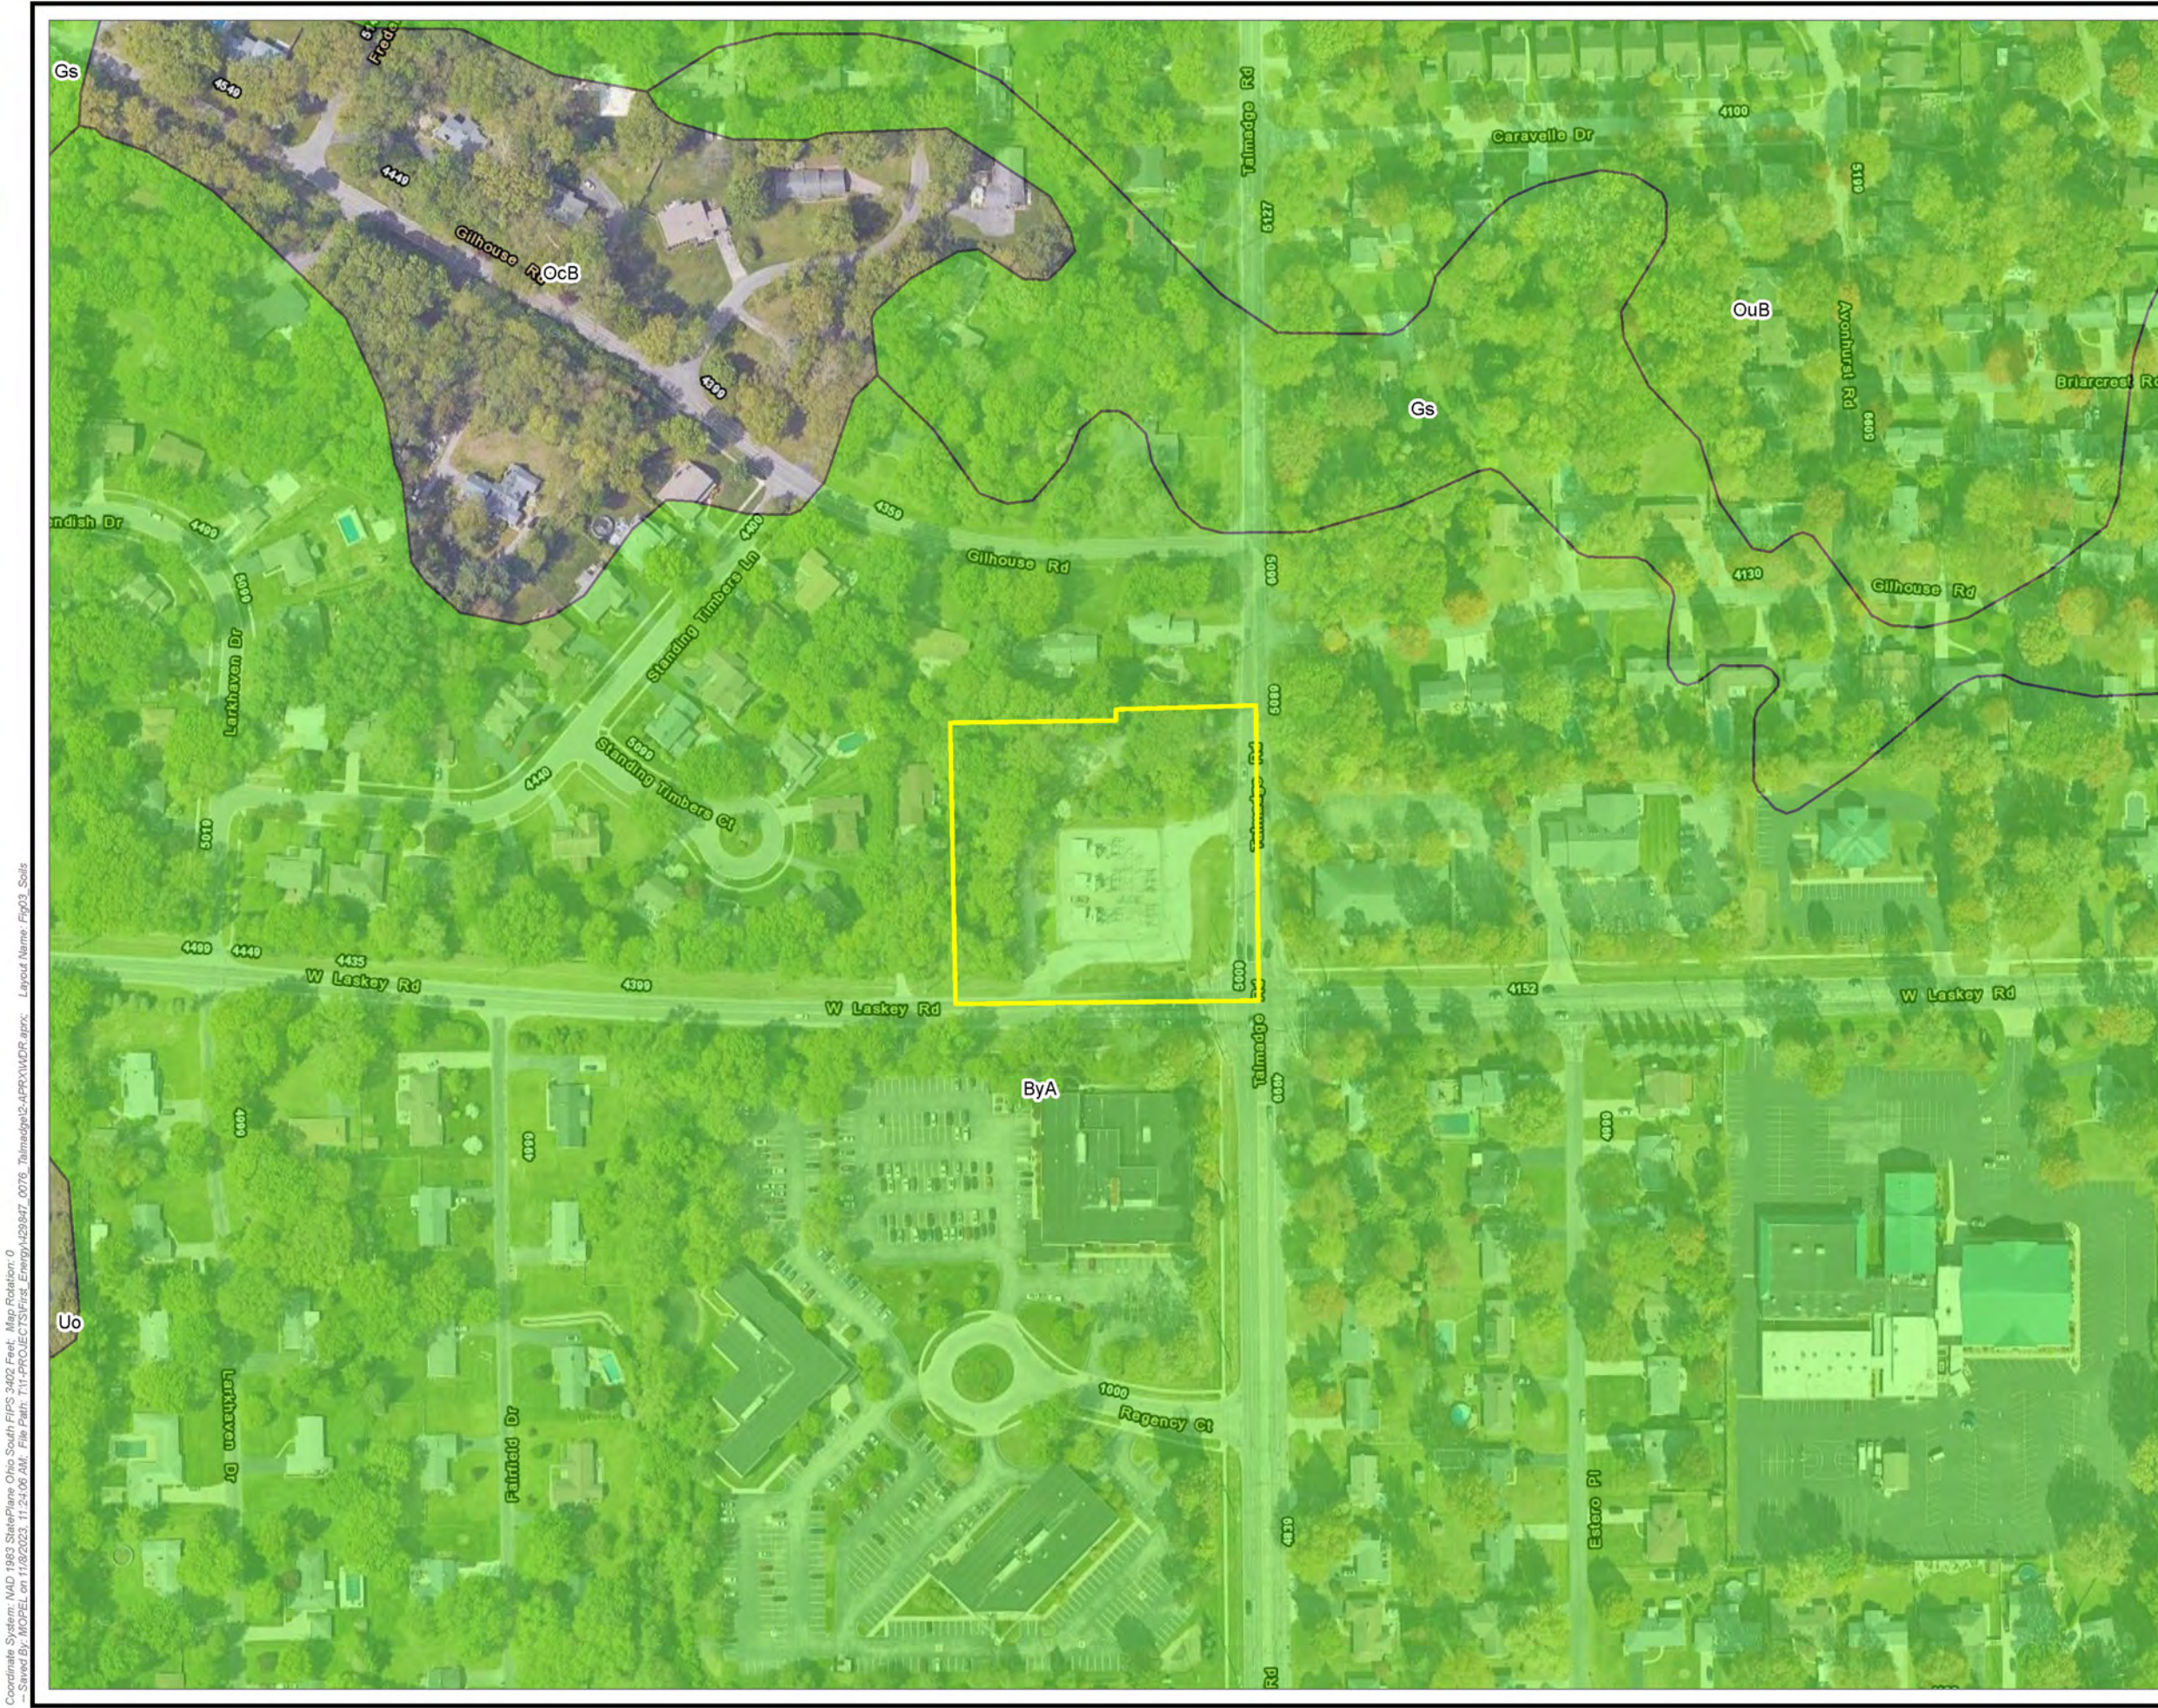
- PROJECT STUDY AREA
- HYDRIC SOIL
- NON-HYDRIC W/ HYDRIC INCLUSIONS SOIL
- NON-HYDRIC SOIL

PROJECT: FIRSTENERGY TALMADGE 138KV RING BUS 15379141 PROJECT LUCAS COUNTY, OH	
TITLE: SOILS MAP	
DRAWN BY: M. OPEL	PROJ. NO.: 429847.0076
CHECKED BY: E. GIVEN	FIGURE 3
APPROVED BY: B. FALKINBURG	
DATE: NOVEMBER 2023	
1382 WEST NINTH STREET SUITE 400 CLEVELAND, OH 44113 PHONE: 216-344-3072	
FILE:	WDR.aprx

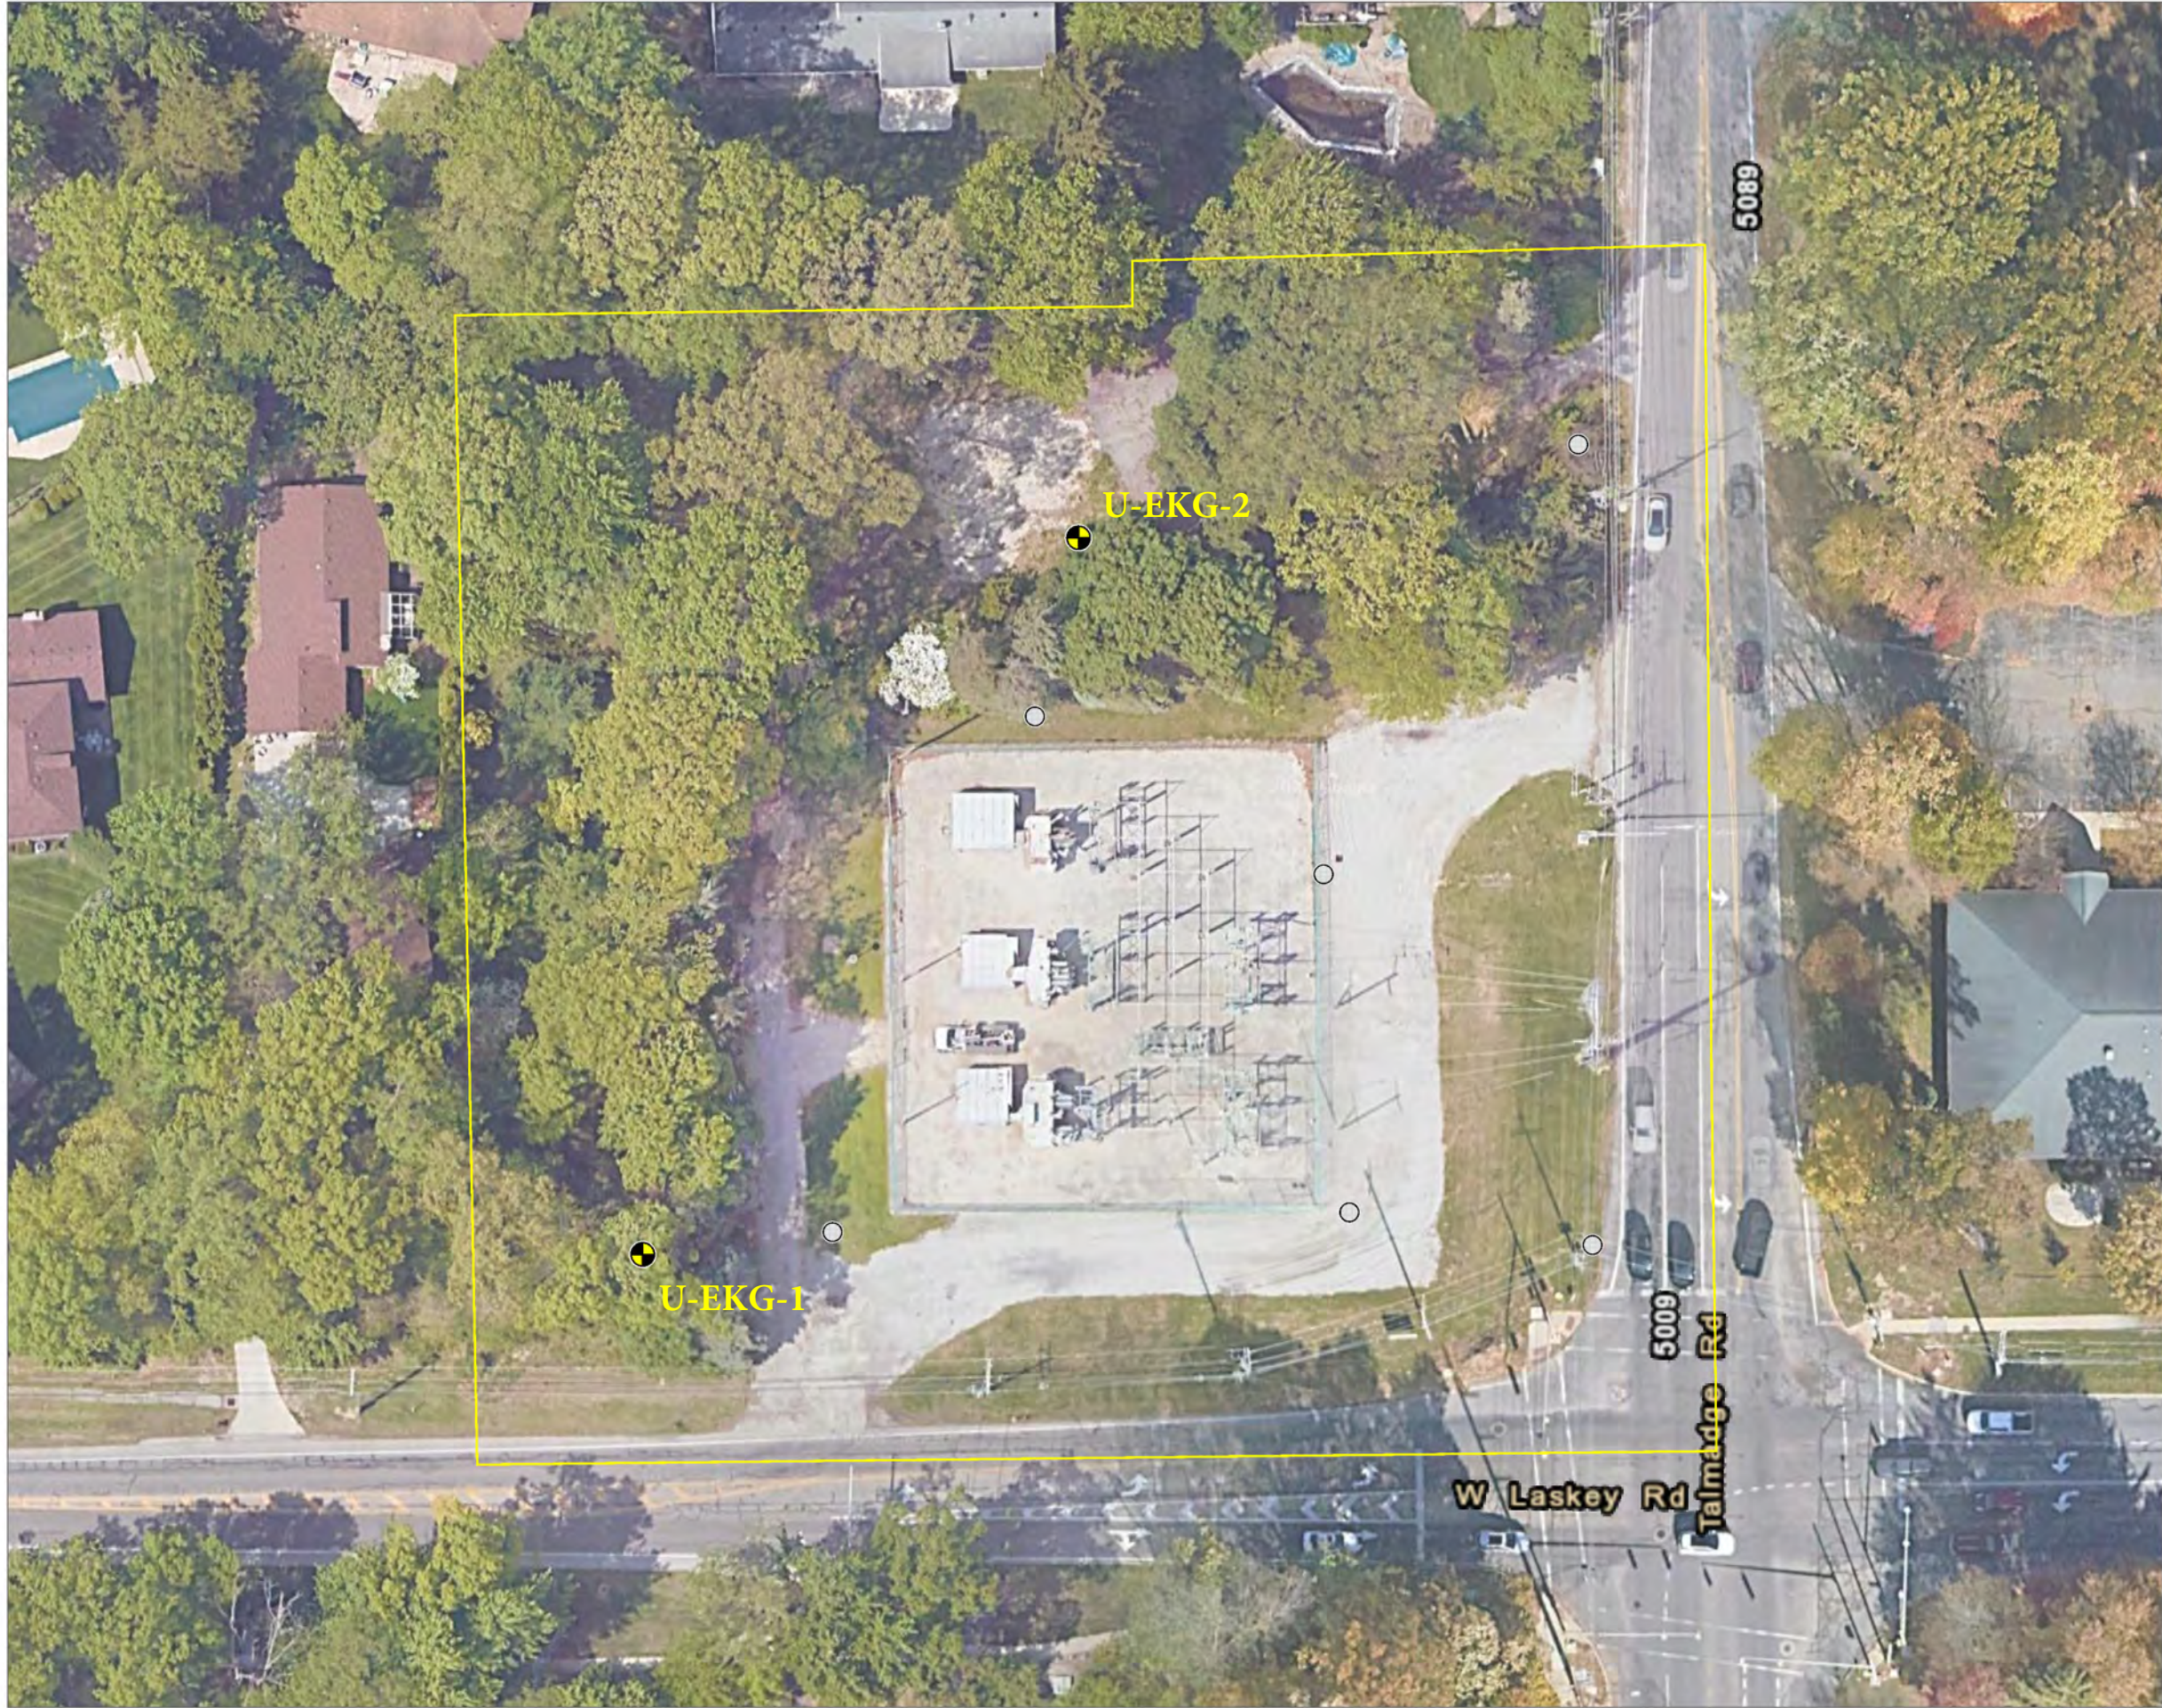
- PROJECT STUDY AREA
- CULVERT
- RULE OUT POINT

BASE MAP: GOOGLE MAPS.
 DATA SOURCES: TRC WETLAND DELINEATION COMPLETED NOVEMBER 2, 2023.

PROJECT:		FIRSTENERGY TALMADGE 138KV RING BUS 15379141 PROJECT LUCAS COUNTY, OH	
TITLE:		DELINEATED RESOURCES MAP	
DRAWN BY:	M. OPEL	PROJ. NO.:	429847.0076
CHECKED BY:	E. GIVEN	FIGURE 5	
APPROVED BY:	B. FALKINBURG		
DATE:	NOVEMBER 2023		
		1382 WEST NINTH STREET SUITE 400 CLEVELAND, OH 44113 PHONE: 216-344-3072	
FILE:			WDR.aprx
