**CONSTRUCTION NOTICE**

**JUNIPER-NEWBURGH / JUNIPER-JENNINGS &  
JUNIPER-PLEASANT VALLEY Q1 & Q2 138kV  
TRANSMISSION LINE STRUCTURE REPLACEMENT  
PROJECT**

**OPSB CASE NO.: 20-1647-EL-BNR**

**November 6, 2020**

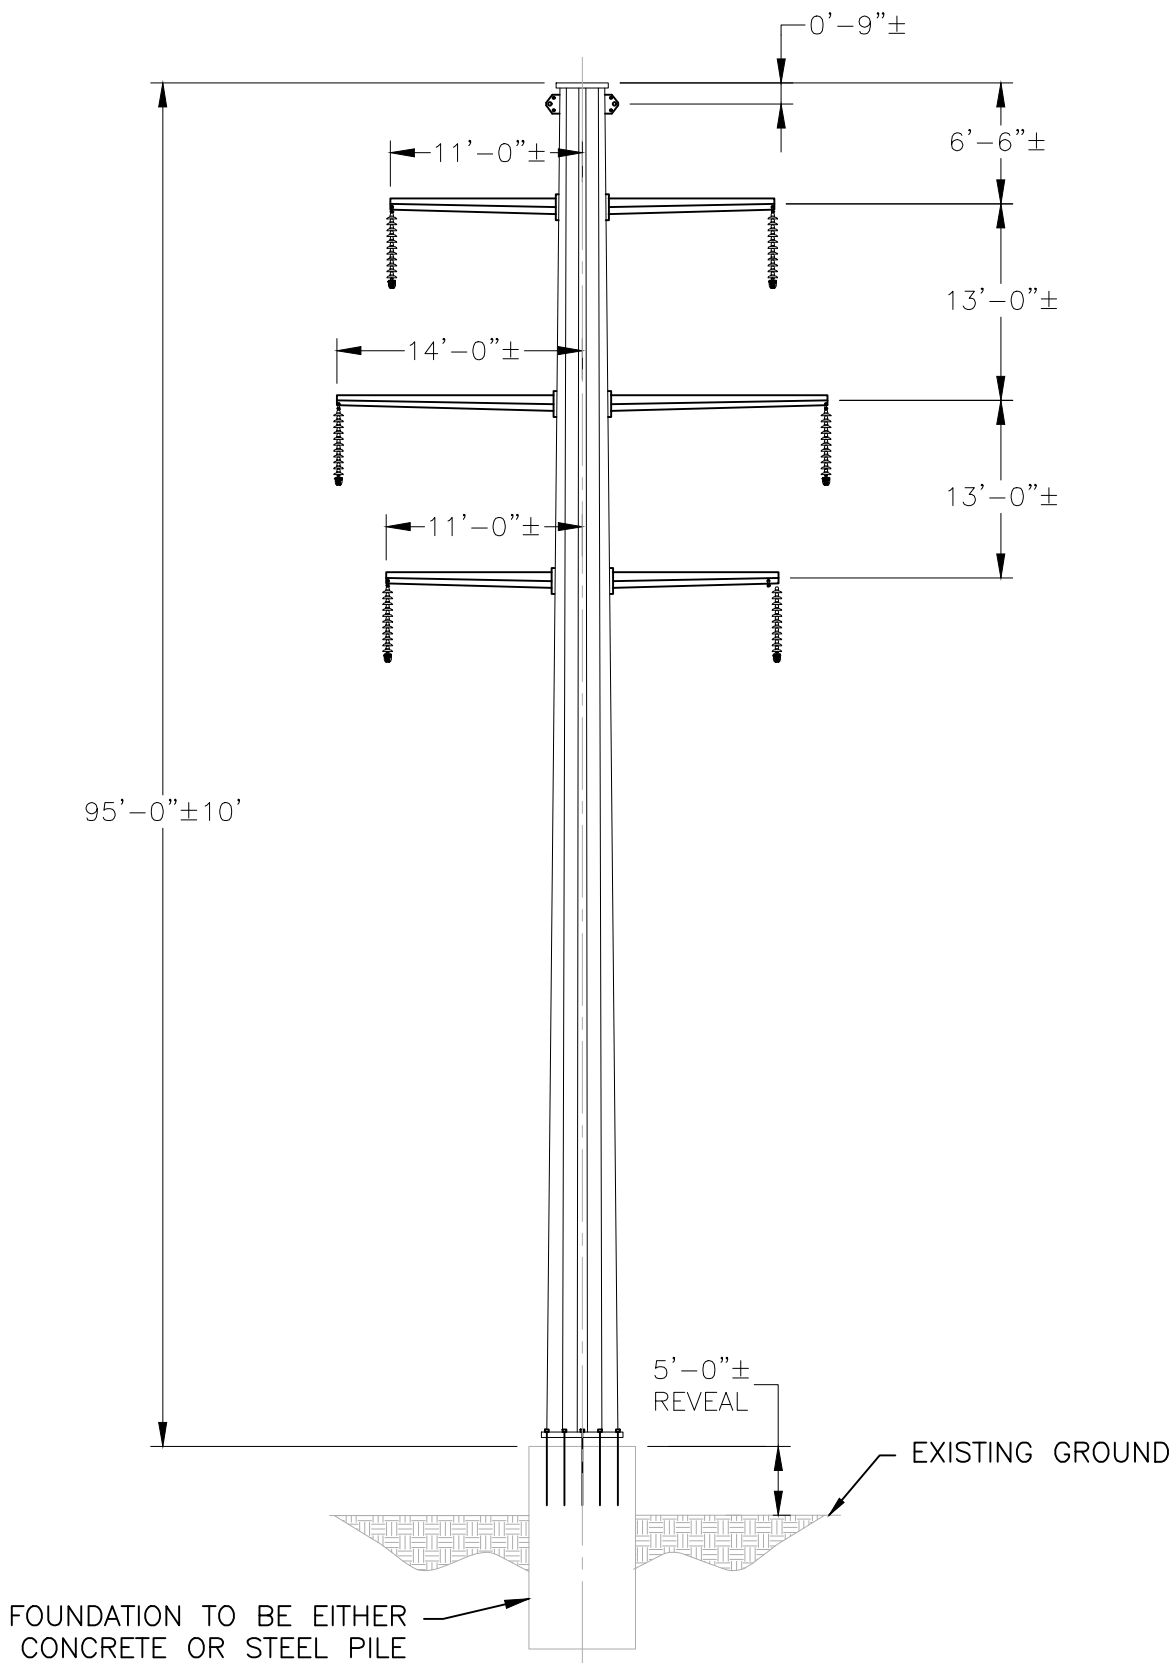
EXHIBIT 4

DOUBLE-CIRCUIT SUSPENSION SINGLE SHIELD WIRE,  
STEEL MONOPOLE WITH FOUNDATION

Structure Types: Exhibit 4: Double-Circuit Suspension Steel Monopole Single Shield Wire; One (1) structure needed.

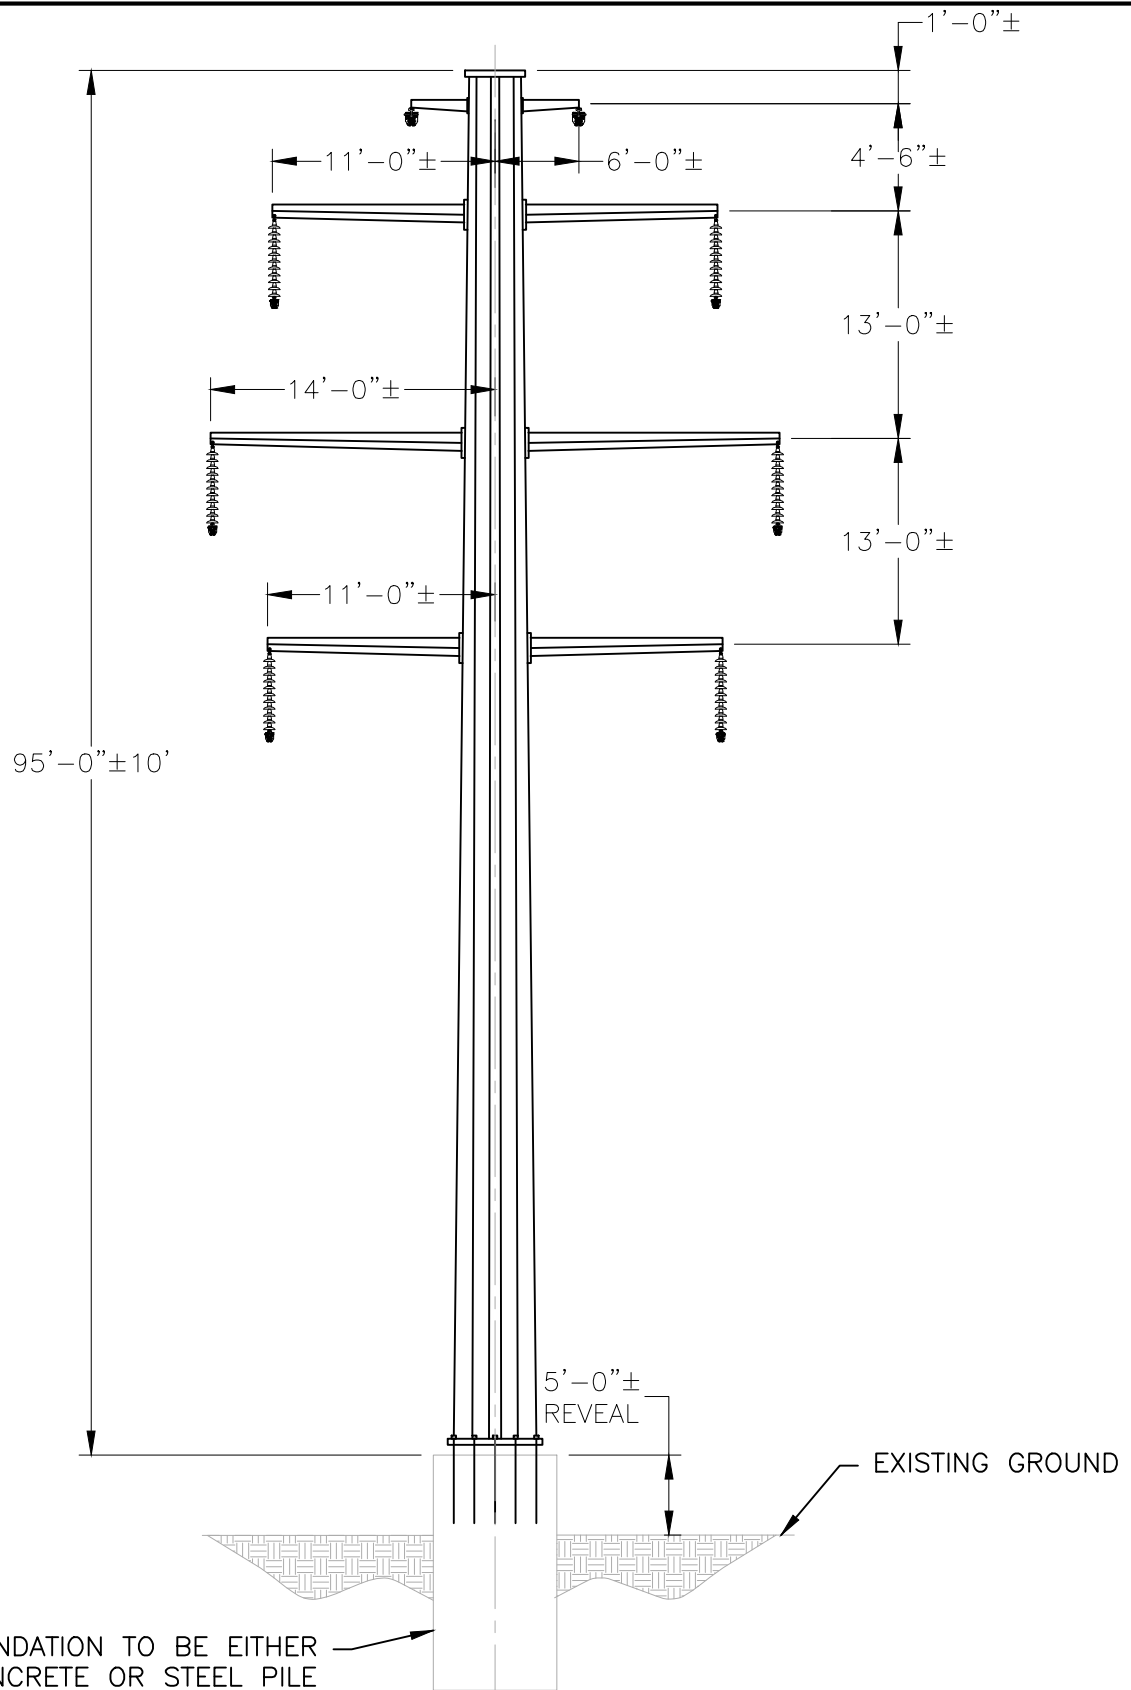
EXHIBIT 5

DOUBLE-CIRCUIT SUSPENSION, DOUBLE SHIELD WIRE,  
 STEEL MONOPOLE WITH FOUNDATION

Exhibit 5: Double-Circuit Suspension Steel Monopole Double Shield Wire; One (1) structure needed.

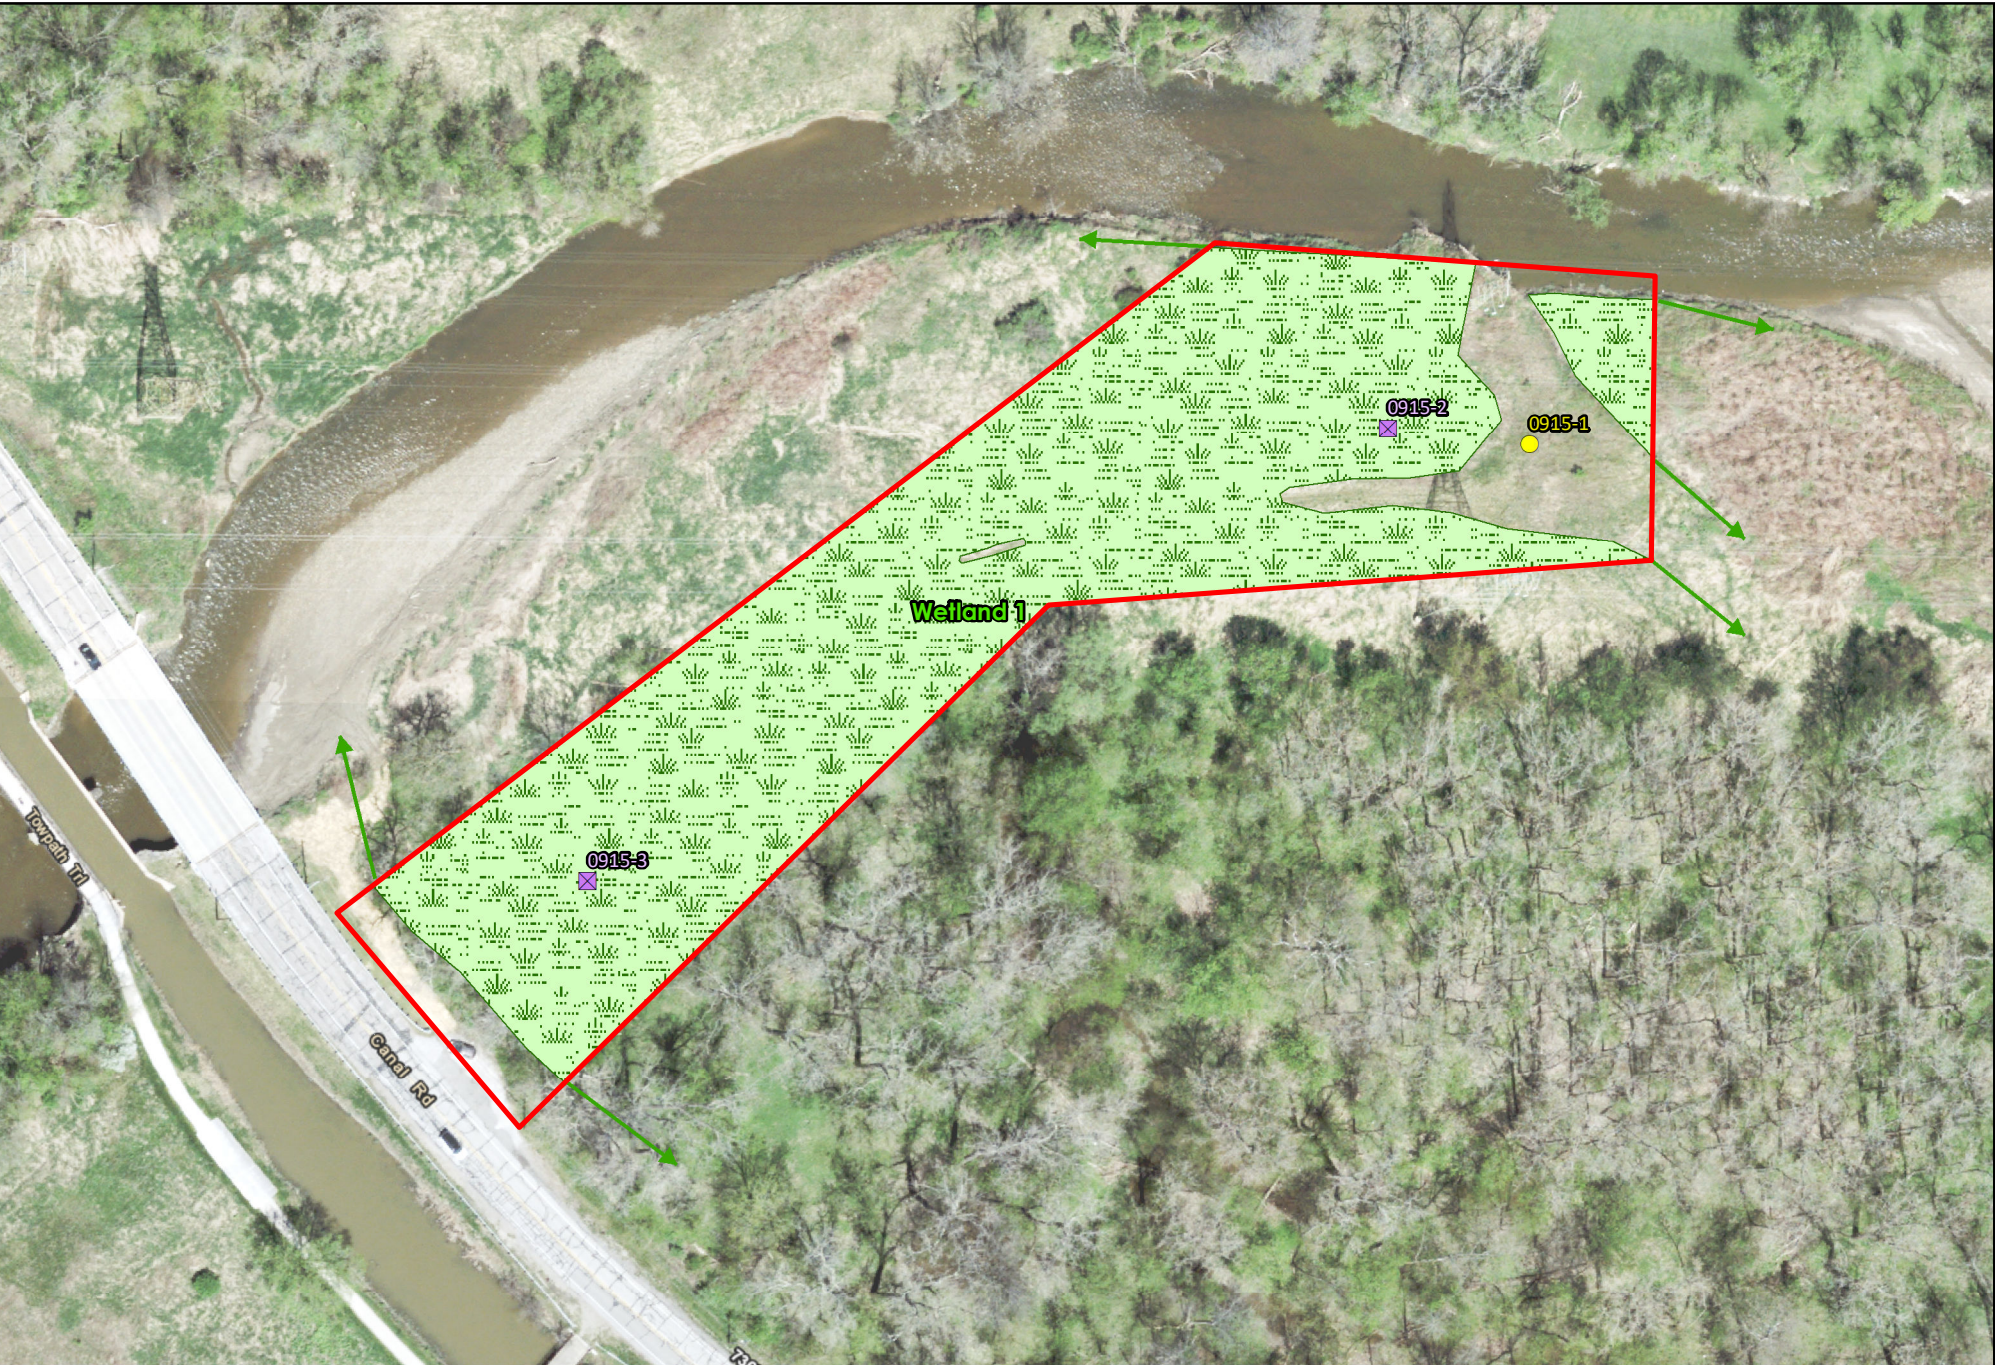
Figure 2  
 Aquatic Resources Map  
 Juniper-Newburgh / Juniper-Jennings & Juniper-Pleasant Valley Q1 & Q2 138kV  
 Transmission Line Structure Replacement Project  
 Cuyahoga County, OH

Wetland data forms and ORAM field forms can be found in Appendix A, and representative photographs can be found in Appendix B. A detailed summary of the Wetland 1 is presented in the table below.

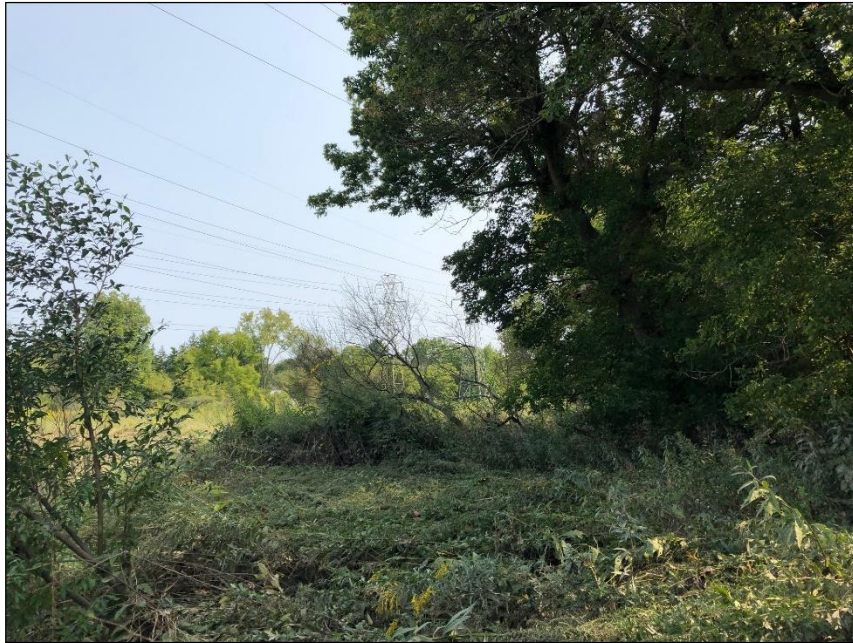
Photograph 1. Representative view of Wetland 1 looking northeast.

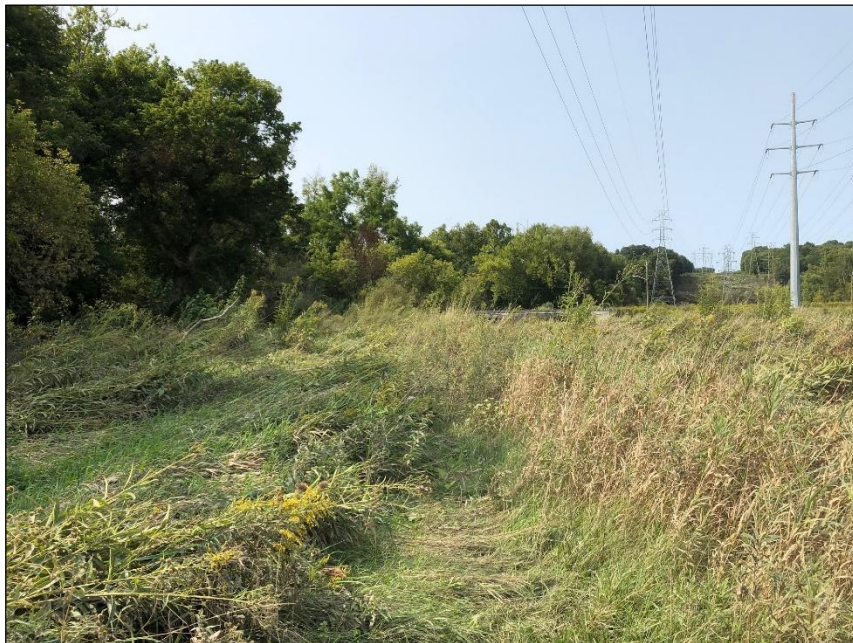
Photograph 2. Representative view of Wetland 1 looking southwest.

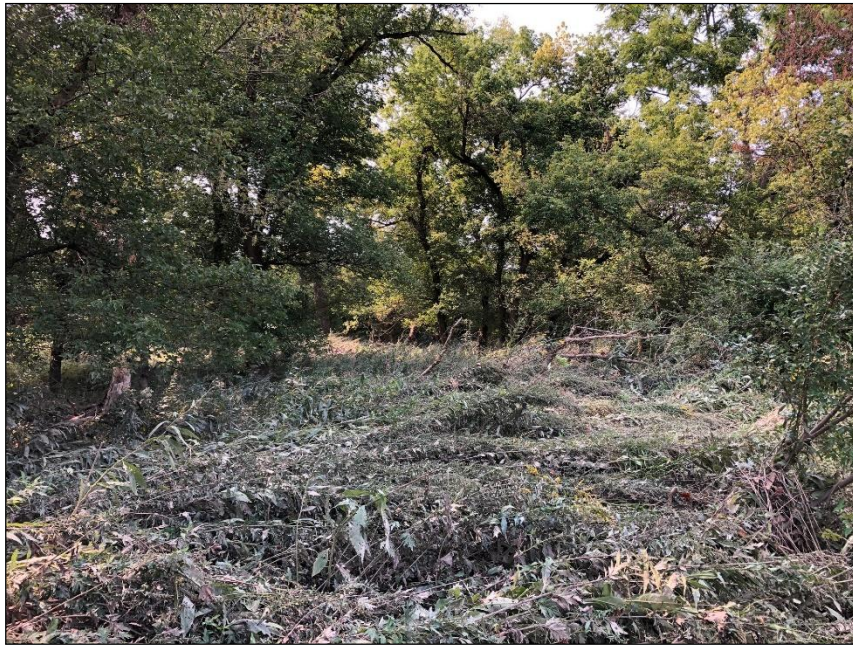
Photograph 3. Representative view of Wetland 1 looking northeast.
