**AMERICAN TRANSMISSION SYSTEMS,
INCORPORATED
A FIRSTENERGY COMPANY**

CONSTRUCTION NOTICE

**VISTEON-GREENFIELD 138 KV TRANSMISSION
LINE SWITCH REPLACEMENT PROJECT**

OPSB CASE NO.: 26-0021-EL-BNR

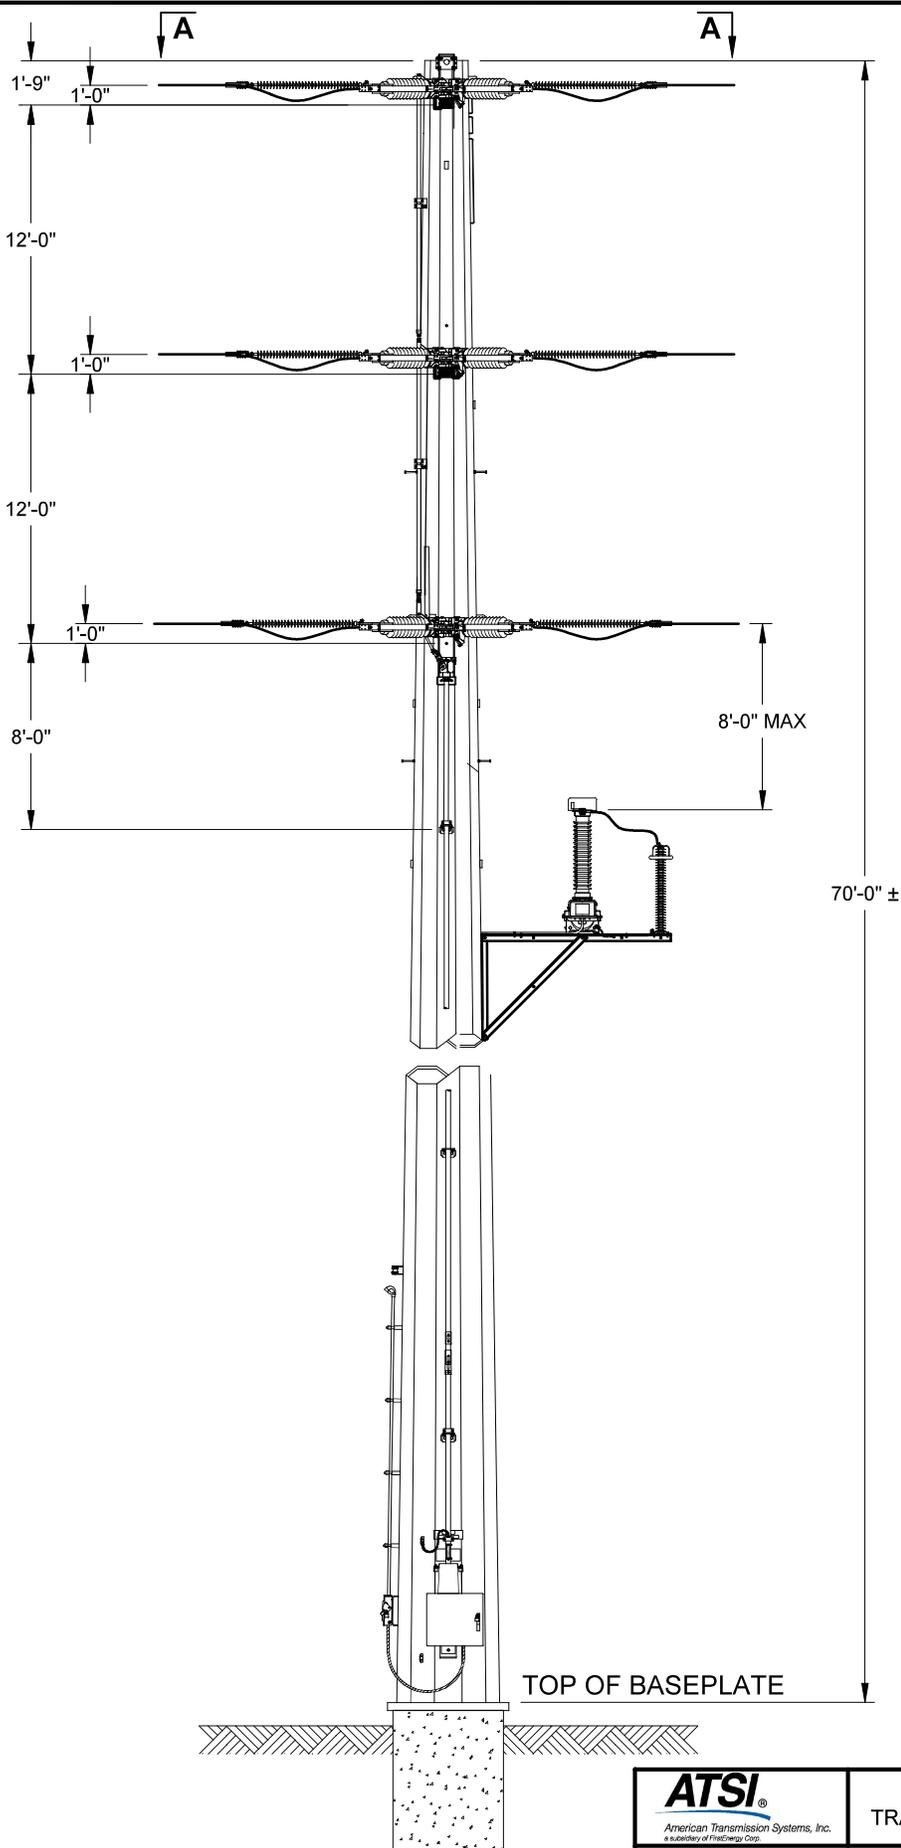
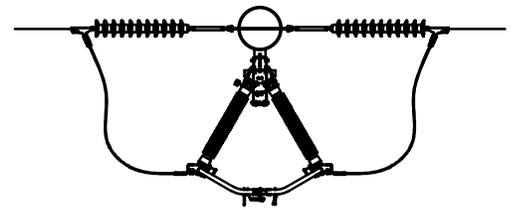
SECTION A-A

<p>VISTEON-GREENFIELD 138 kV TRANSMISSION LINE SWITCH REPLACEMENT PROJECT</p>
<p>138kV SINGLE CIRCUIT STEEL DEADEND SWITCH STRUCTURE VERTICAL SINGLE POLE WITHOUT SHIELD WIRE</p>	
<p>EXHIBIT 4</p>

American Transmission Systems, Incorporated (“ATSI”), a FirstEnergy company, is proposing to replace one (1) existing transmission line switch and one (1) associated existing transmission structure on the Visteon-Greenfield 138 kV Transmission Line. The Project will require the removal of one (1) existing switch and one (1) existing structure and will require the installation of one (1) new 1-way switch and one (1) new steel pole on a drilled pier concrete foundation. The existing conductor 336.4 kmil 26/7 ACSR “Linnet” will be transferred to the new structure. The existing shield wire will not be transferred.
