CONSTRUCTION NOTICE

**ALLEN JUNCTION-WESTGATE 138kV TRANSMISSION
LINE STRUCTURE RELOCATION-ODOT PROJECT**

Case No.: 25-0111-EL-BNR

April 15, 2025

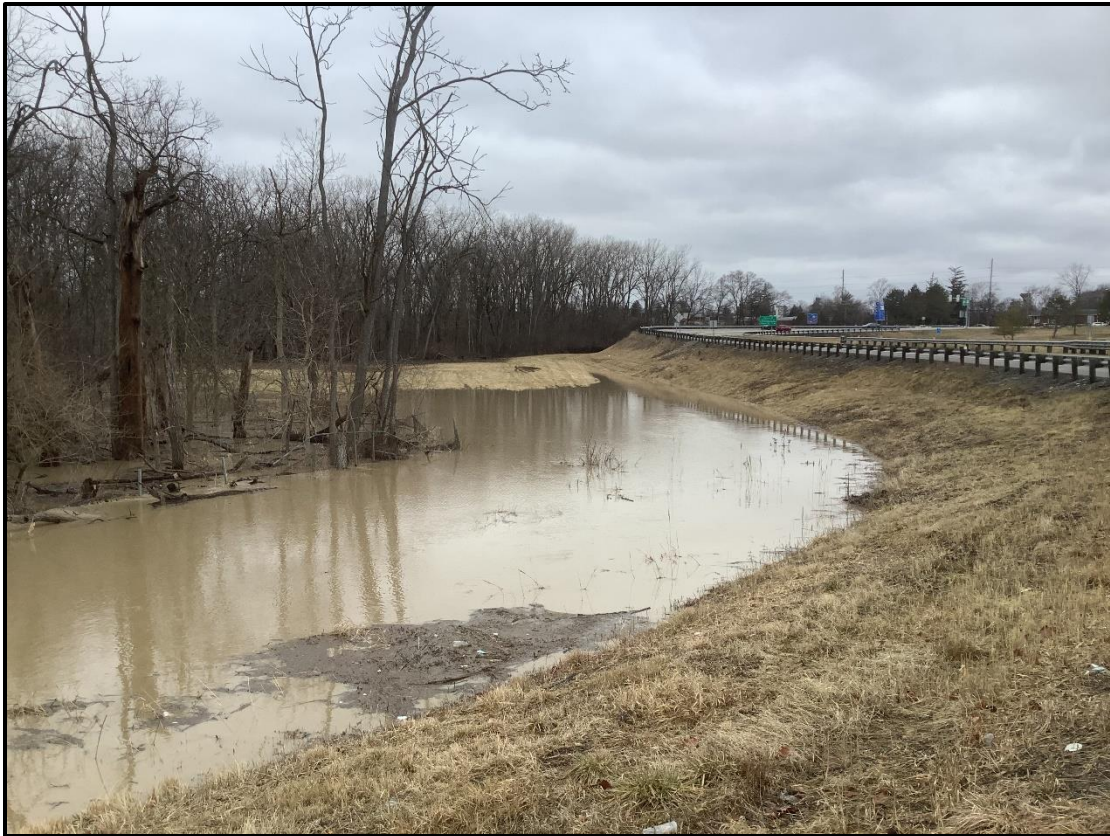
Figure 5. View looking northwest along the US 23 southbound on ramp from State Route 51/Monroe Street showing areas in hydric Sloan soils flooded at the time of the field review.

deposits. Sloan soils are also reported in the project area, along the US 23 southbound on-ramp and near the Ottawa River. These soils are very poorly drained and occupy floodplains. Sloan soils are designated as a hydric soil and are occasionally flooded, as was the case during the field review (Figure 5).

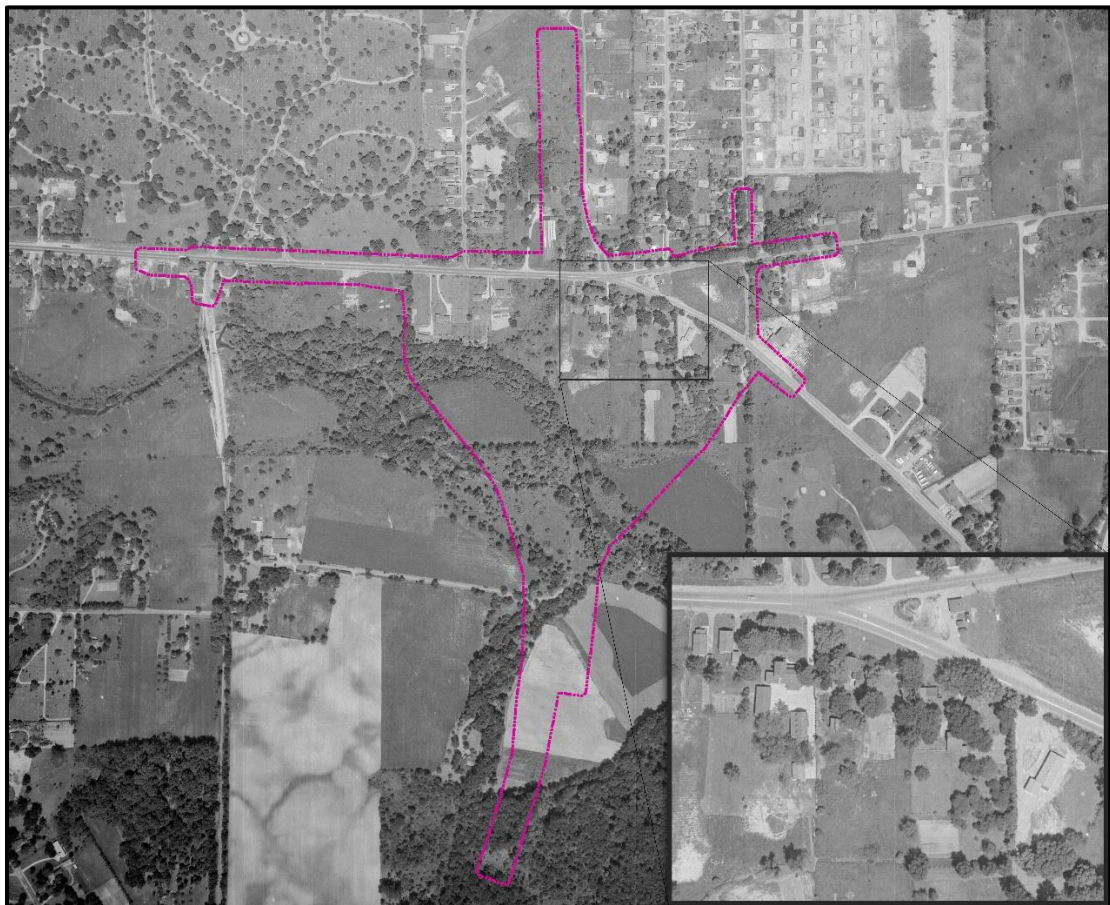
Figure 6. 1955 aerial photo showing the project footprint and a detail of the residences that once occupied the area where the interstate and ramps are today.

Background research also included a review of archived aerial photos of the area, particularly aerials taken during US 23 construction. Prior to US 23, a number of residences line State Route 51/Monroe Street where the interchange sits today (Figure 6). Construction on US 23 between 1960 and 1962 heavily altered the project area (Figures 7 through 9). Both infields were thoroughly modified by ramp construction, borrowing for elevated roadways, stream channelization, the removal of the once extant residences, and grading. Today, vegetation in portions of the eastern infield has recovered with mature trees scattered across the northern side of the infield. However, modern aerials still show evidence of previous disturbance with exposed subsoil obvious across the surface (Figure 10).

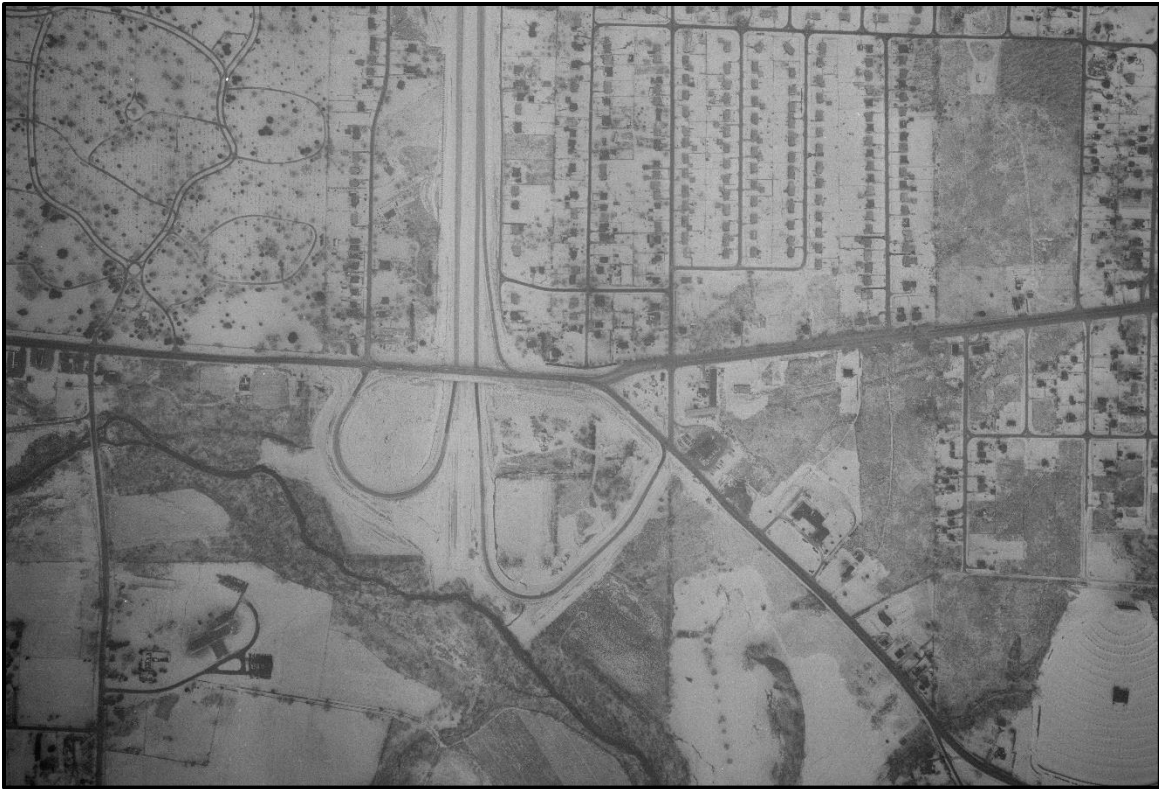
Figure 7. 1960 aerial showing a partially constructed US Route 23. Although snow covered, graded areas are clearly visible along the interstate and ramp areas.

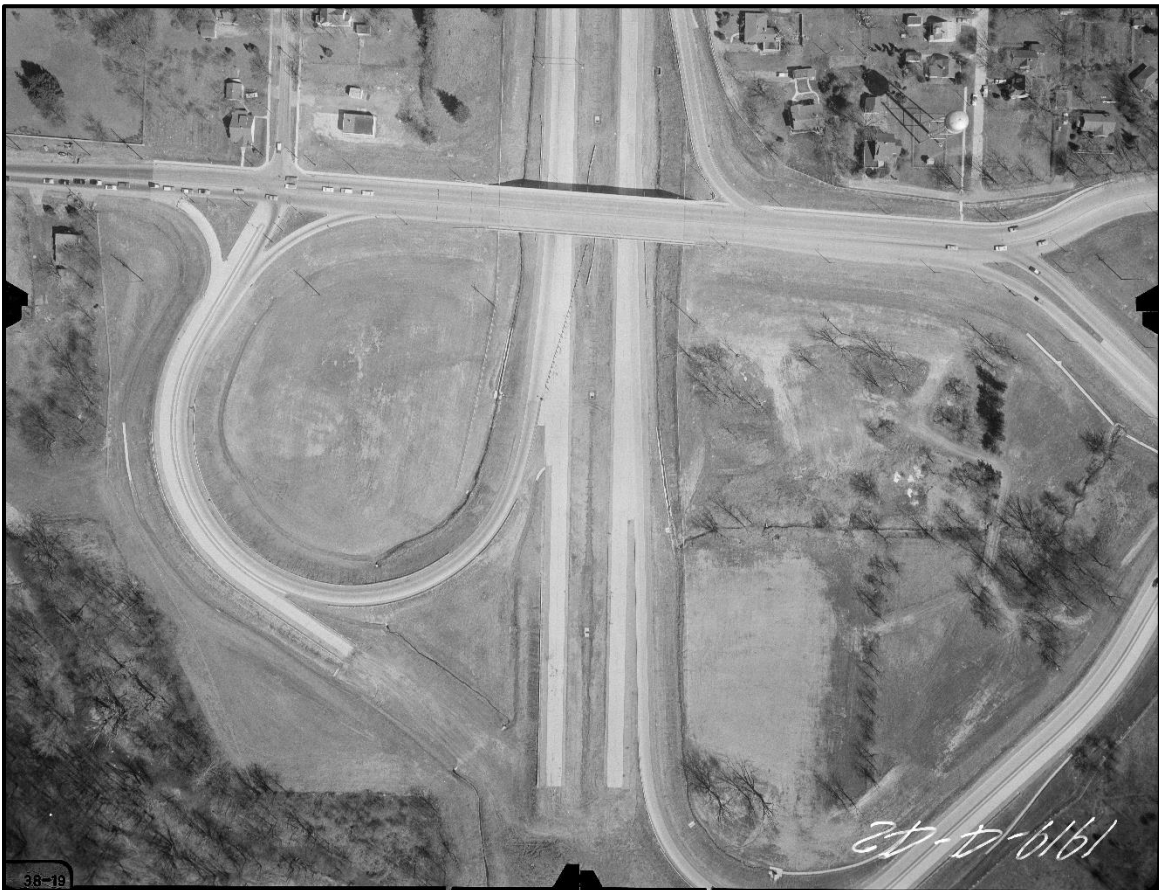
Figure 8. 1961 aerial showing a partially constructed US Route 23. Grading and clearing is evident across the area, particularly in the infield on the east side of the interstate.

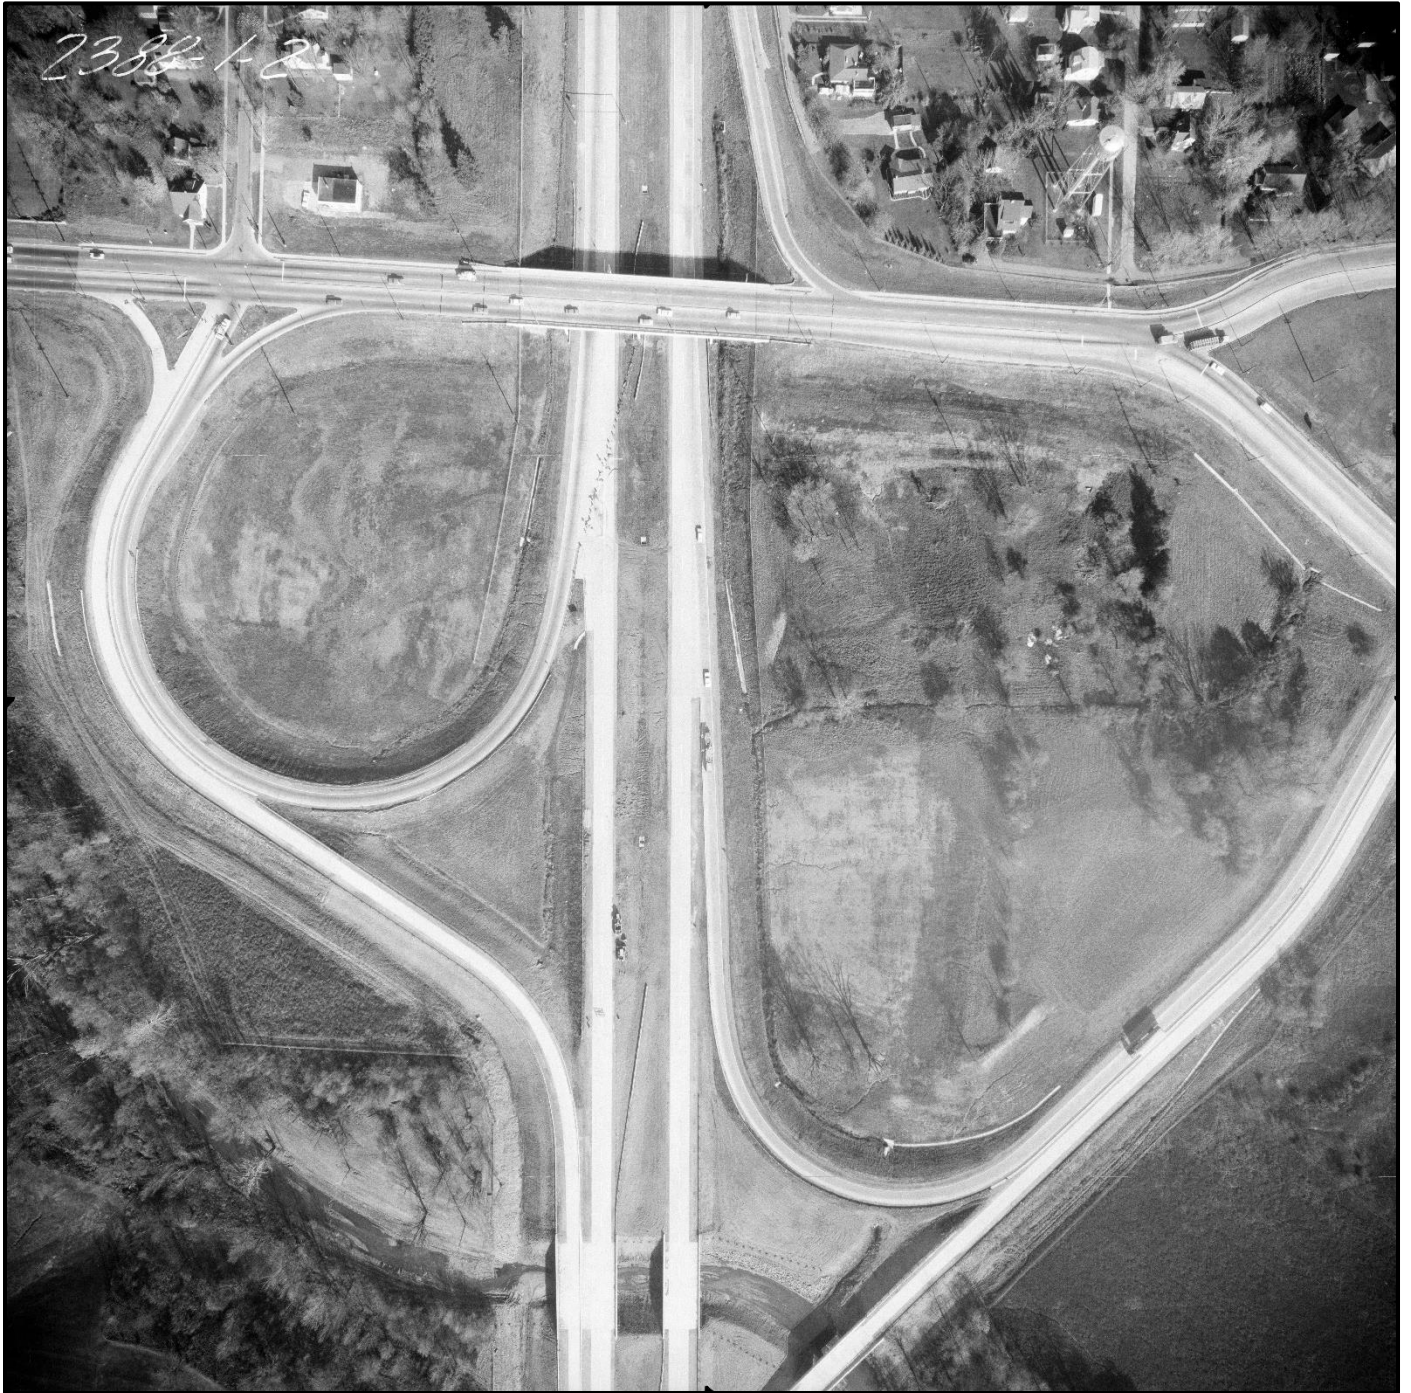
Figure 9. 1962 aerial photo taken during the construction of US Route 23 south of the State Route 51/Monroe Street interchange.

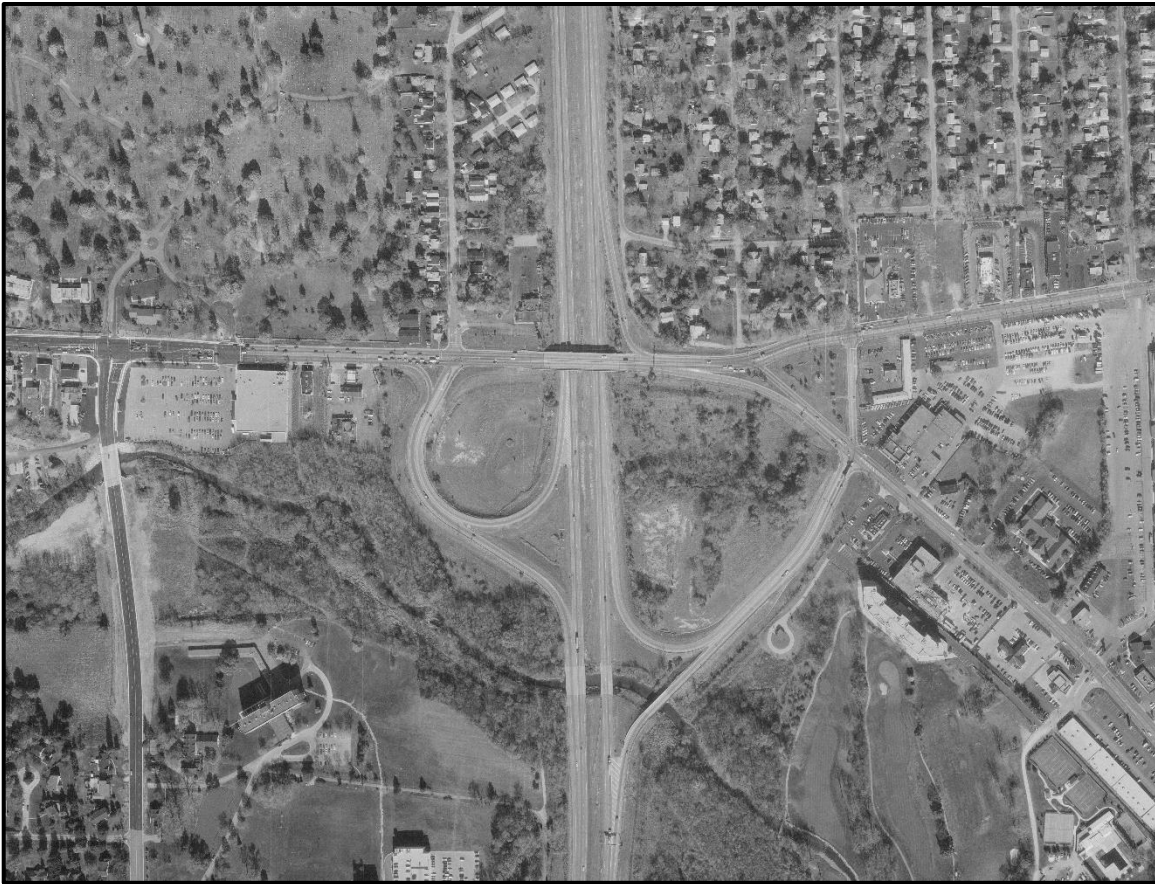
Figure 10. 1990 aerial photo showing denuded ground and exposed subsoil in the infield areas, a result of heavy modifications when the interstate and ramps were constructed.

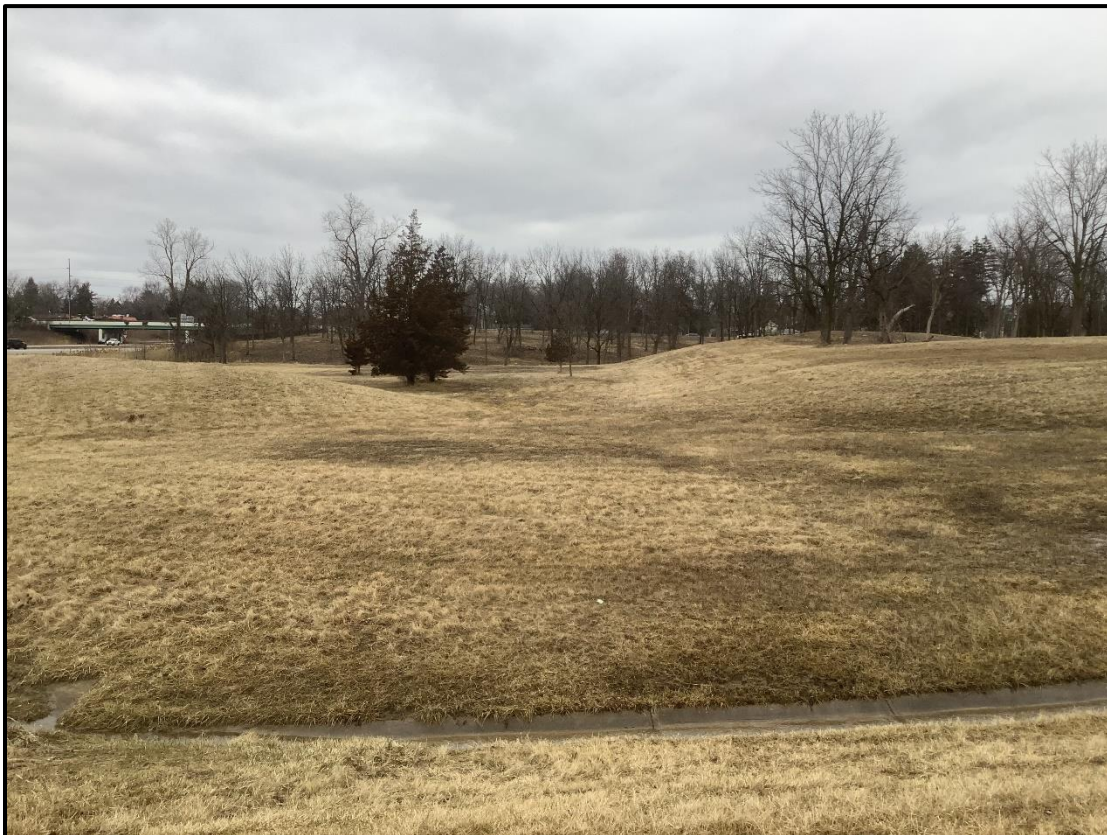
Figure 11. View looking north across the infield east of US 23 showing contoured and modified ground.

ODOT's Office of Environmental Services completed an archaeological field review for the LUC-23-11.75 interchange improvement project on February 28, 2023. Disturbance across the eastern infield area was obvious immediately upon arrival (Figures 11 through 14). A walkover survey also observed push piles of concrete, stumps and mixed soils indicative of bulldozing and tree removal across the area (Figure 15). Disturbance was also observed along State Route 51/Monroe Street relating to a channelized drainage and a graded area where residences once stood prior to US 23 construction (Figure 16).

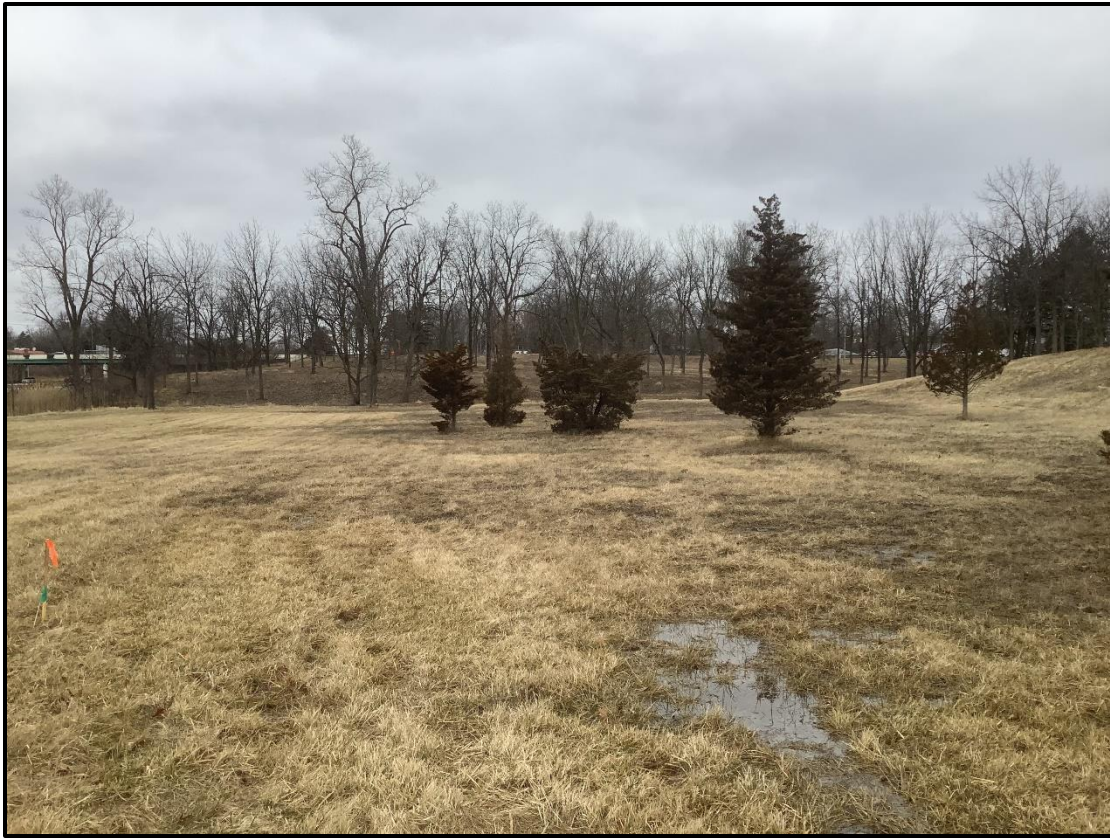
Figure 12. View looking north across the infield east of US 23 showing a flat area used for borrow.

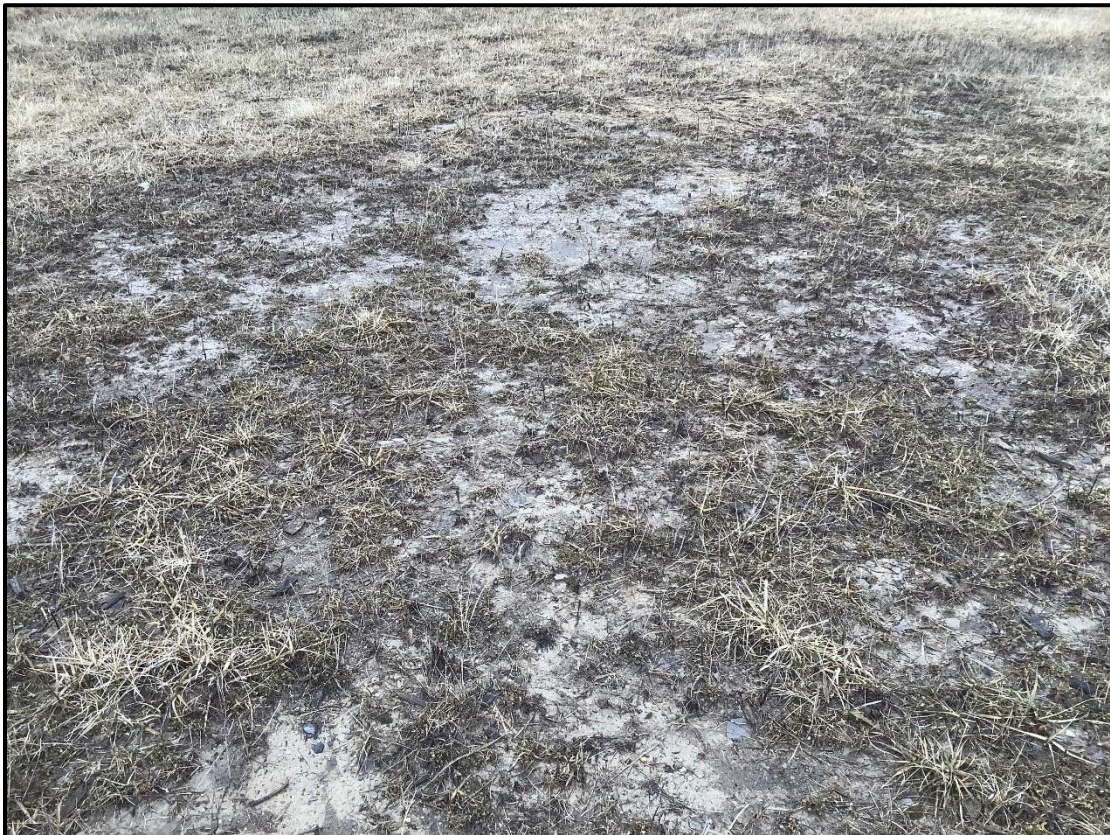
Figure 13. Representative photo of the ground surface and conditions (thin vegetation and exposed subsoil) in the infield area east of US 23.

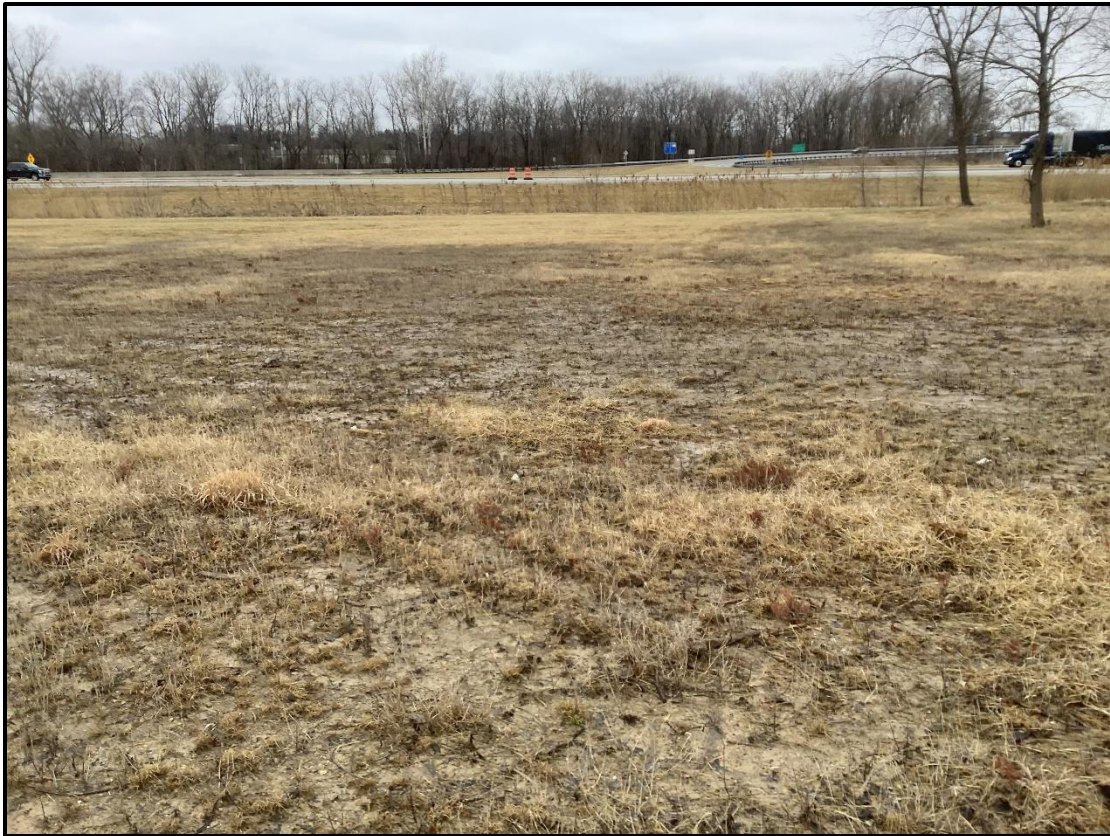
Figure 14. View looking west toward US 23 and across the eastern infield showing the ground surface and conditions (thin vegetation and exposed subsoil).

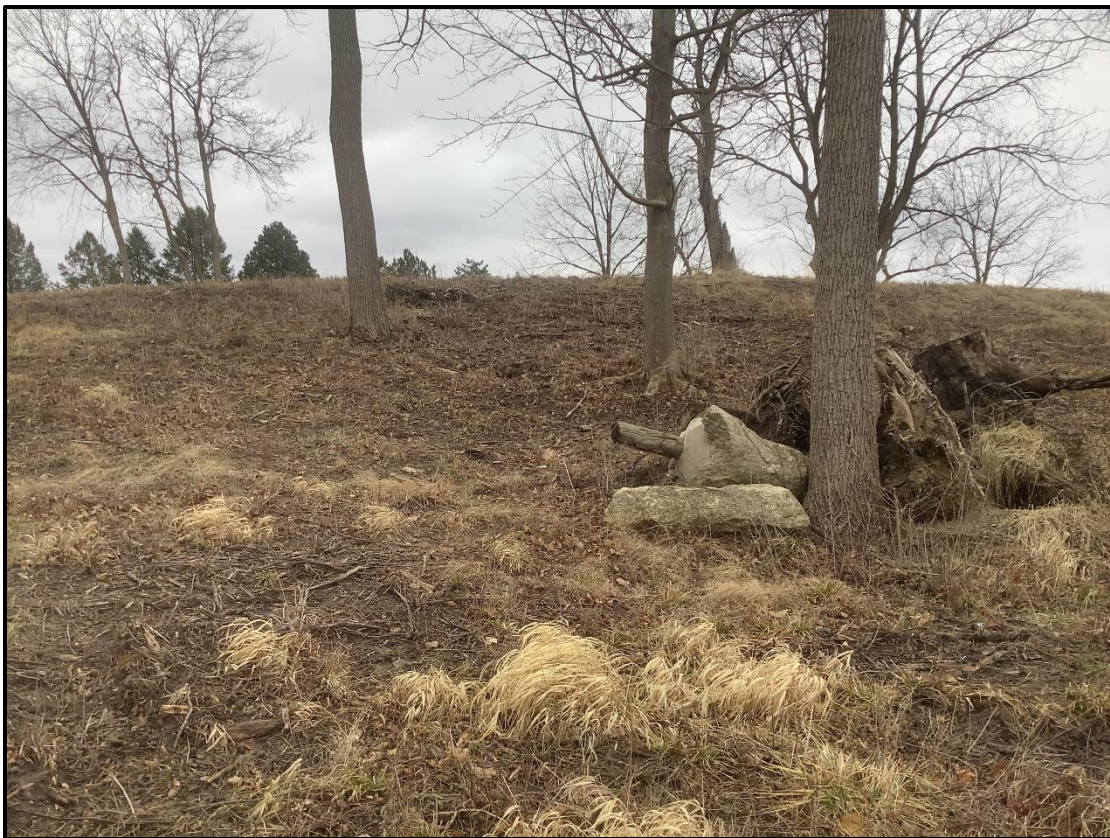
Figure 15. View looking southeast showing stumps, concrete and other bulldozed material in the eastern infield area.

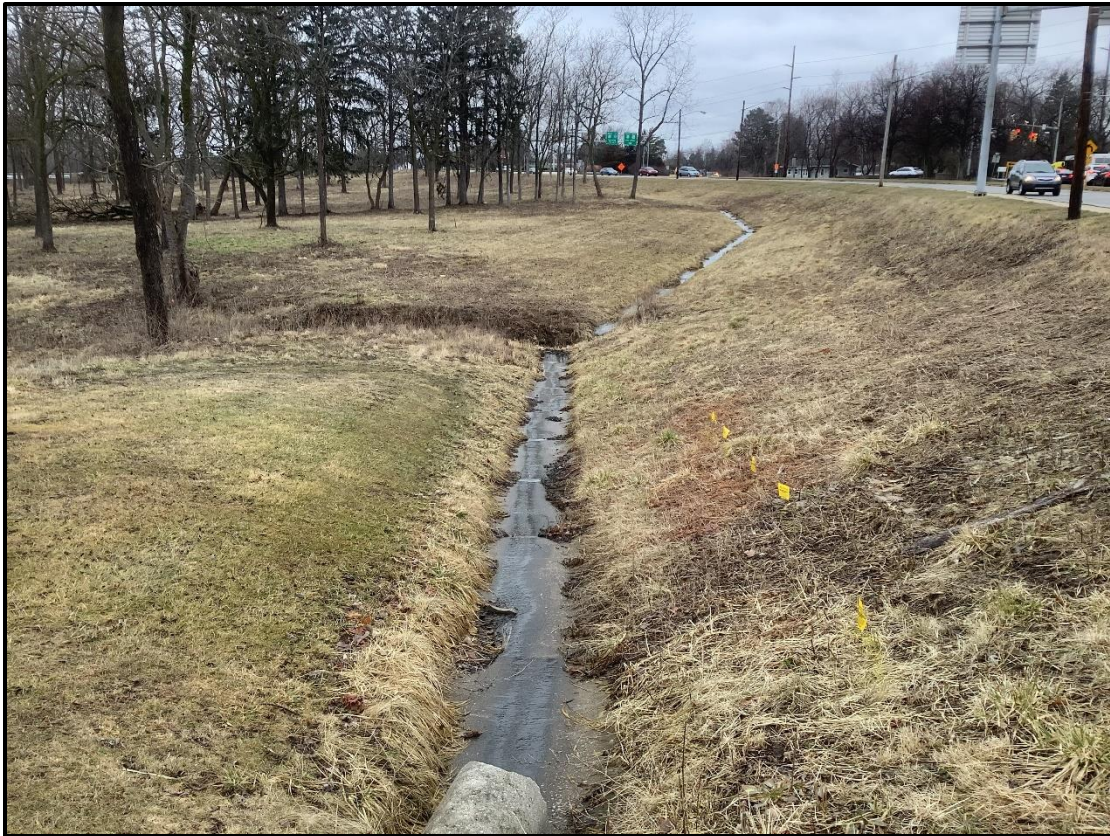
Figure 16. View looking west along State Route 51/Monroe Street showing the graded area where residences once stood prior to the construction of US 23.

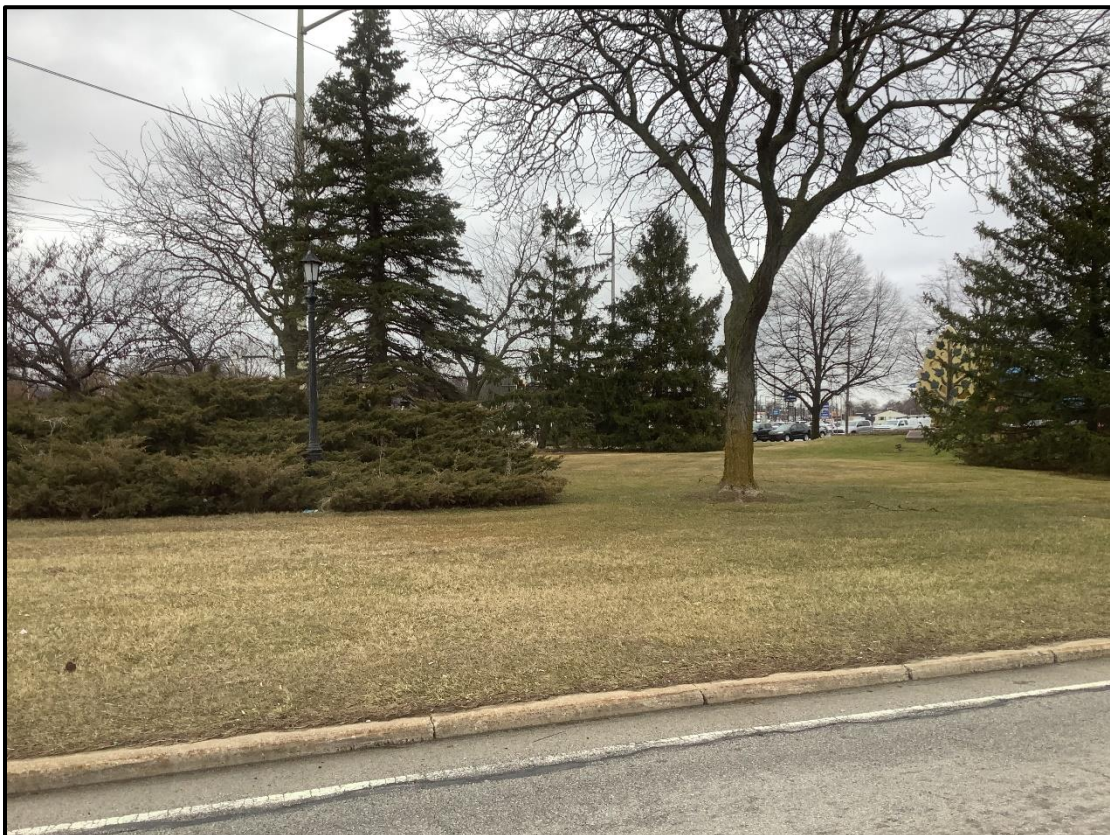
Figure 17. View looking east across the triangular-shaped grassy area between State Route 51 and State Route 184. The intersection will be modified through this area to allow the new intersection to line up with the new ramp configuration.

Areas along the State Route 51 and State Route 184 intersection, where the roadways will be modified to accommodate the new ramps east of US 23, have been heavily modified by residential, roadway, and underground utility development (Figure 17). Proposed temporary and permanent right-of-way west of US 23 is confined to urban land (along State Route 51/Monroe Street) and land previously modified by US 23 construction and/or in hydric Sloan soils (which were flooded at the time of the field review). The extent of modern disturbances across the entire LUC-23 project area preclude the presence of significant and intact archaeological deposits.

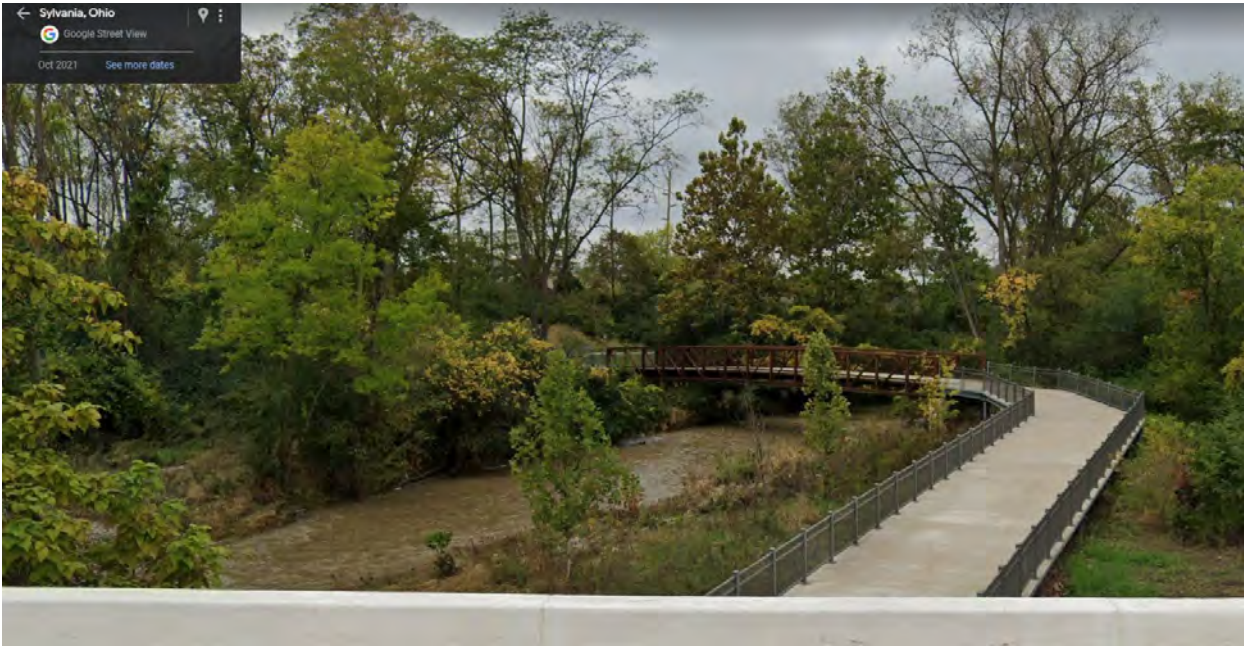
Photograph 4 View of the easement area on the ProMedica Flower Hospital property, looking west from US 23. The far side of the bridge is on the ProMedica Flower Hospital property. An easement will be needed here for access during construction and perhaps for roadway maintenance; the modern bridge is not being altered or removed. Google Street View, October 2021

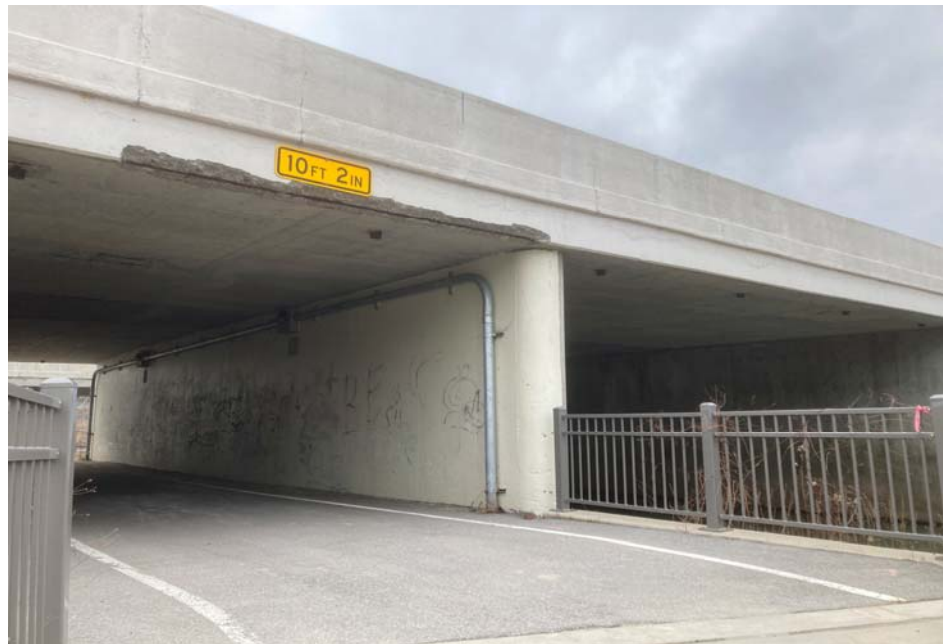
Photo 11:
View of the underside of the
bridge conveying OH-23N
over the Ottawa River.

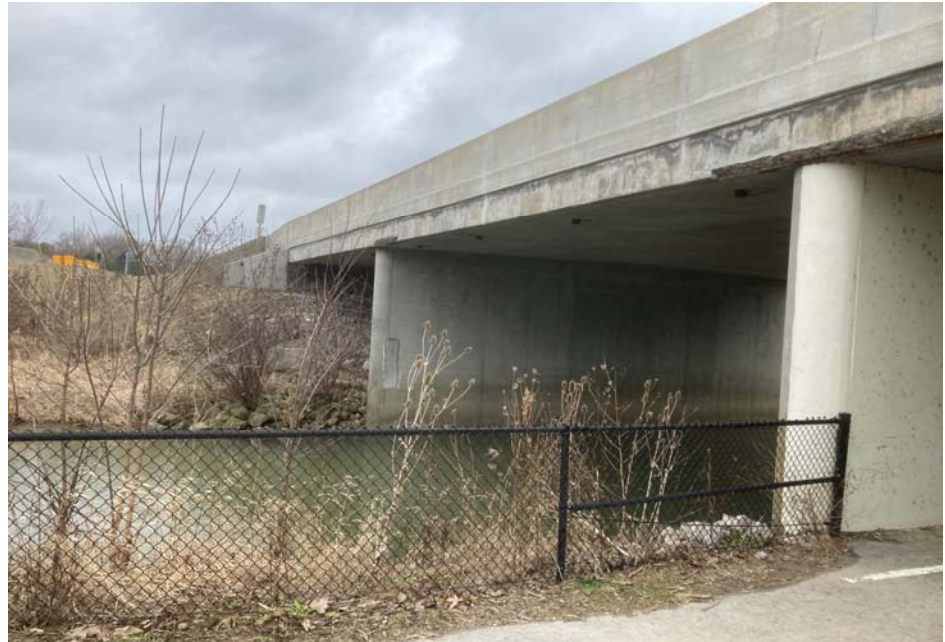
Photo 12:
View of the underside of the
bridge conveying the OH-23N
exit ramp over the Ottawa
River.

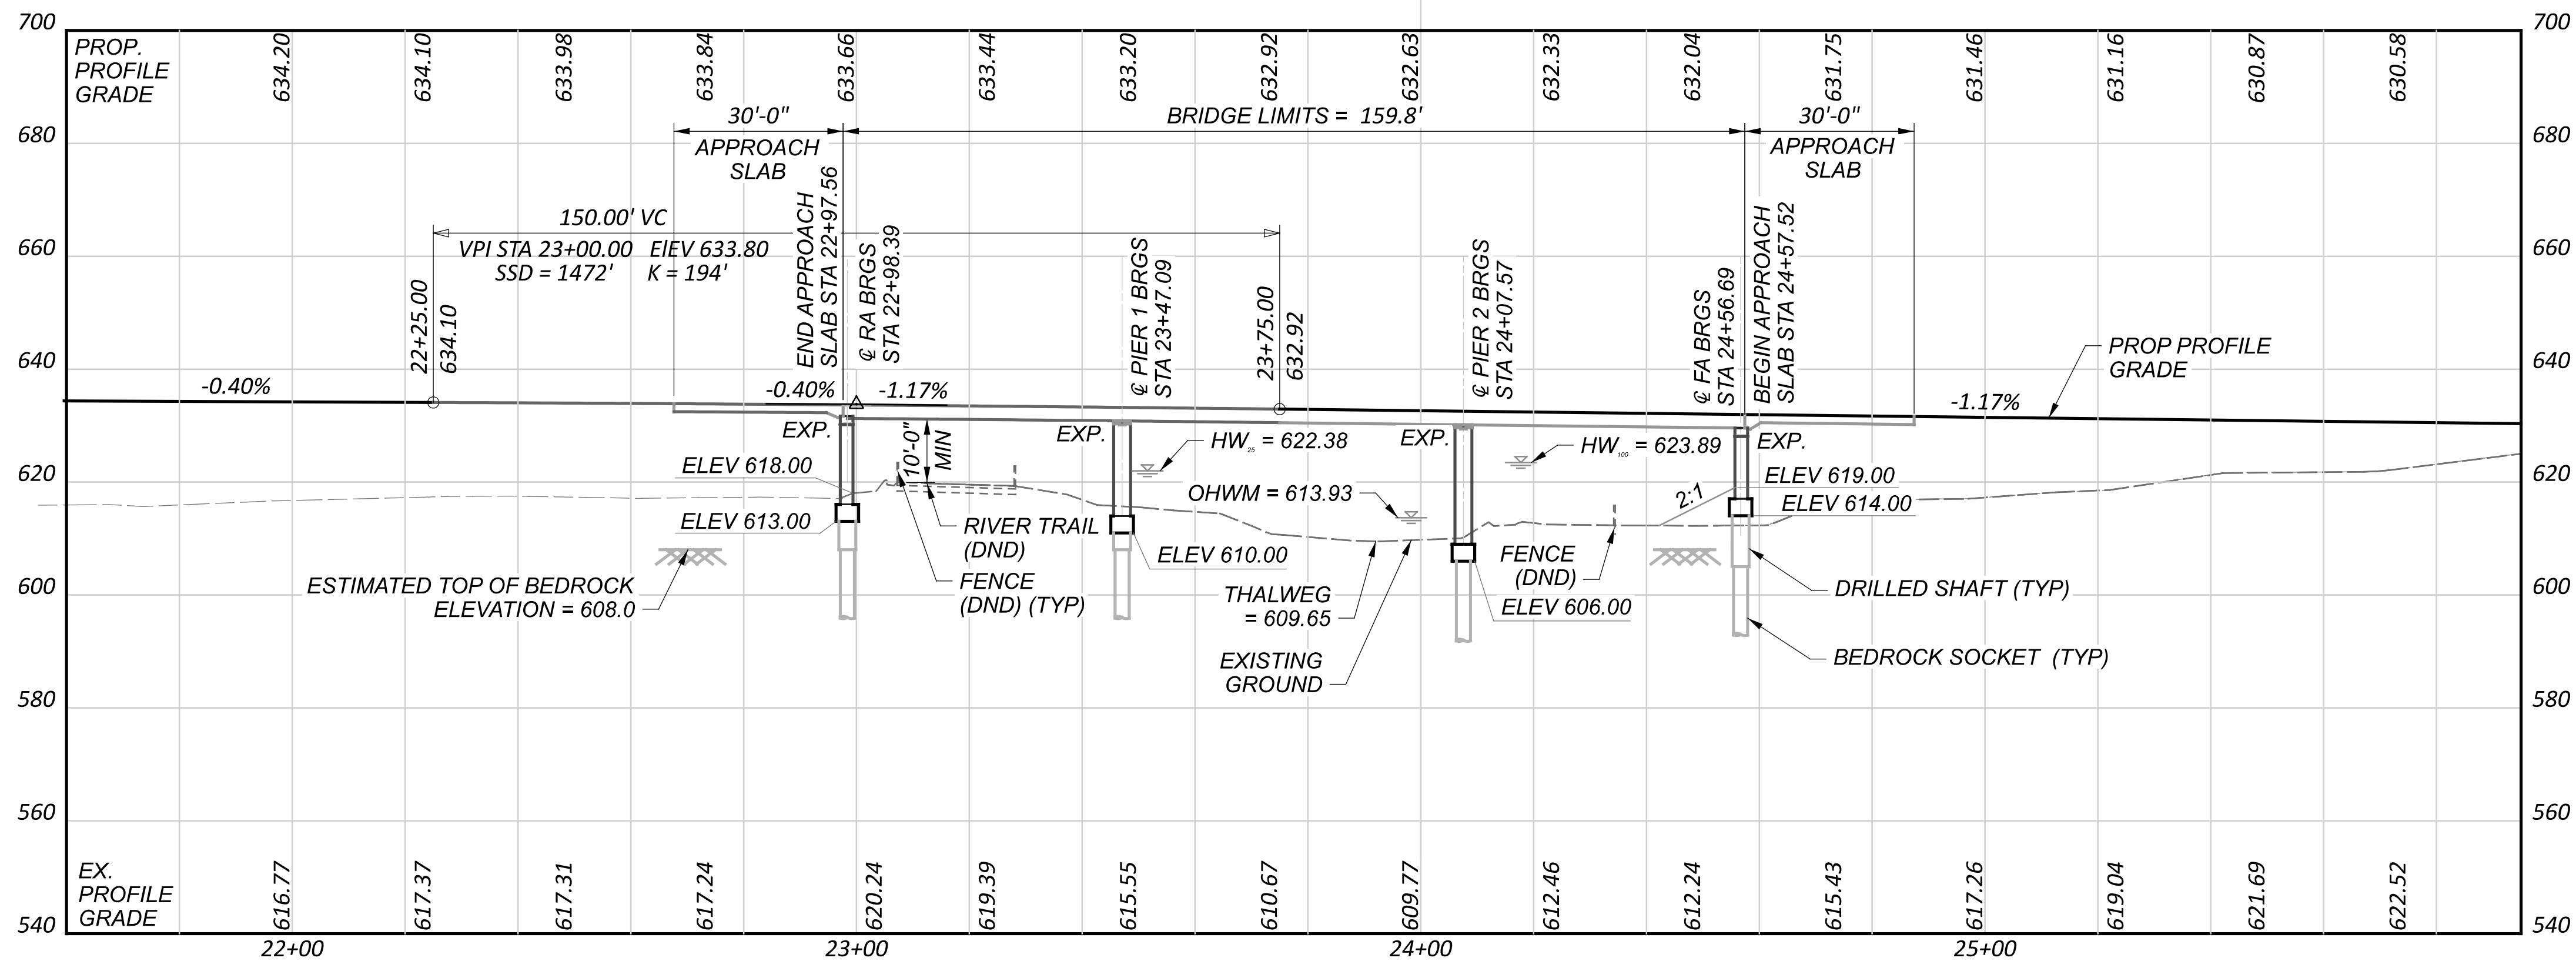
SITE PLAN
BRIDGE NO. LUC-51-1285
OVER US 23

PLAN

PROFILE ALONG & CONSTRUCTION SOUTHBOUND RAMP

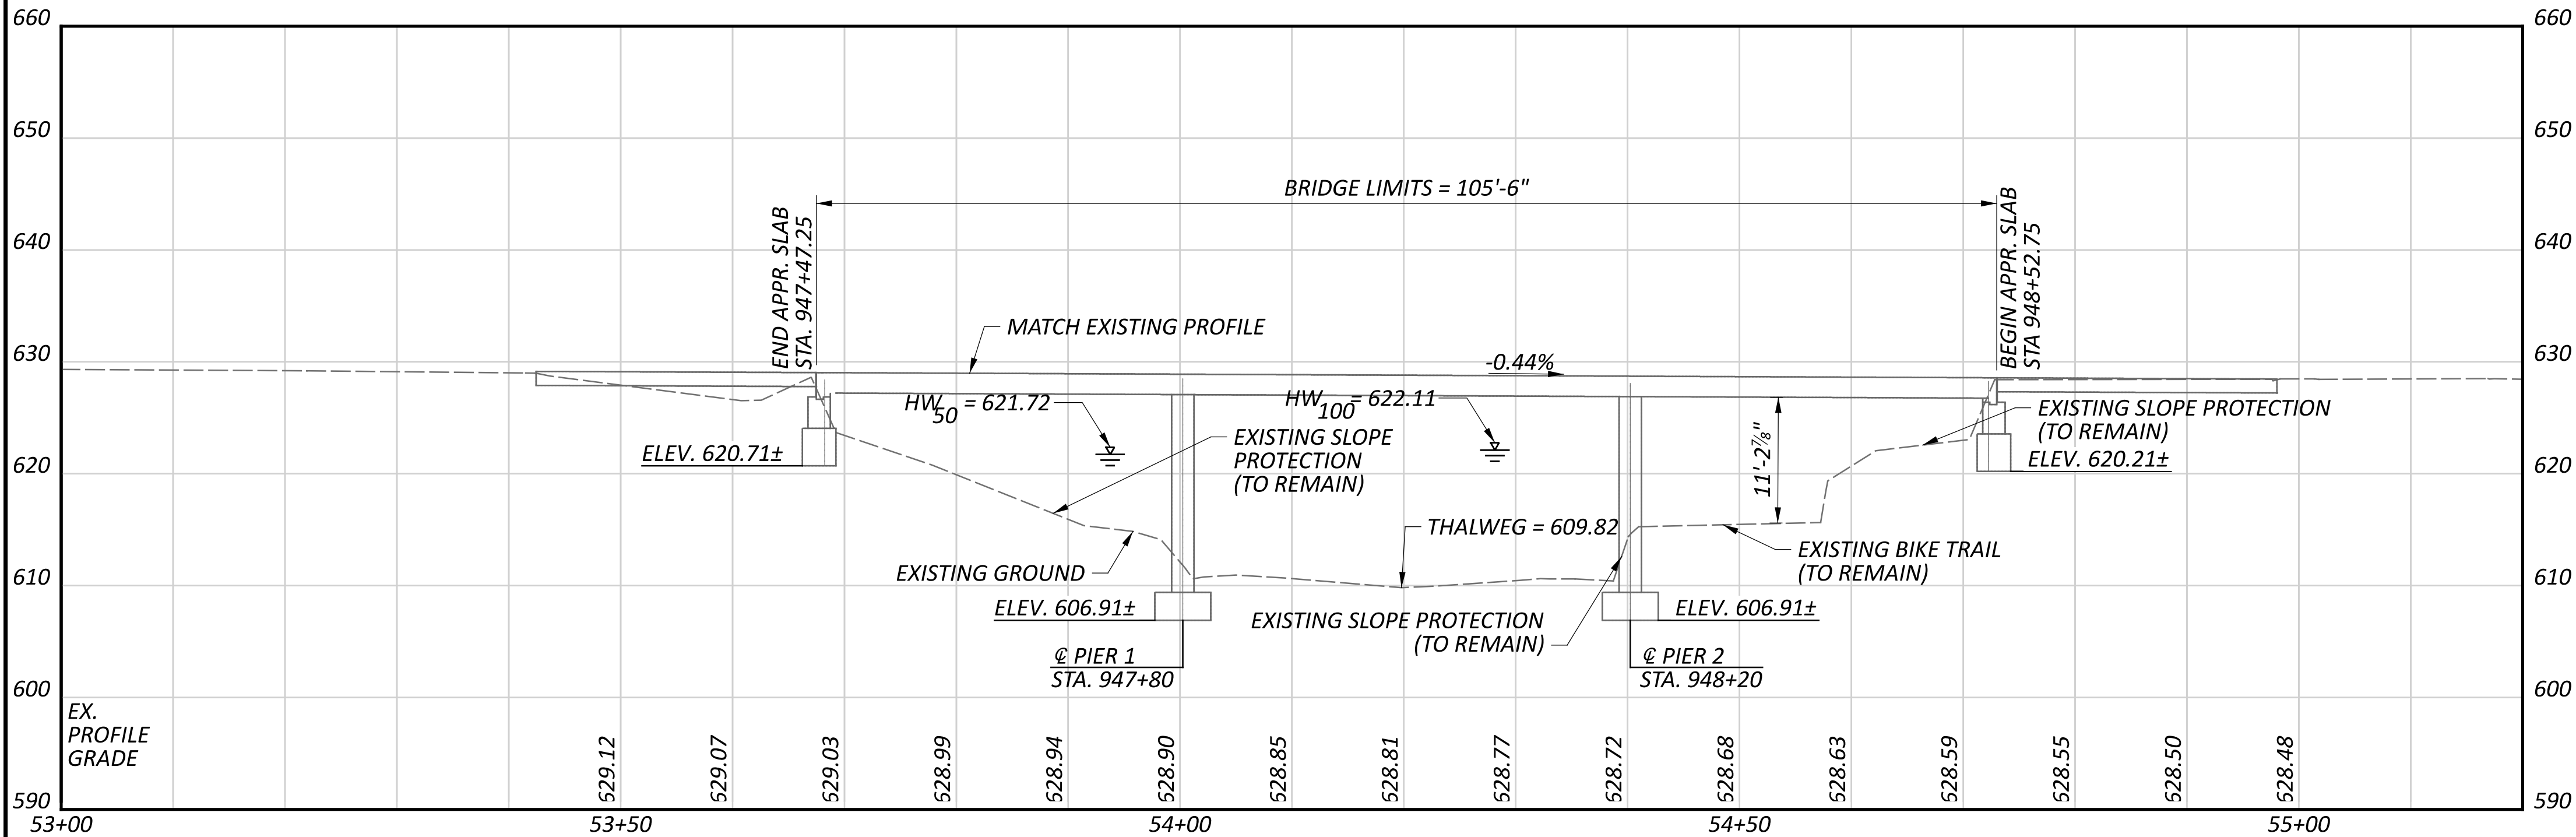
TYPE: 3-SPAN CONTINUOUS REINFORCED CONCRETE SLAB WITH SEMI-INTEGRAL ABUTMENTS AND SOLID WALL PIERS ON DRILLED SHAFTS.
SPANS: 49'-6", 49'-6", 49'-6" C/C BEARINGS ALONG REFERENCE CHORD
ROADWAY: 25'-0" TOE/TOE PARAPET
LOADING: HL93 AND 60PSF FUTURE WEARING SURFACE
SKEW: VARIES
WEARING SURFACE: 1" MONOLITHIC CONCRETE
APPROACH SLABS: 25'-0" LONG (AS-1-15, AS-2-15)
ALIGNMENT: 4°-00'-04" CURVE LT
CROWN: VARIES FT/FT
DECK AREA: 3702 SF
COORDINATES: LATITUDE 41° 42' 43.90" N
LONGITUDE 83° 41' 15.10" W

PLAN

PROFILE ALONG # US 23 SOUTHBOUND
