CONSTRUCTION NOTICE

**ALLEN JUNCTION-WESTGATE 138kV TRANSMISSION
LINE STRUCTURE RELOCATION-ODOT PROJECT**

Case No.: 25-0111-EL-BNR

April 15, 2025

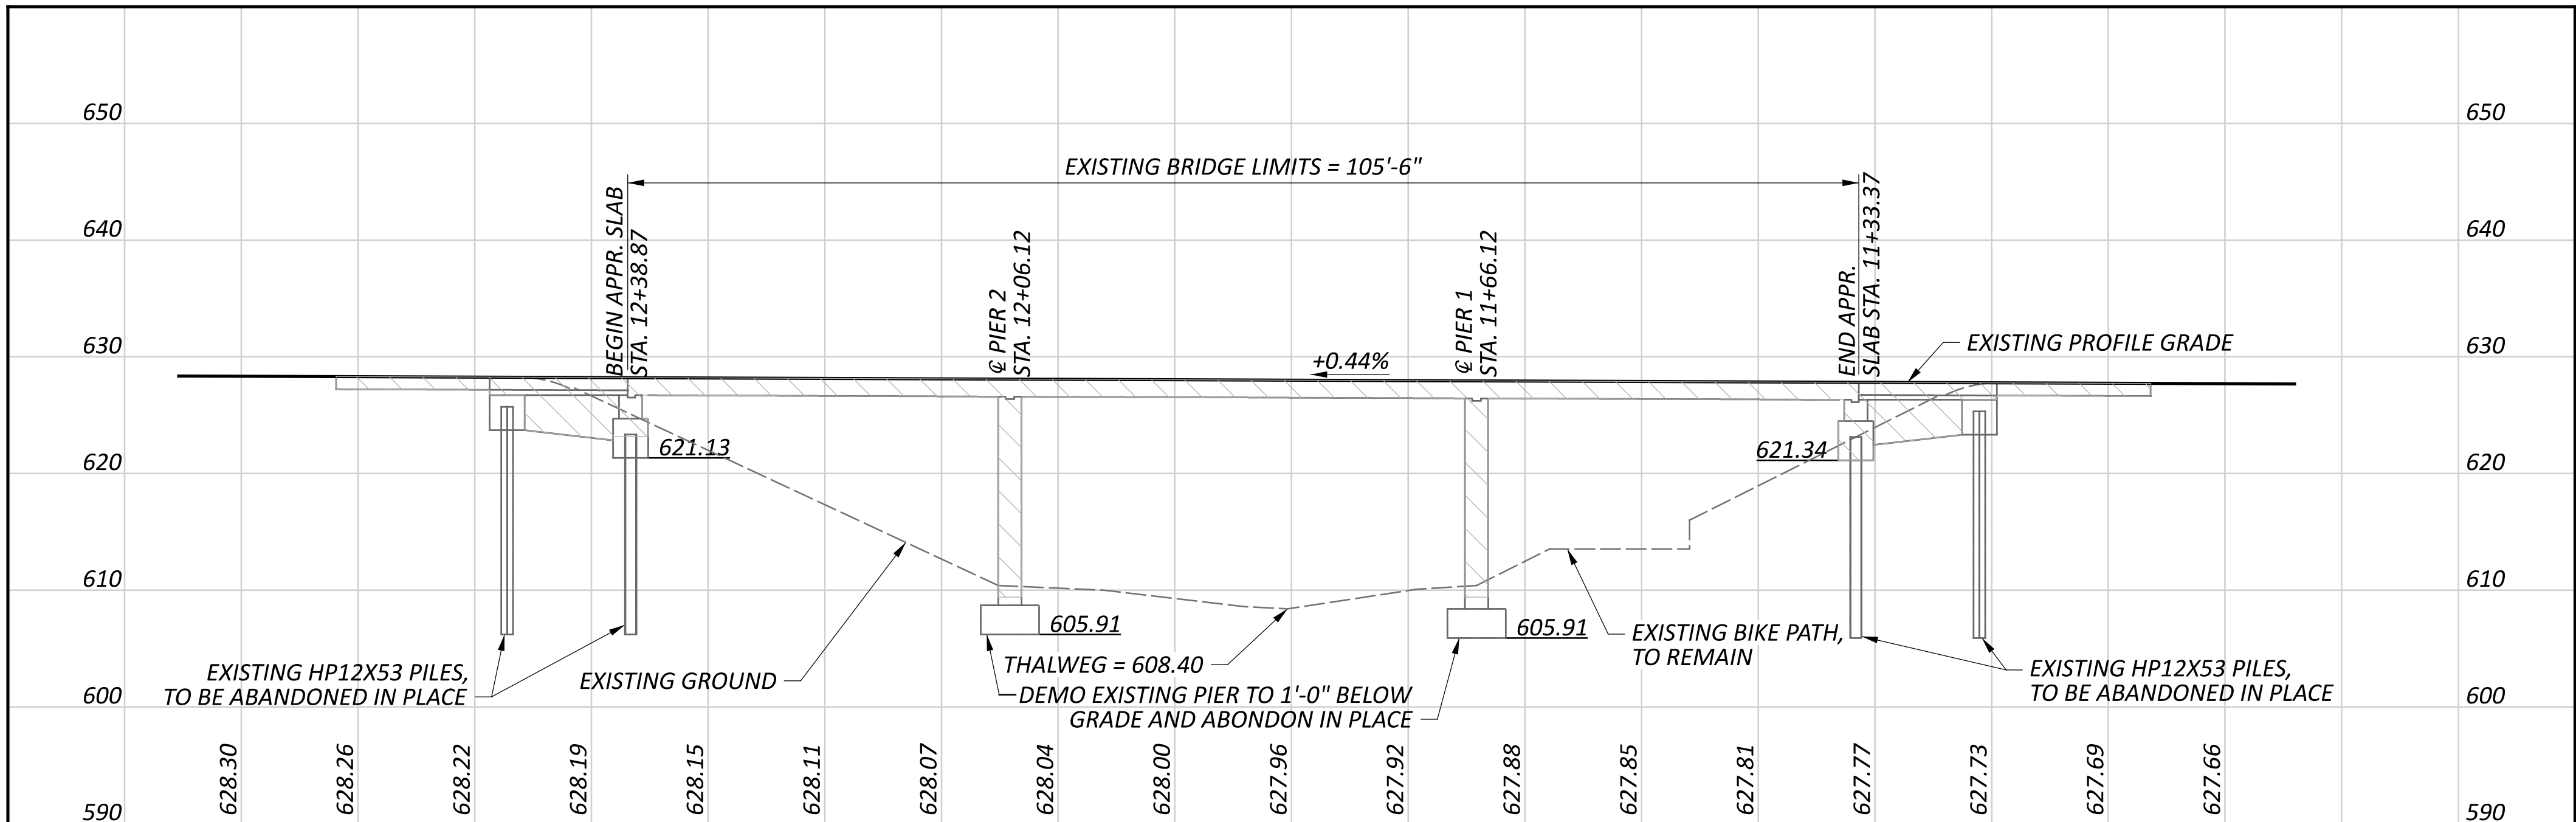
PLAN

- BRIDGE PARAPETS, DECK, AND APPROACH SLABS SHALL BE REMOVED IN THEIR ENTIERITY.
- BRIDGE ABUTMENTS, PIERS, AND WINGWALLS SHALL BE REMOVED TO 1'-0" BELOW GRADE.
- AREAS OF STRUCTURAL REMOVAL SHALL BE REGRADED TO MATCH SURROUNDING TERRAIN.

PROFILE ALONG BL OF US 23 NORTHBOUND OFF RAMP (RAMP A)
