**AMERICAN TRANSMISSION SYSTEMS,
INCORPORATED
A FIRSTENERGY COMPANY**

CONSTRUCTION NOTICE

**CARLISLE-LORAIN Q-24 138 KV TRANSMISSION
LINE SWITCH REPLACEMENT PROJECT**

OPSB CASE NO.: 25-0162-EL-BNR

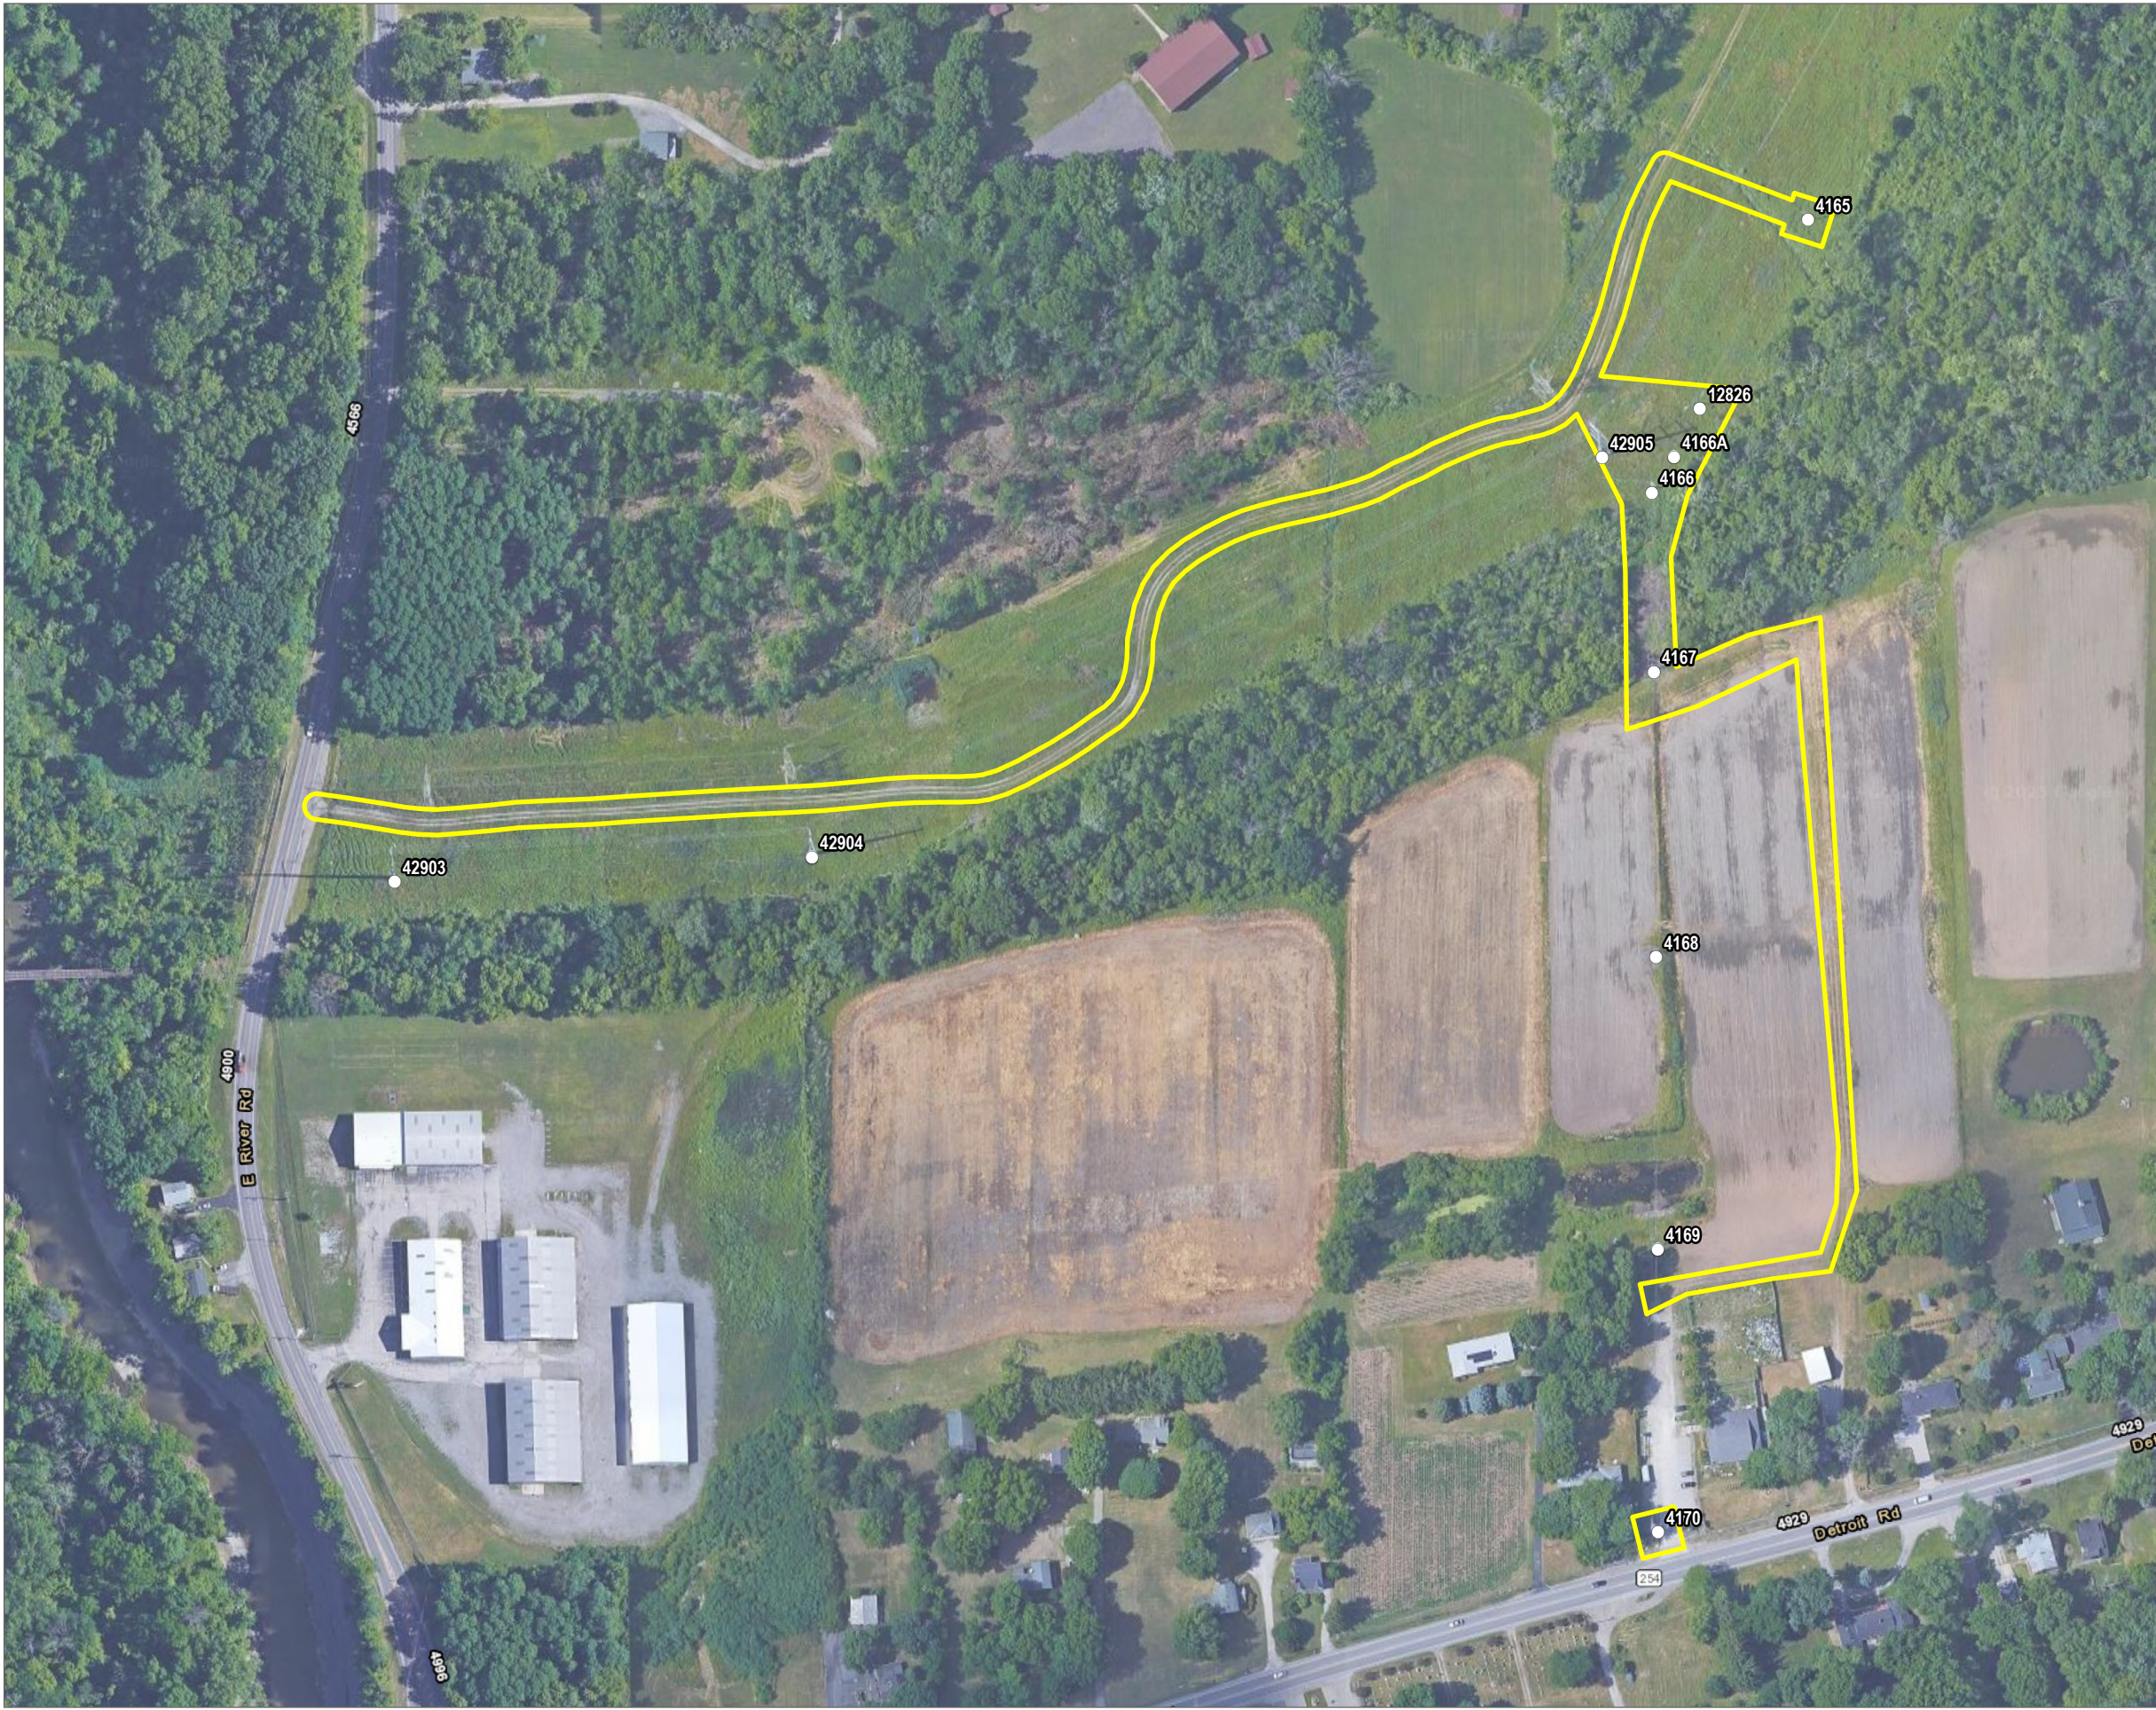
- PROJECT STUDY AREA
- EXISTING STRUCTURE

BASE MAP: GOOGLE MAPS.

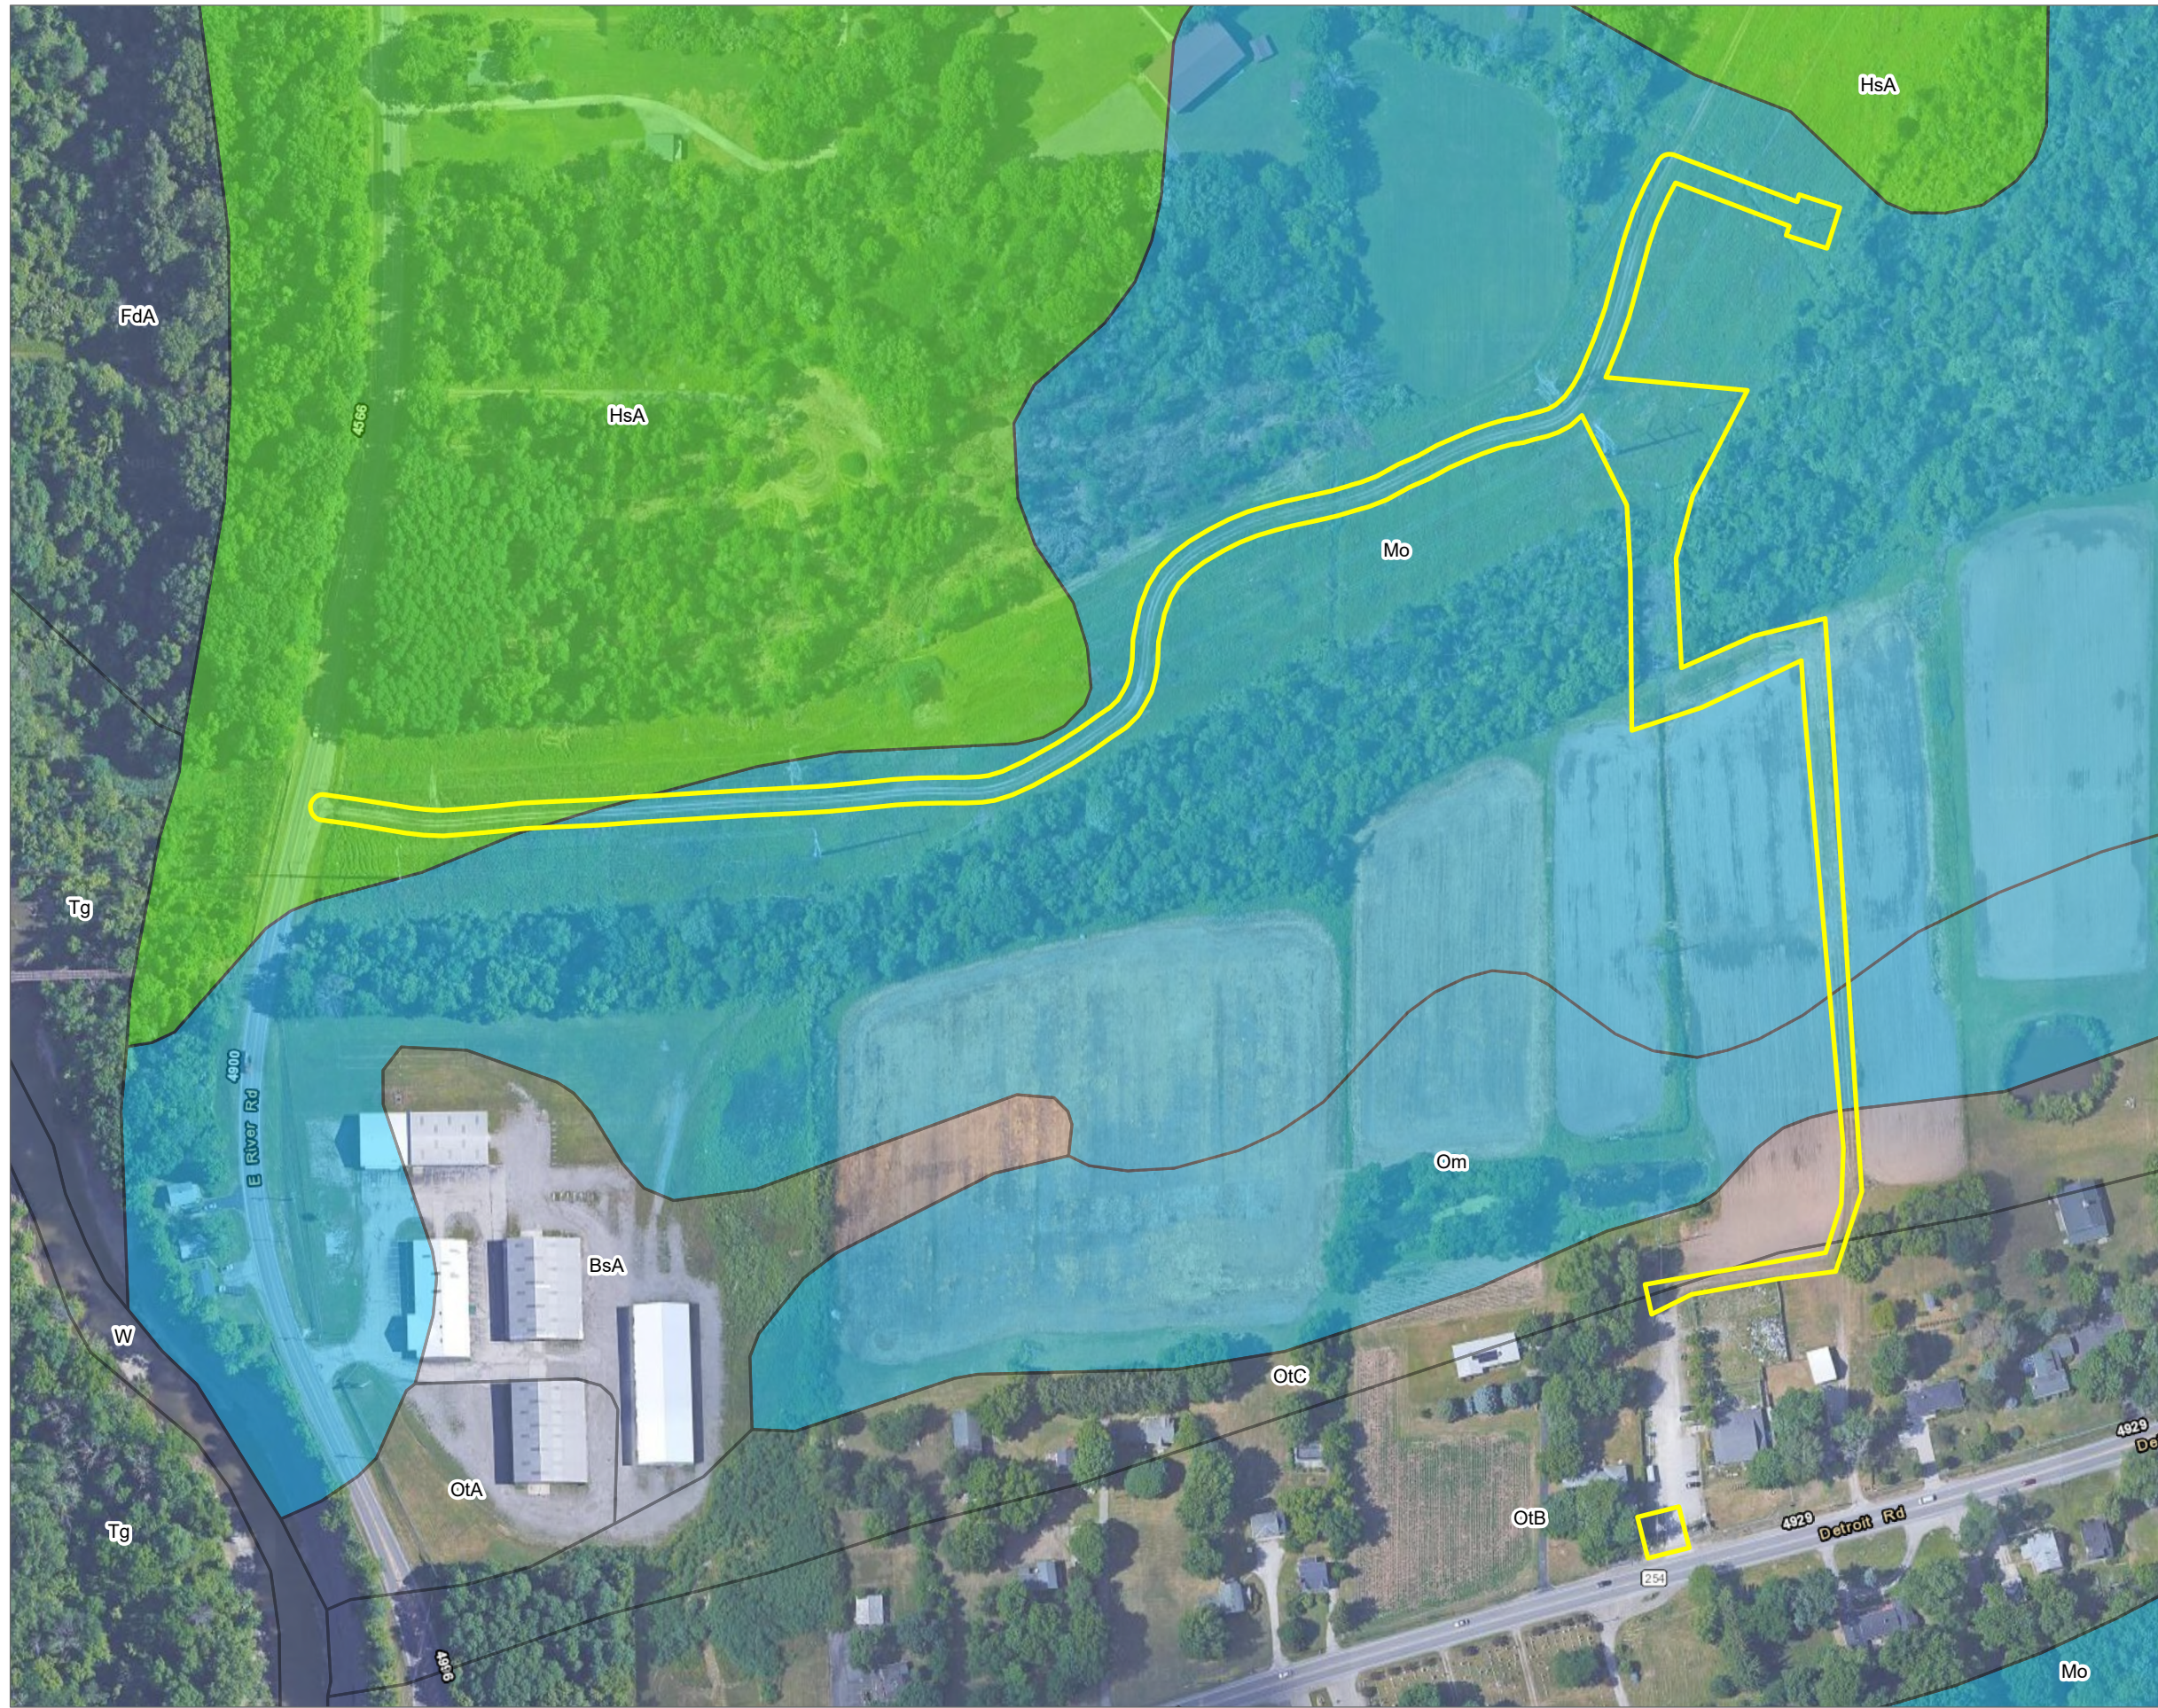
- PROJECT STUDY AREA
- HYDRIC SOIL
- NON-HYDRIC W/ HYDRIC INCLUSIONS SOIL
- NON-HYDRIC SOIL

BASE MAP: GOOGLE MAPS.
DATA SOURCES: SOILS DATA ACQUIRED FROM USDA/NRCS SSURGO DATABASE.

PROJECT: FIRSTENERGY - CARLISLE-LORAIN 138KV Q-24 TRANSMISSION LINE SWITCH REPLACEMENT PROJECT LORAIN COUNTY, OH	
TITLE: SOILS MAP	
DRAWN BY: M. OPEL	PROJ. NO.: 429847.0022.0010
CHECKED BY: M. MOLNAR	FIGURE 3
APPROVED BY: B. FALKINBURG	
DATE: MAY 2025

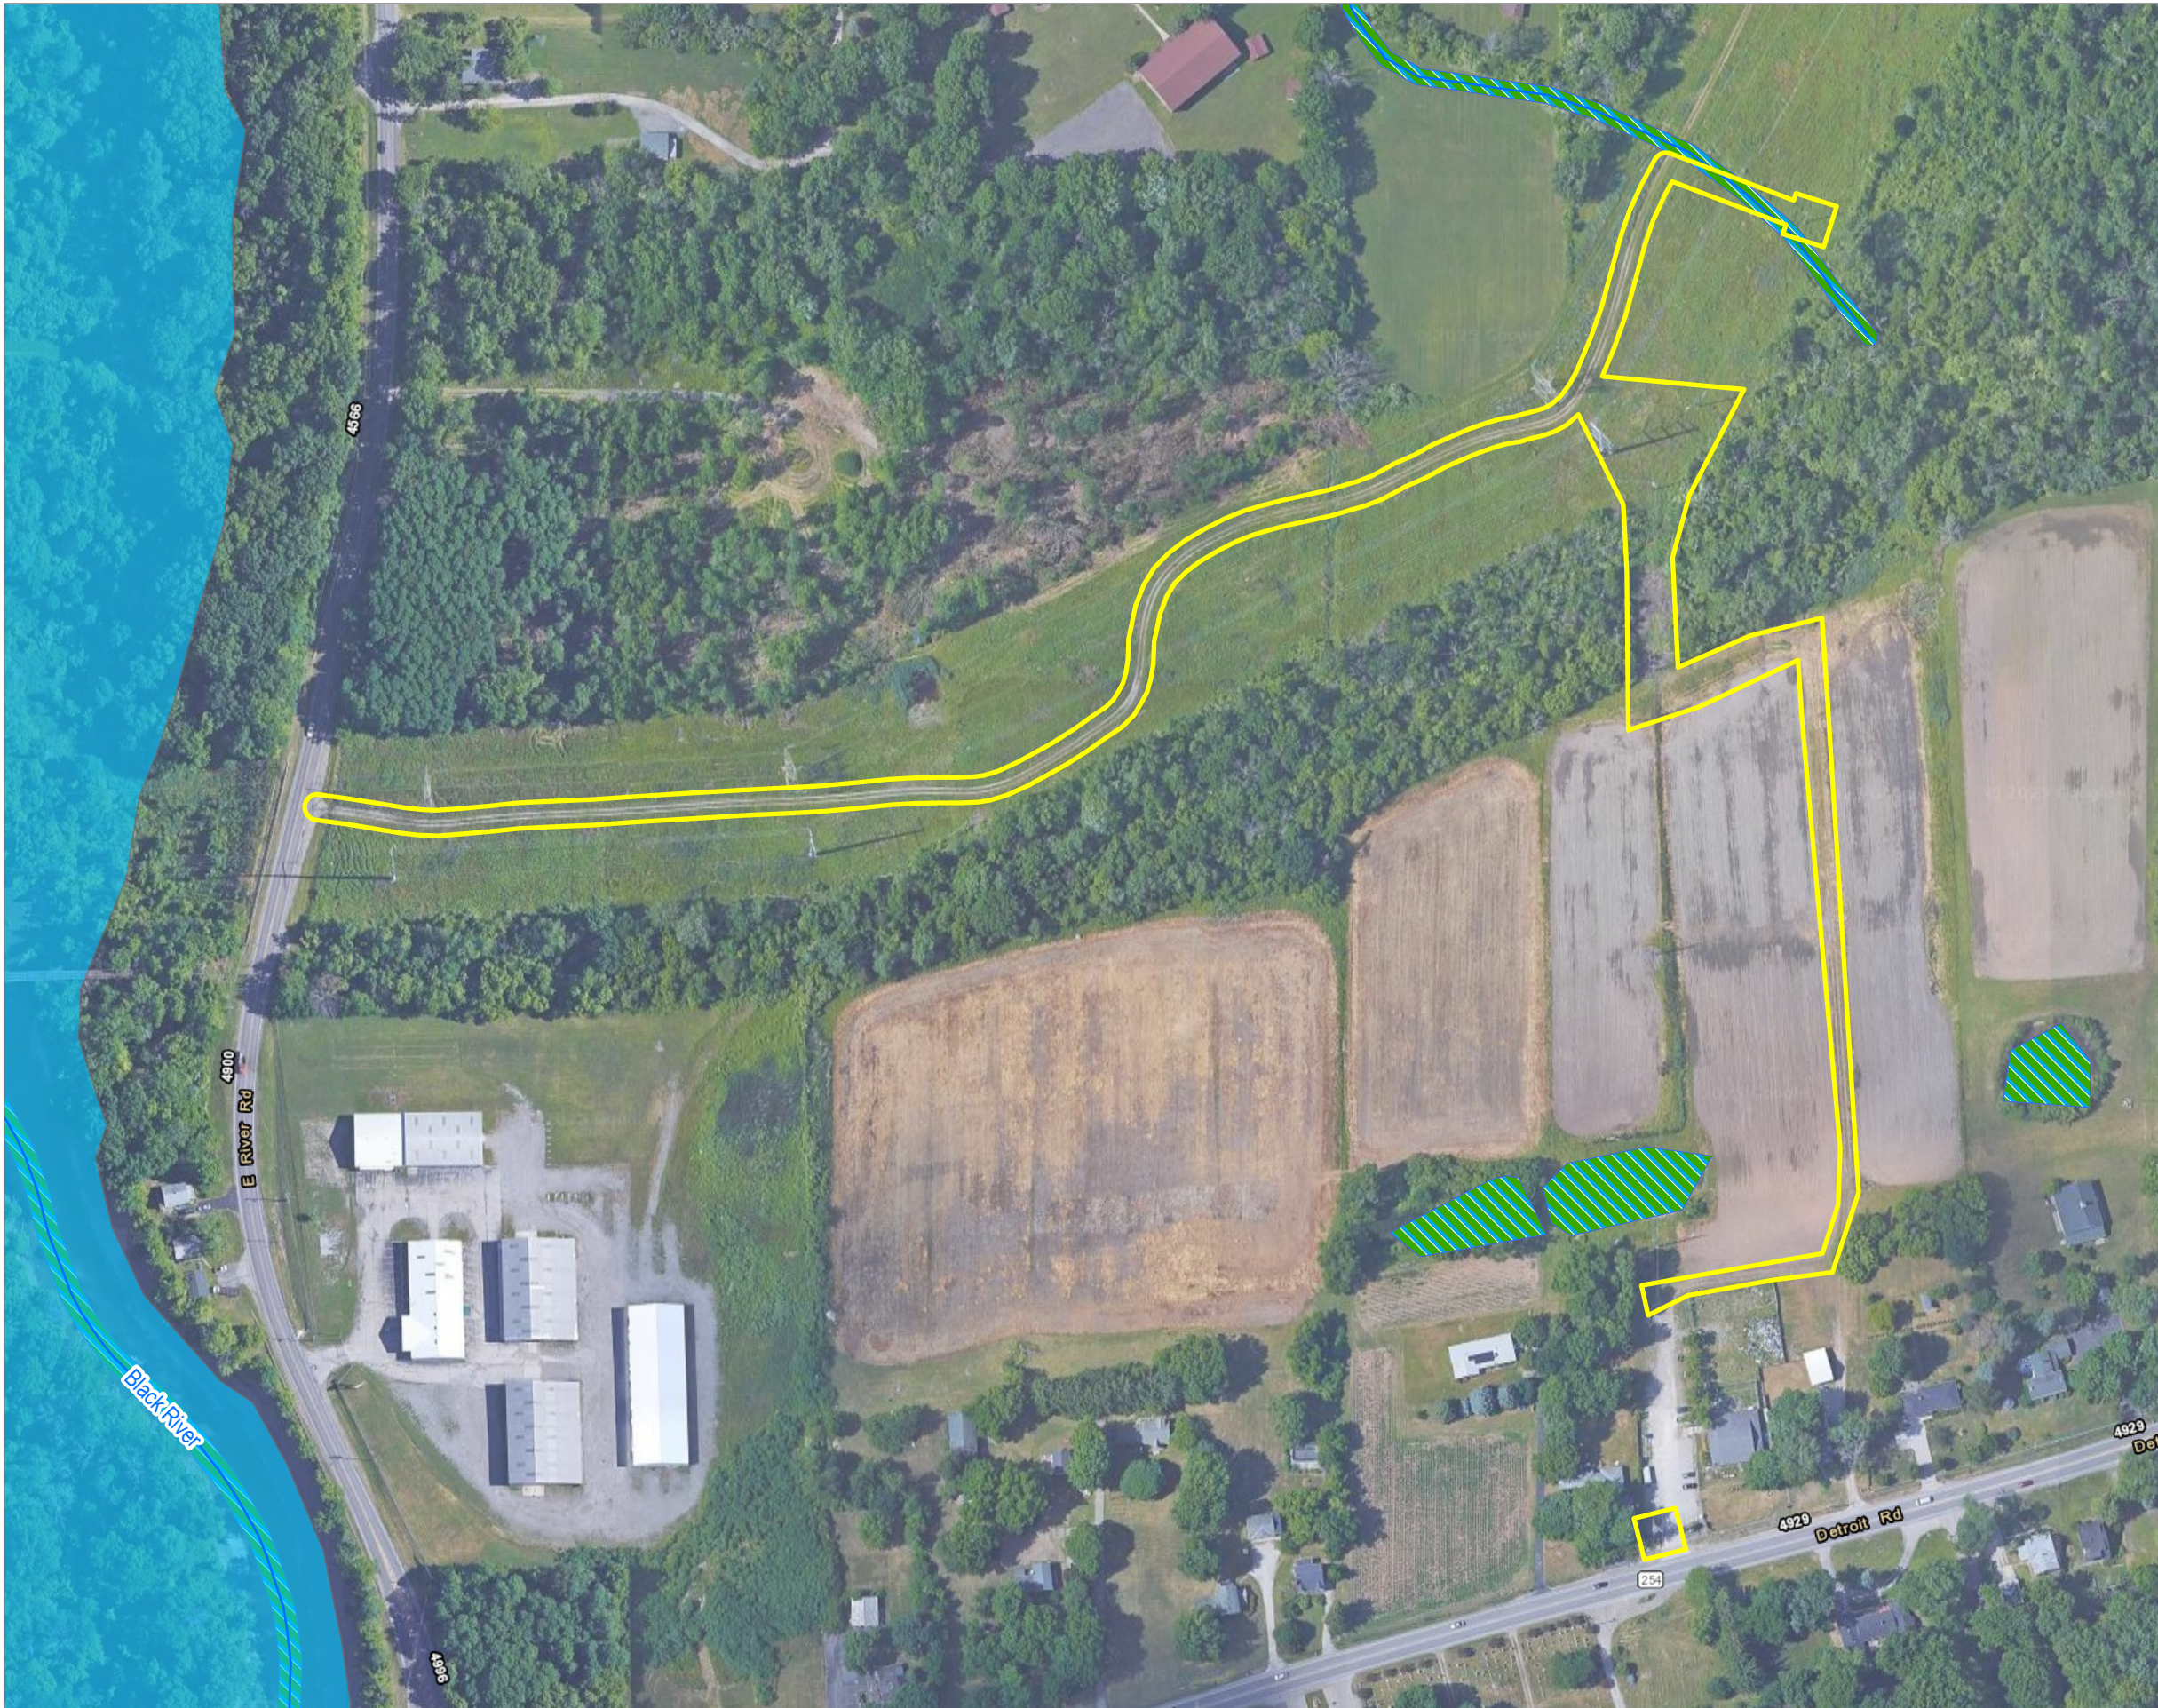
- PROJECT STUDY AREA
- NATIONAL HYDROGRAPHY DATASET (NHD) STREAM
- NATIONAL WETLANDS INVENTORY (NWI) FEATURE
- 100-YEAR FLOOD ZONE

BASE MAP: GOOGLE MAPS.
DATA SOURCES: WETLAND DATA ACQUIRED FROM U.S. FISH & WILDLIFE SERVICE, NATIONAL WETLANDS INVENTORY (NWI). STREAM DATA ACQUIRED FROM USGS, NATIONAL HYDROGRAPHY DATASET (NHD). FLOOD DATA ACQUIRED FROM FEMA, NATIONAL FLOOD HAZARD LAYER (NFHL).

PROJECT: FIRSTENERGY - CARLISLE-LORAIN 138KV Q-24 TRANSMISSION LINE SWITCH REPLACEMENT PROJECT LORAIN COUNTY, OH			
TITLE: NHD, NWI AND FEMA FLOODPLAIN MAP			
DRAWN BY:	M. OPEL	PROJ. NO.:	429847.0022.0010
CHECKED BY:	M. MOLNAR	FIGURE 4	
APPROVED BY:	B. FALKINBURG		
DATE:	MAY 2025		
		1382 WEST NINTH STREET SUITE 400 CLEVELAND, OH 44113 PHONE: 216-344-3072	
FILE:		WDR_SwitchReplacement.aprx
