LETTER OF NOTIFICATION

DARROW SUBSTATION EXPANSION PROJECT

OPSB CASE NO.: 19-0585-EL-BLN

**WETLAND DELINEATION
AND SURFACE WATER STUDY**

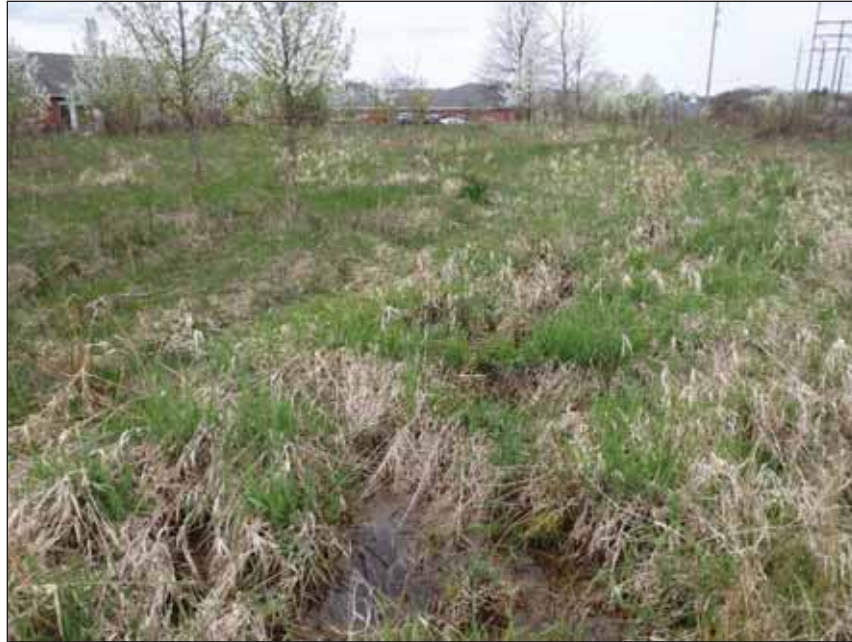
Photograph 1. View facing southwest towards Wetland 0423-01.

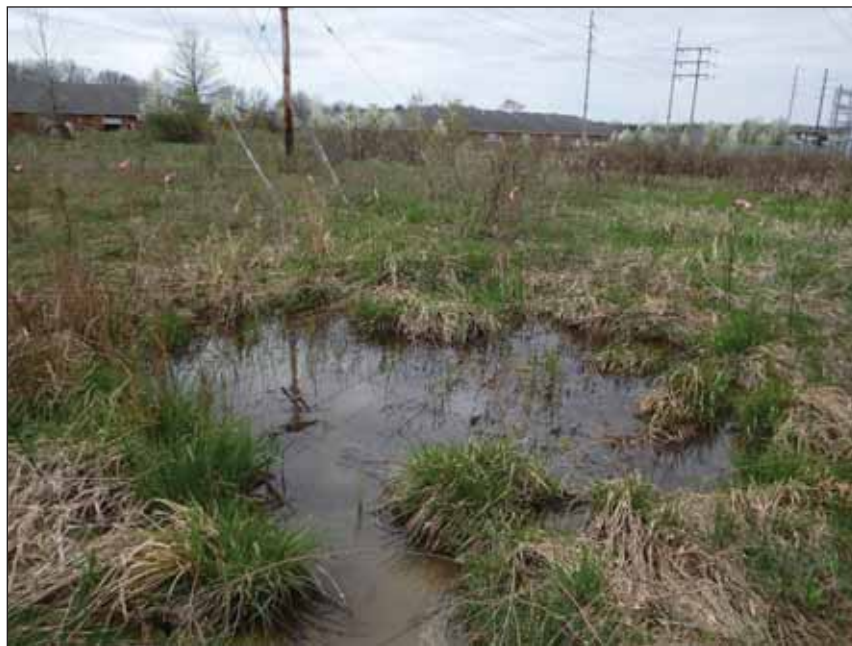
Photograph 2. View facing south towards Wetland 0423-03

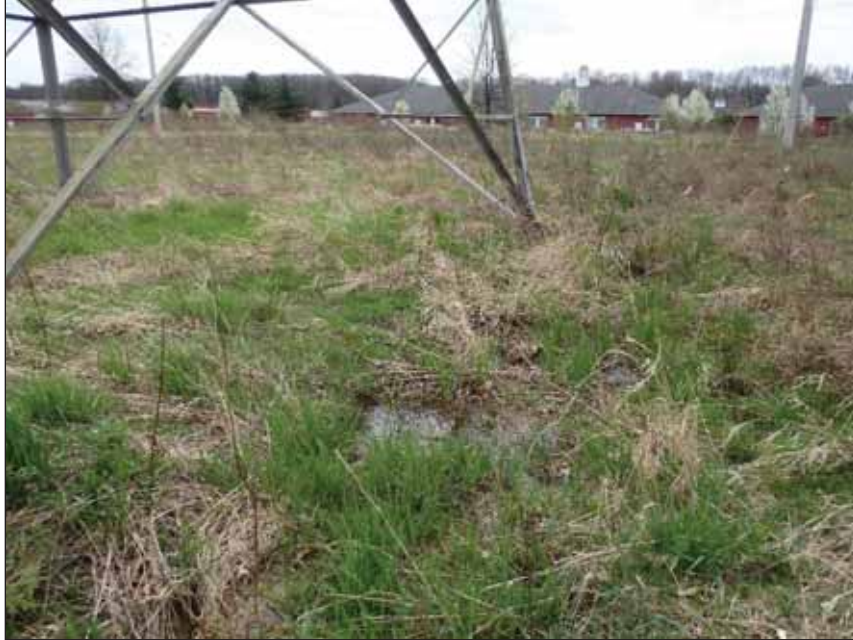
Photograph 3. View facing south towards Wetland 0423-03.

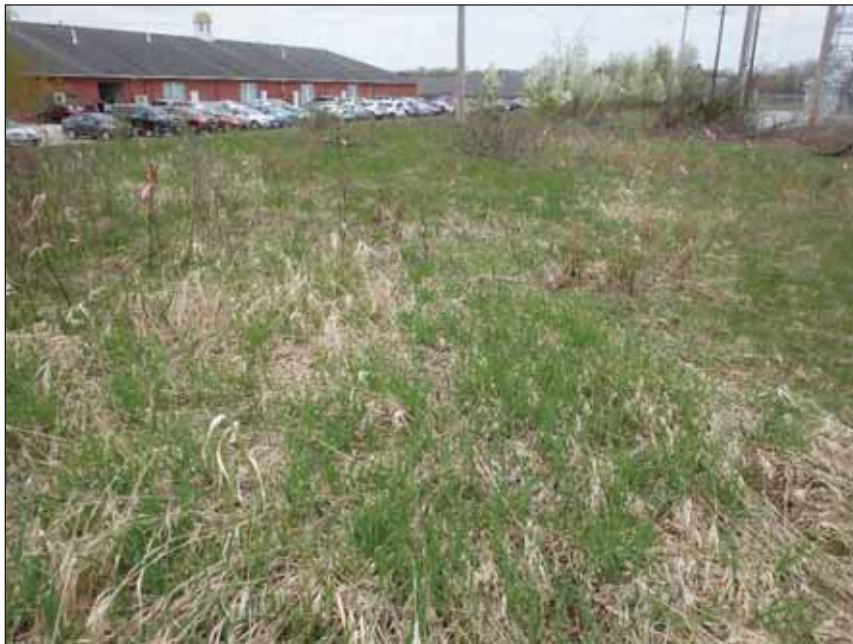
Photograph 4. View facing southwest towards Wetland 0423-05

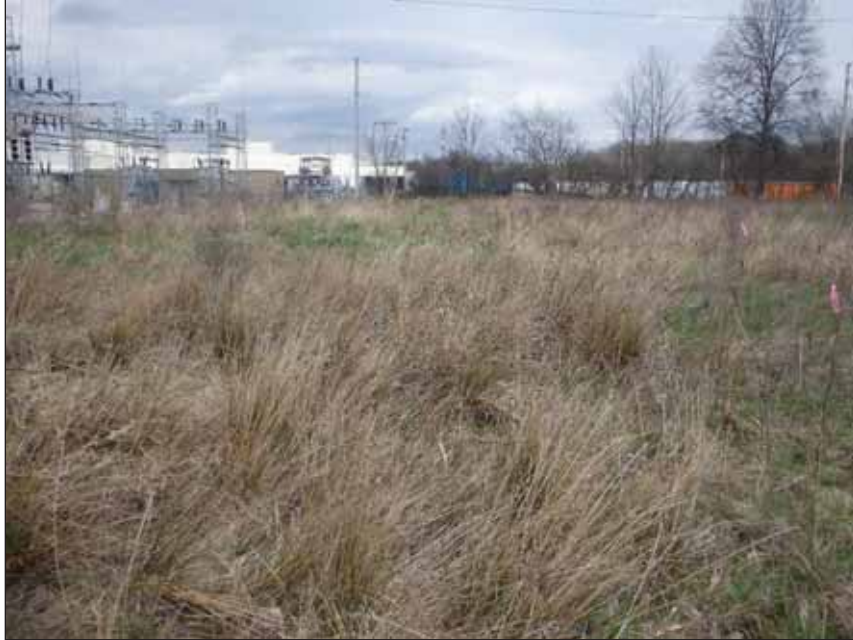
Photograph 5. View facing northwest towards Wetland 0423-07

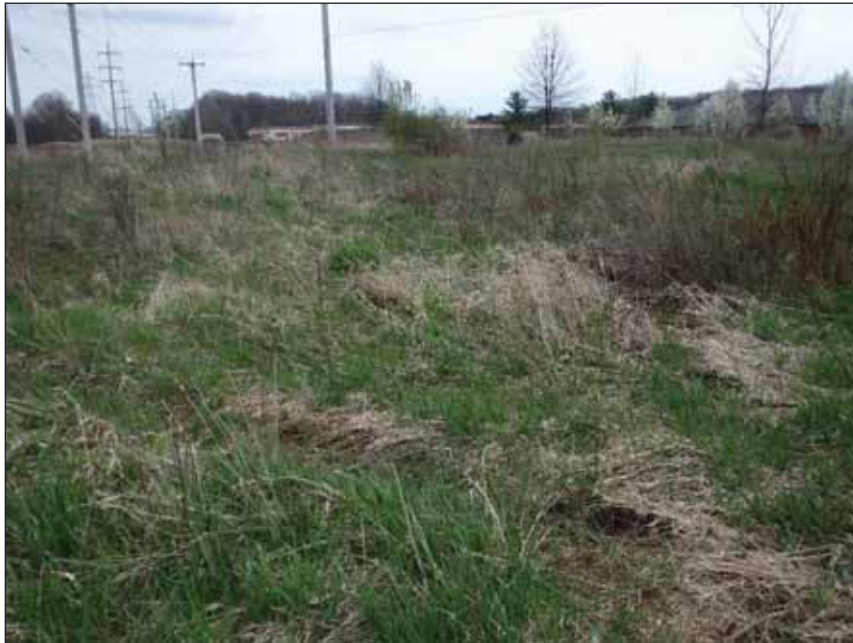
Photograph 6. View facing east towards Wetland 0423-07

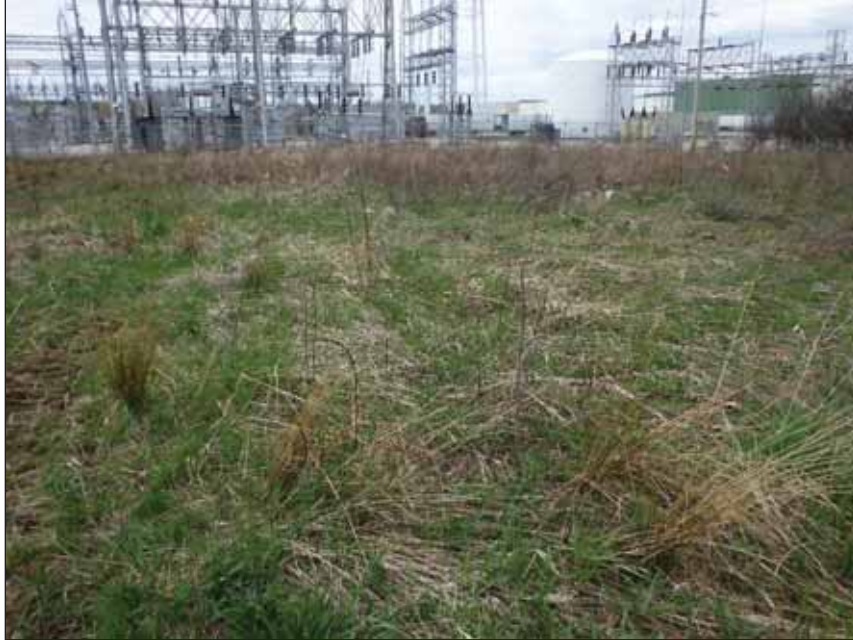
Photograph 7. View facing west towards Wetland 0423-09

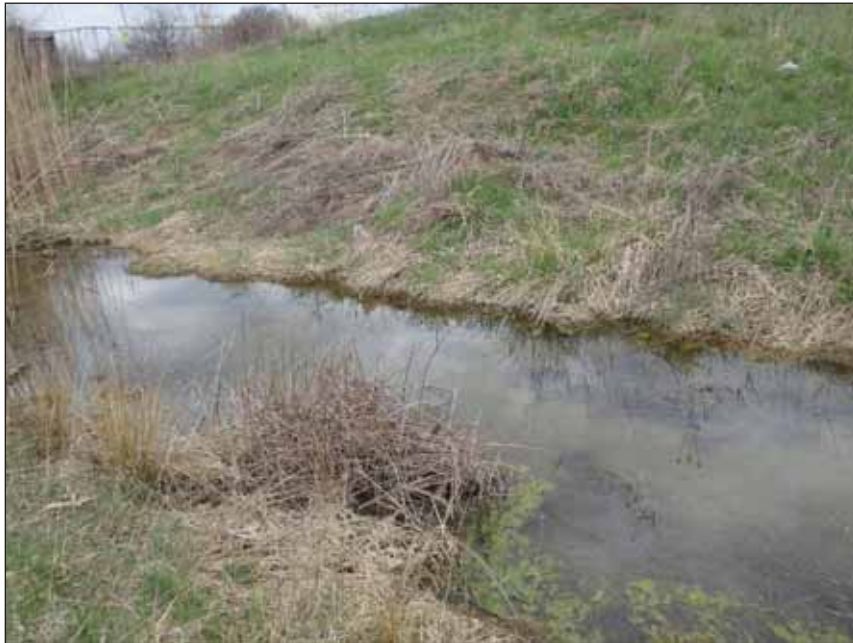
Photograph 8. View facing northwest facing upstream along Stream 0423-04

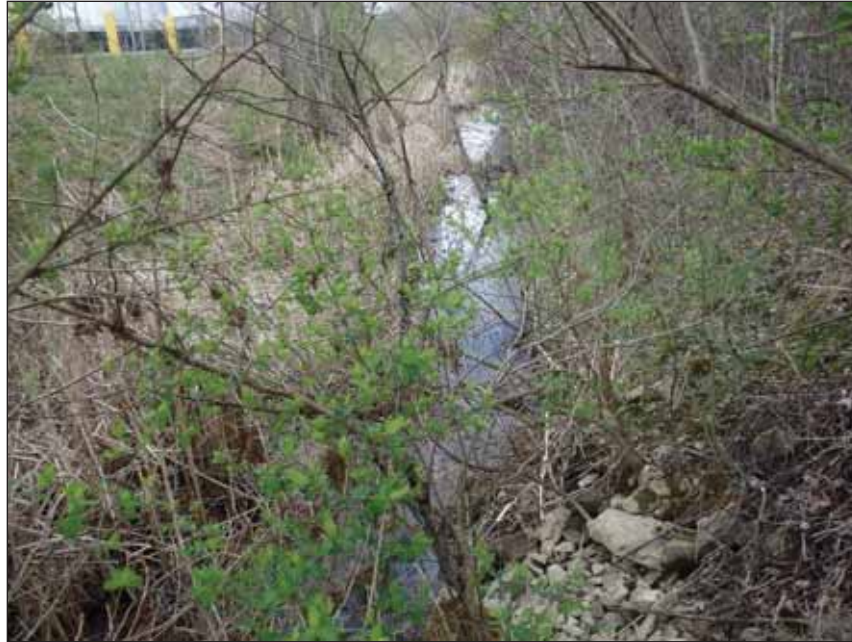
Photograph 9. View facing east facing downstream along Stream 0423-04
