**AMERICAN TRANSMISSION SYSTEMS, INCORPORATED  
A FIRSTENERGY COMPANY**

**CONSTRUCTION NOTICE**  
**BAYSHORE SUBSTATION EXPANSION II PROJECT**  
**Case No.: 26-0797-EL-BNR**

**August 10, 2026**

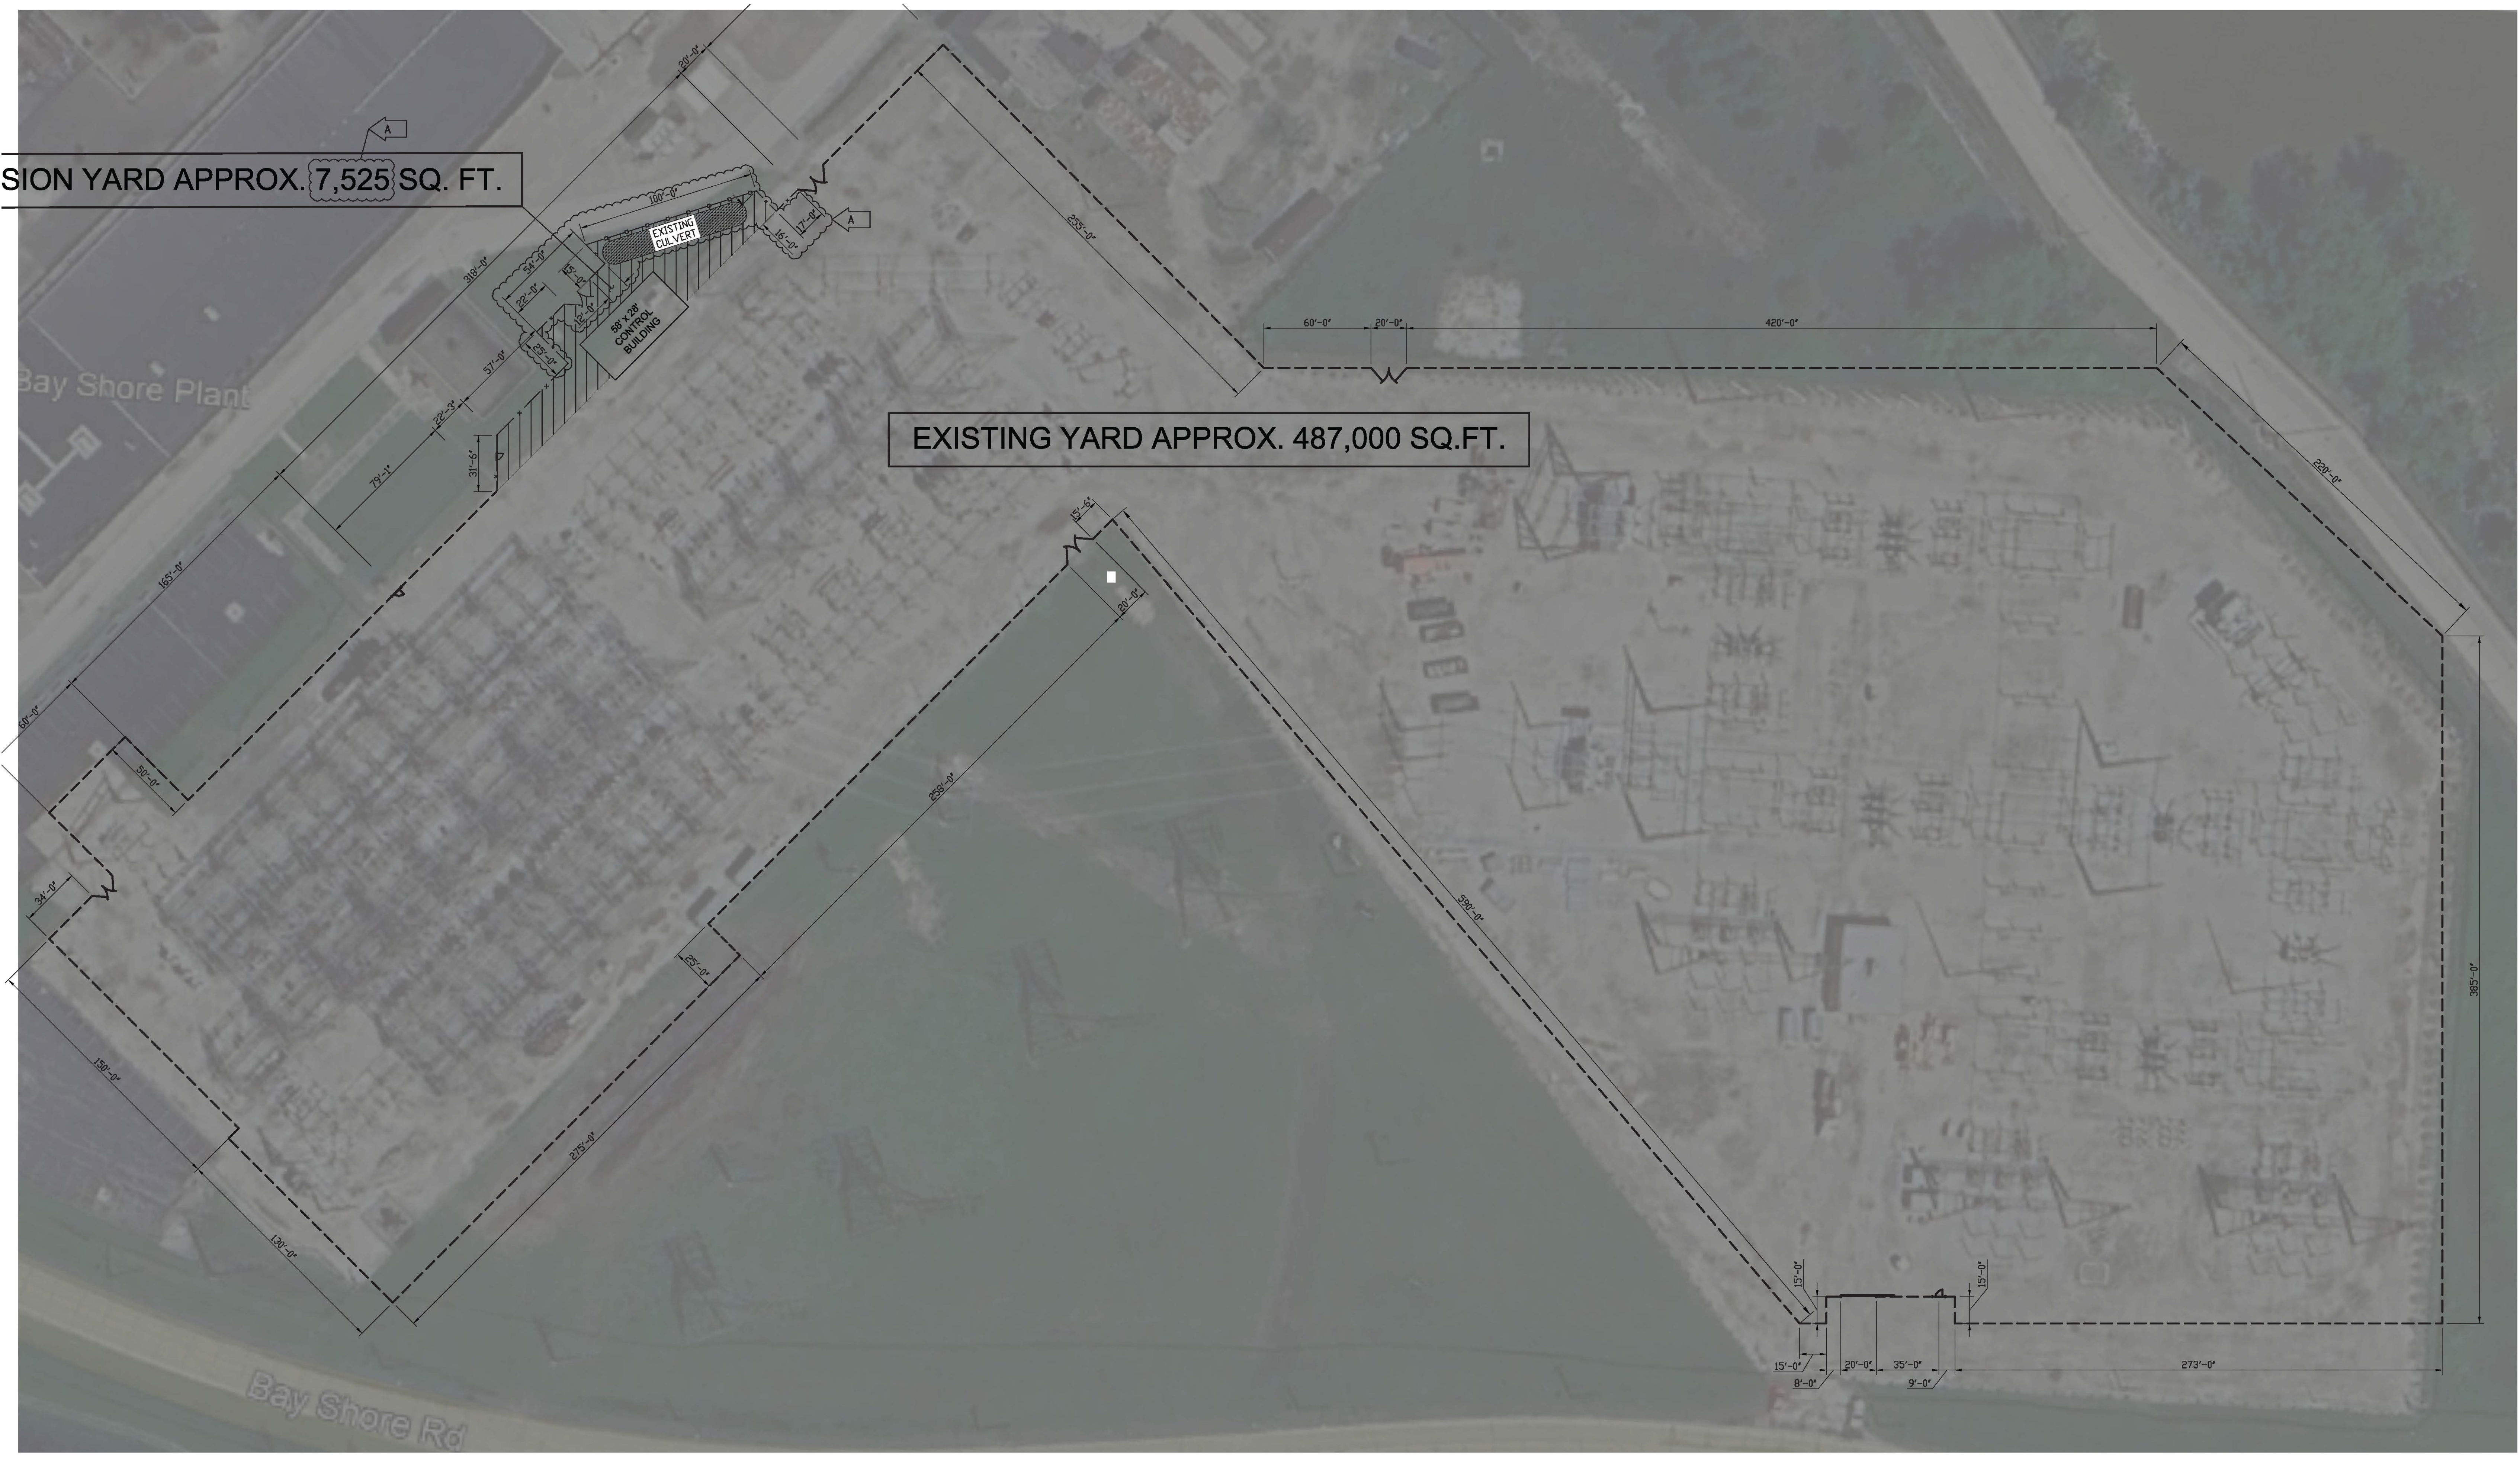
| EXHIBIT 3 | |

EXPANSION YARD APPROX. 7,525 SQ. FT.

EXISTING YARD APPROX. 487,000 SQ.FT.

- x - x - x - x - PROPOSED FENCE LINE
- - - - - EXISTING FENCE LINE
- PROPOSED EXPANSION
- □ - □ - □ - PROPOSED NON-CONDUCTIVE FENCE LINE

| GENERAL LAYOUT | |

The Project is in the city of Oregon in Lucas County, Ohio. The general location of the Project is shown in **Exhibit 1**, a partial copy of the United States Geologic Survey, Lucas County, OH, Quad Map. **Exhibit 2** is a copy of ESRI aerial imagery of the Project area. The general layout of the Project is shown in **Exhibit 3**.

The general location of the Project is shown in **Exhibit 1**, a partial copy of the United States Geologic Survey, Lucas County, OH, Quad Map. **Exhibit 2** is a copy of ESRI aerial imagery of the Project area. The general layout of the Project is shown in **Exhibit 3**.

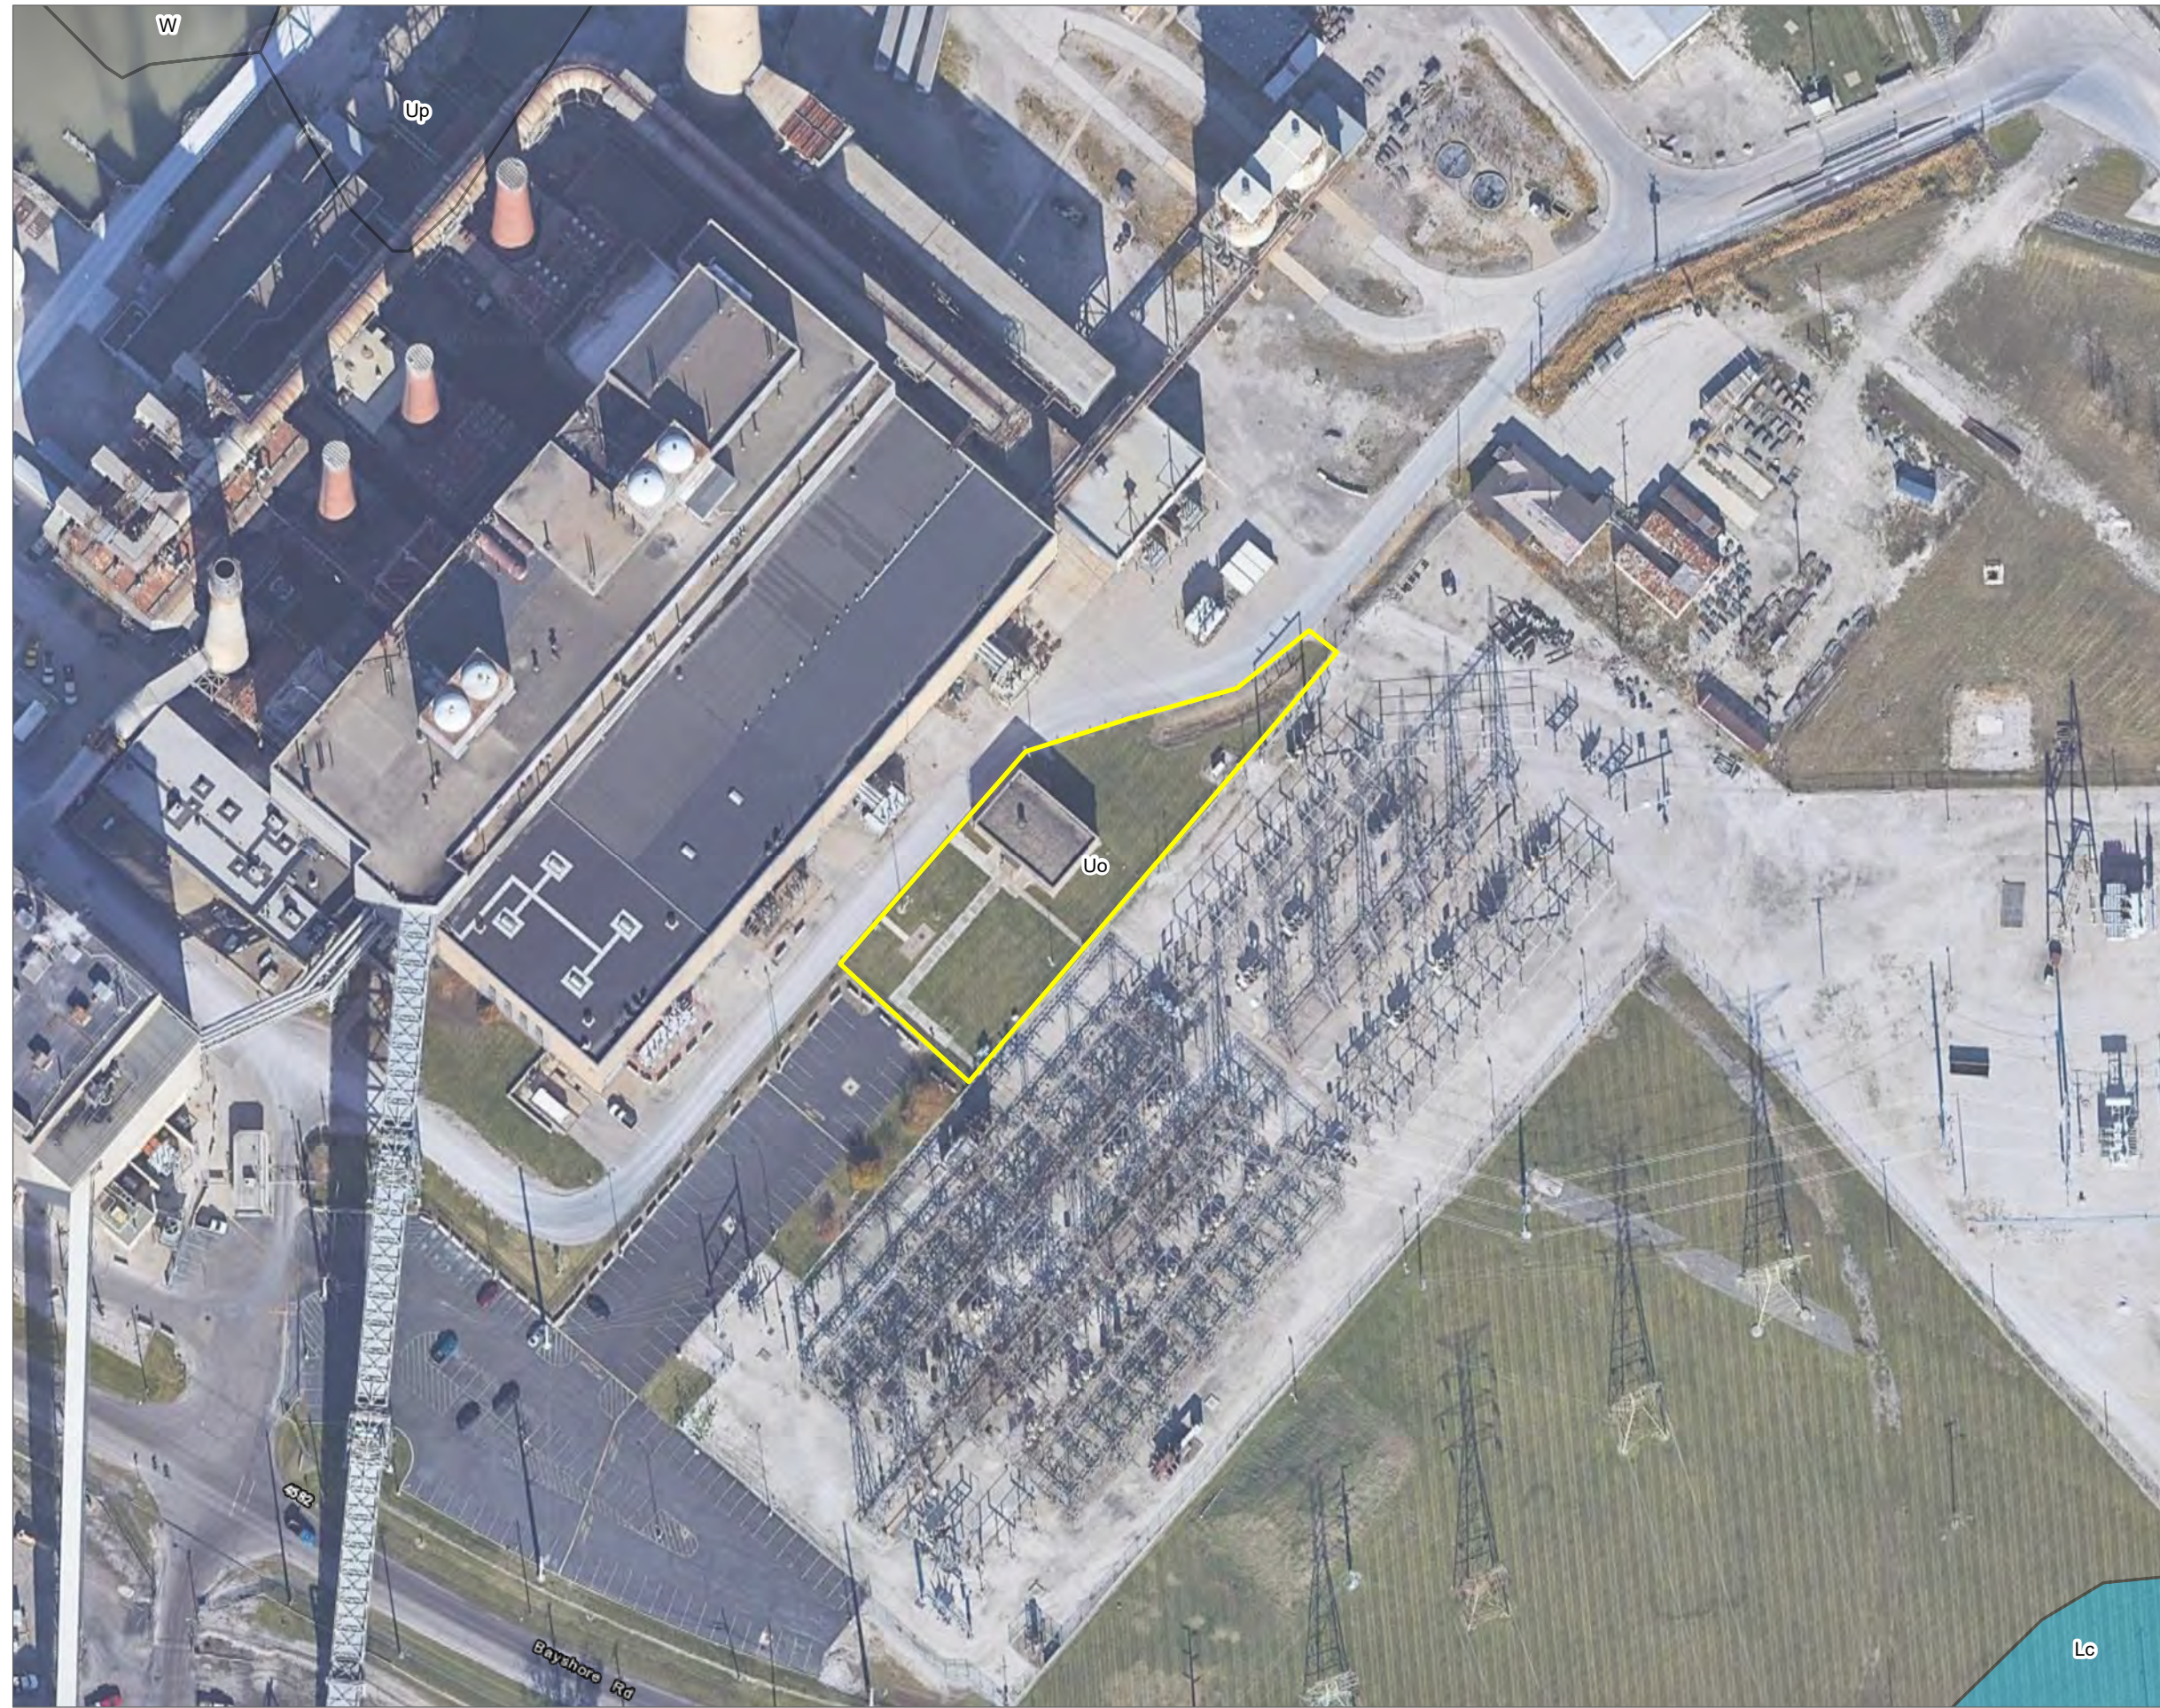
System: NAD 1983 StatePlane Ohio North FIPS 3401 Feet; Map Rotation: 0  
-- Saved By: MOBEL on 11/7/2025, 09:52:40 AM; File Path: T:\1-PROJECTS\First\_Energy\664674\_022\_BayshoreSubstation\2-APR\WDR.aprx; Layout Name: Fig03\_Soils

- PROJECT STUDY AREA
- HYDRIC SOIL
- NON-HYDRIC W/ HYDRIC INCLUSIONS SOIL
- NON-HYDRIC SOIL

BASE MAP: GOOGLE MAPS.  
DATA SOURCES: SOILS DATA ACQUIRED FROM USDA/NRCS SSURGO DATABASE.

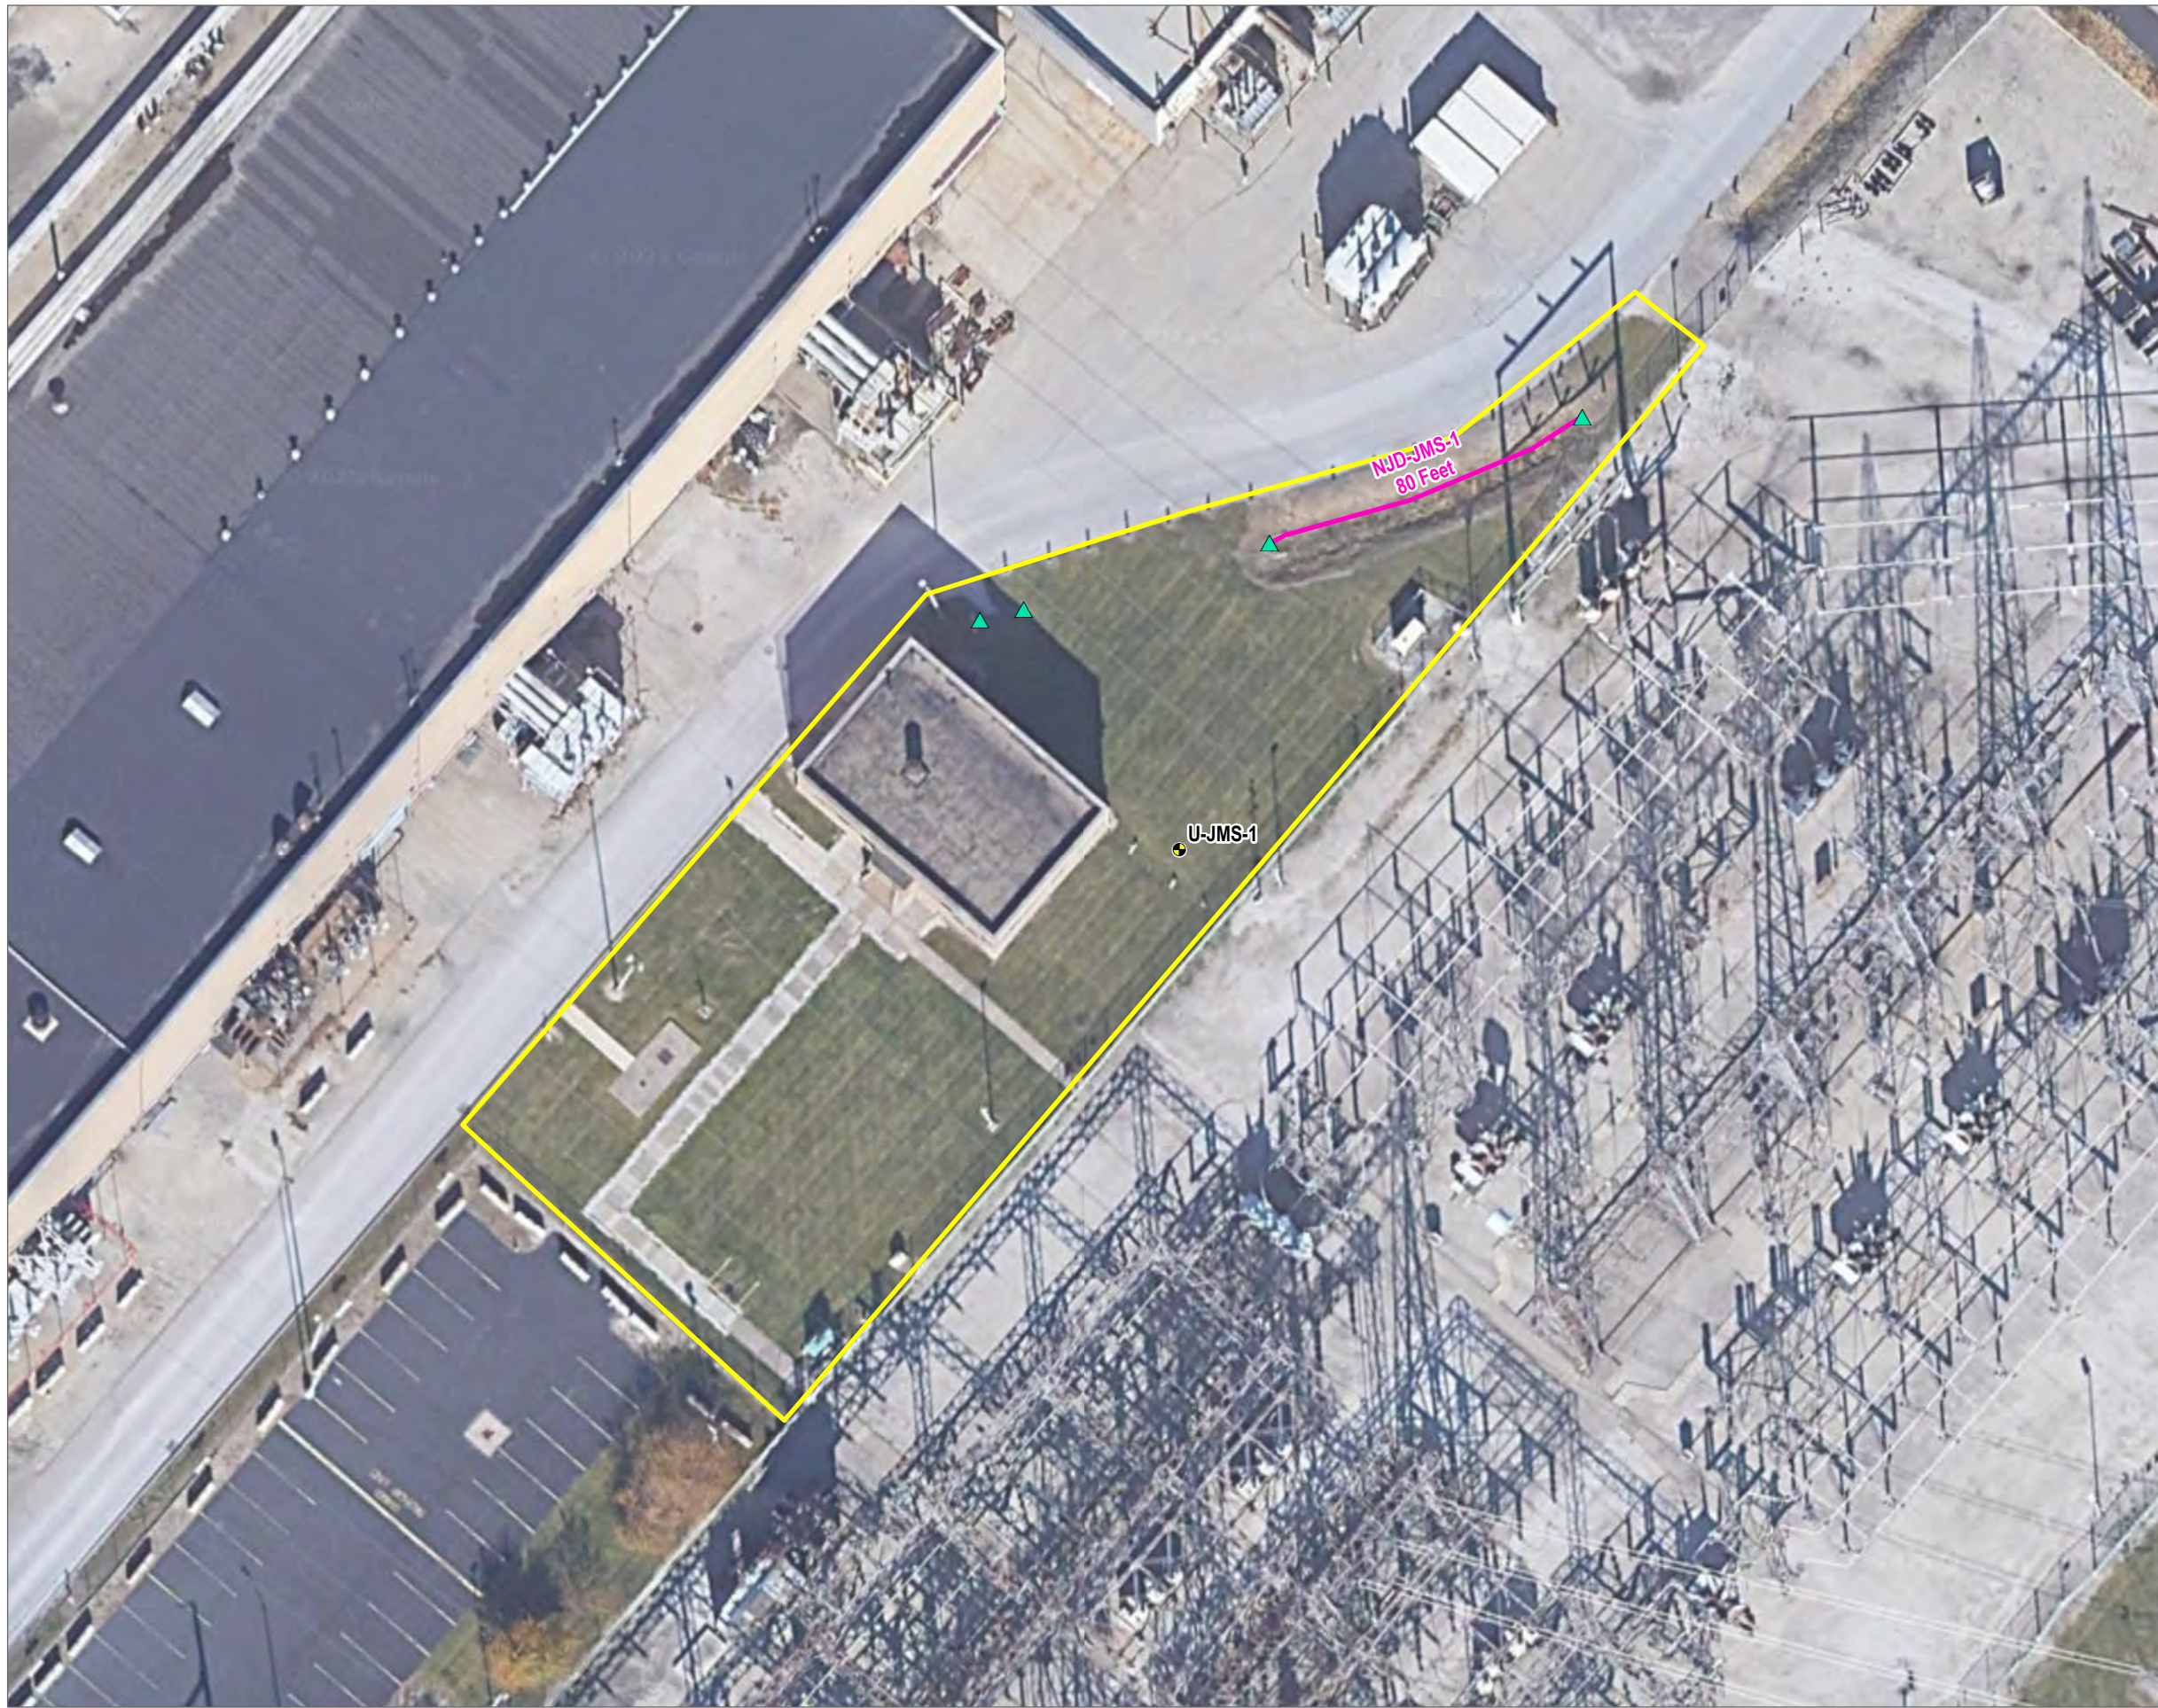
Coordinate System: NAD 1983 StatePlane Ohio North FIPS 3401 Feet, Map Rotation: 0  
-- Saved By: MOPEL on 11/7/2025, 09:38:59 AM. File Path: T:\1-PROJECTS\First\_Energy\664674\_022\_BayshoreSubstation\2-APR\X\WDR.aprx; Layout Name: Fig05, Delineation

PROJECT STUDY AREA

CULVERT

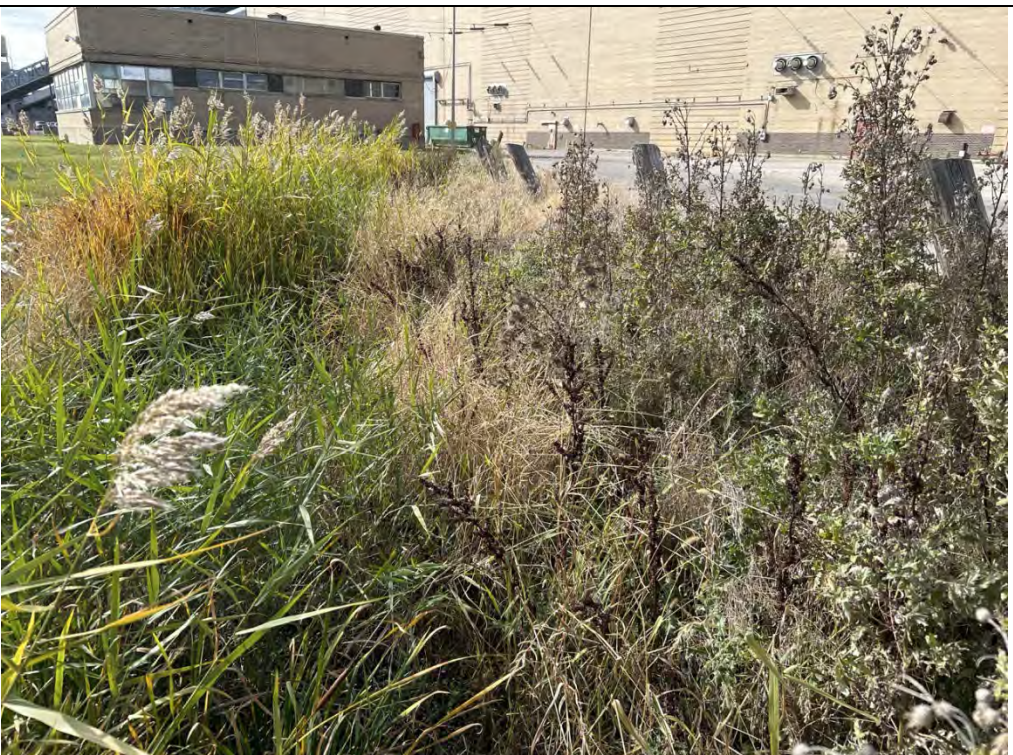
| <b>Photo No. 4.</b> | |

| <b>Description:</b><br><br>Photo of NJD-JMS-1 within the Project Study Area, facing west. | |
